# Aviation Investigation Final Report

<b>Location:</b>	Norfolk, Virginia	<b>Accident Number:</b>	ERA15FA144
<b>Date &amp; Time:</b>	March 4, 2015, 04:13 Local	<b>Registration:</b>	N66BB
<b>Aircraft:</b>	Mooney M20F	<b>Aircraft Damage:</b>	Substantial
<b>Defining Event:</b>	Controlled flight into terr/obj (CFIT)	<b>Injuries:</b>	3 Fatal
<b>Flight Conducted Under:</b>	Part 91: General aviation - Personal

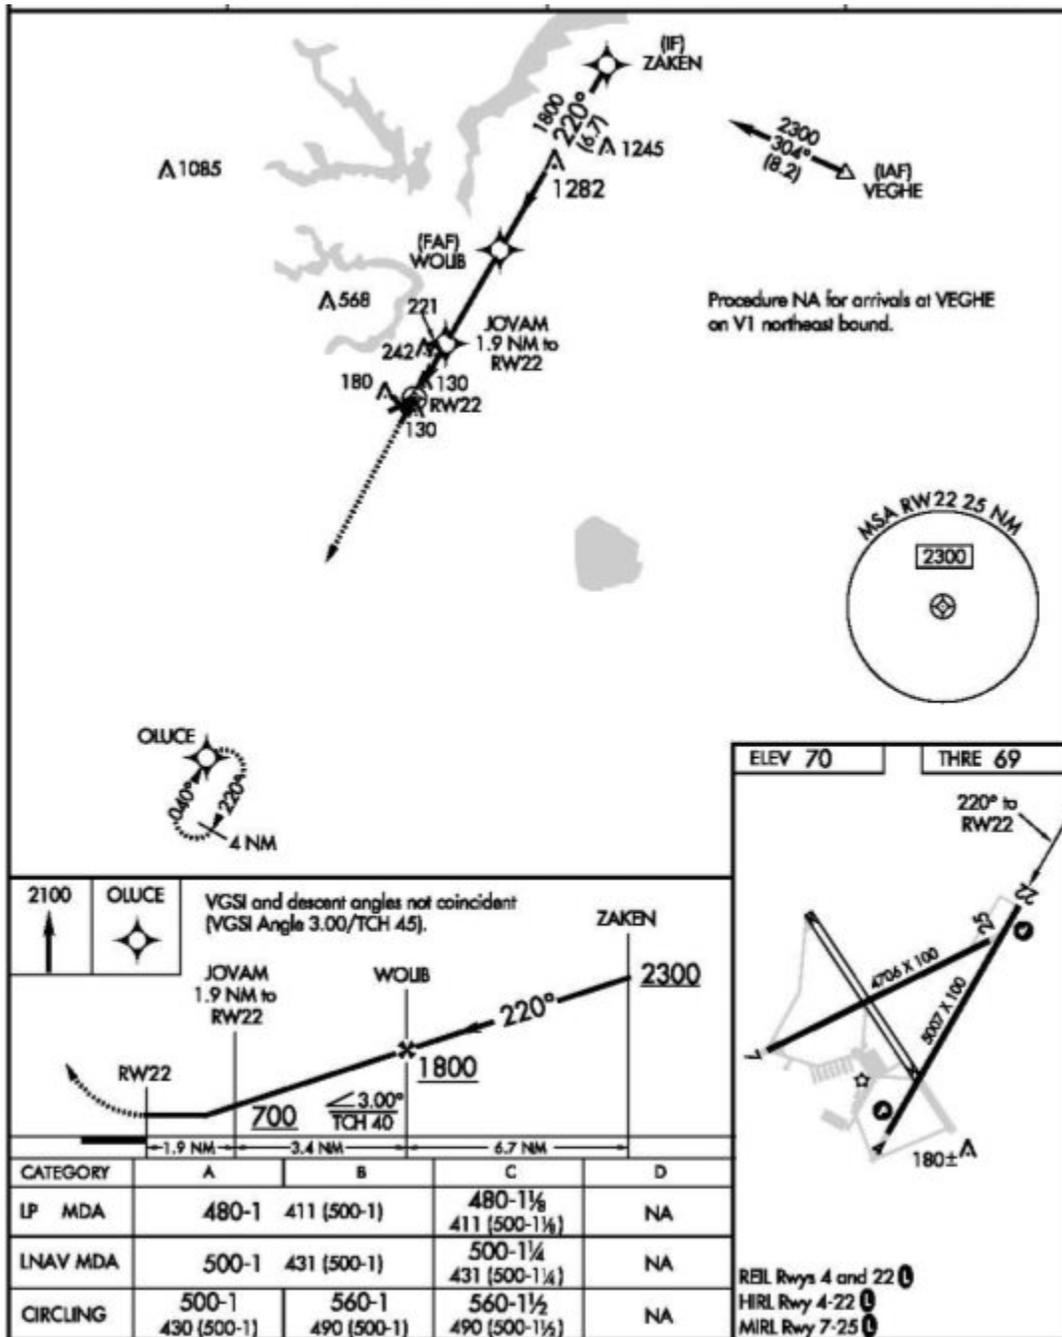
According to air traffic control (ATC) voice communication and radar data provided by the Federal Aviation Administration (FAA), along with data recovered from a handheld GPS receiver, the pilot contacted the approach control facility at ORF at 0253, while en route to SFQ. The controller asked the pilot to advise when he had obtained the weather conditions at SFQ. The pilot subsequently asked the controller for permission to change frequencies so that he could obtain the weather information and said, "I can't get it on my phone." About 3 minutes later, the pilot requested the RNAV GPS RWY 22 instrument approach to SFQ. (See figure 1 for the instrument approach procedure.)

Figure 1 - SFQ RNAV RWY 22 instrument approach procedure (excerpt).

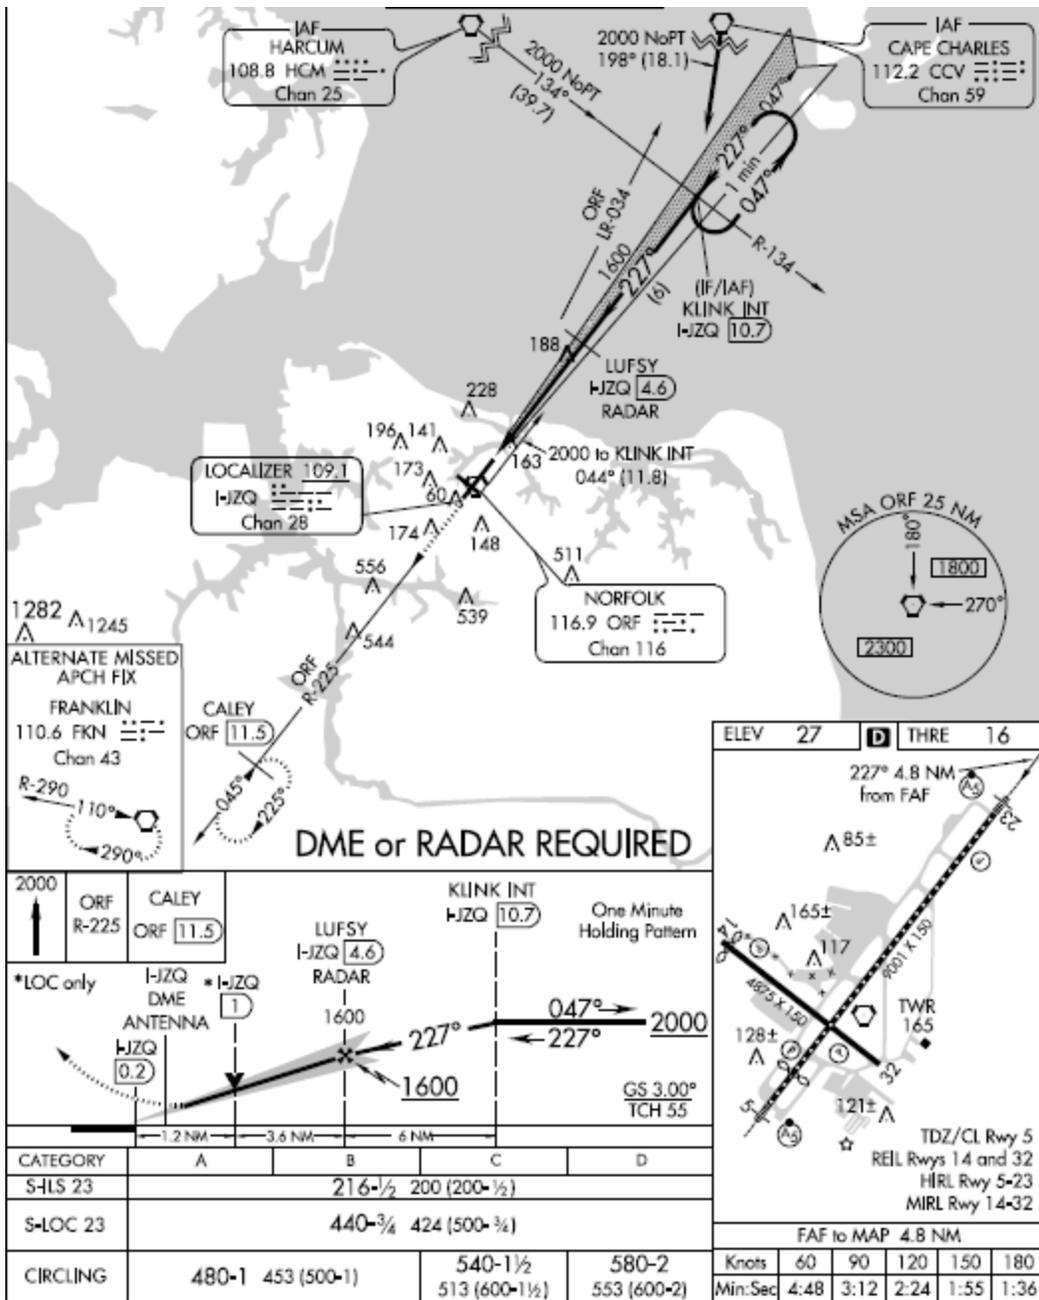
At 0342, the controller confirmed that the pilot had established the airplane on the localizer course. The pilot responded, "we are on the localizer at 1,300 ft, glideslope is coming down to us." The controller reiterated that the pilot should maintain 1,600 ft until reaching LUFYSY (see figure 4) and stated, "once you get to LUFYSY, you can follow the glideslope down, but the proper height now is 1,600." The controller then advised the pilot that he had adjusted the runway lights to their maximum intensity.

Figure 4 - ORF ILS RWY 23 instrument approach procedure (excerpt).
