Aviation Investigation Final Report

Location:	Moncks Corner, South Carolina	Accident Number:	ERA15MA259
Date & Time:	July 7, 2015, 11:00 Local	Registration:	N3601V
Aircraft:	Cessna 150M	Aircraft Damage:	Destroyed
Defining Event:	Midair collision	Injuries:	2 Fatal
Flight Conducted Under:	Part 91: General aviation - Personal

Location:	Moncks Corner, South Carolina	Accident Number:	ERA15MA259
Date & Time:	July 7, 2015, 11:00 Local	Registration:	96-0085
Aircraft:	LOCKHEED-MARTIN F-16CM	Aircraft Damage:	Destroyed
Defining Event:	Midair collision	Injuries:	1 Minor
Flight Conducted Under:	Armed Forces

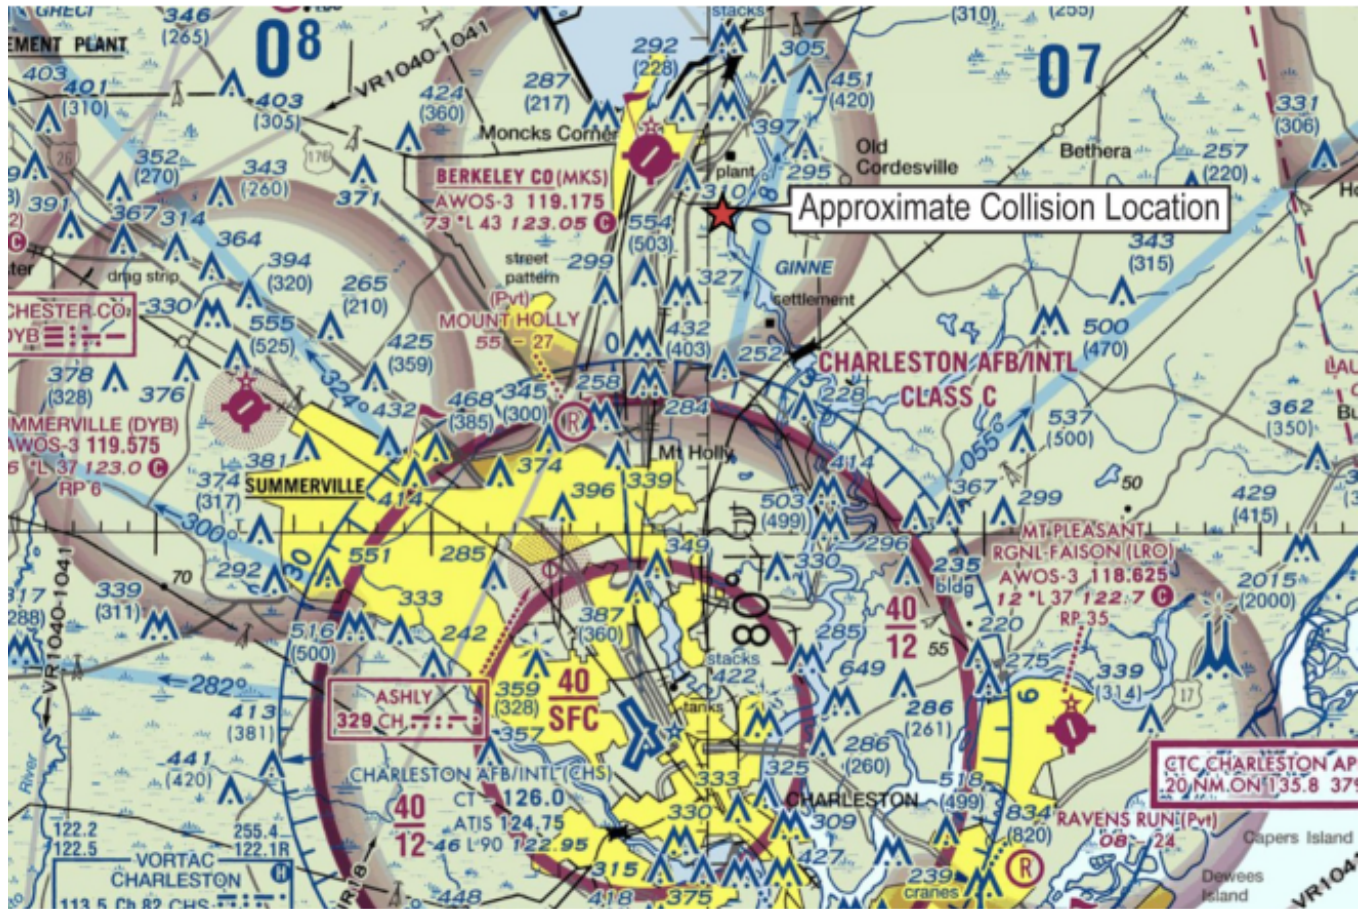
MKS, the Cessna's departure airport, is located about 17 nm north of CHS and is outside the CHS class C airspace. The airspace surrounding MKS and encompassing the collision location is designated as class E and extends from 700 ft agl to 17,999 ft msl. There are no two-way radio communication or transponder use requirements for operation in class E airspace. The established minimum vectoring altitude for ATC in this area is 1,600 ft, which represented the lowest altitude available to controllers when providing radar vectors to aircraft operating under IFR. Figure 2 shows an FAA sectional chart depicting CHS and class C airspace, MKS, and the approximate collision location.

Figure 2. FAA sectional aeronautical chart view depicting CHS and class C airspace, MKS, and the approximate collision location. (Not for navigational use.)

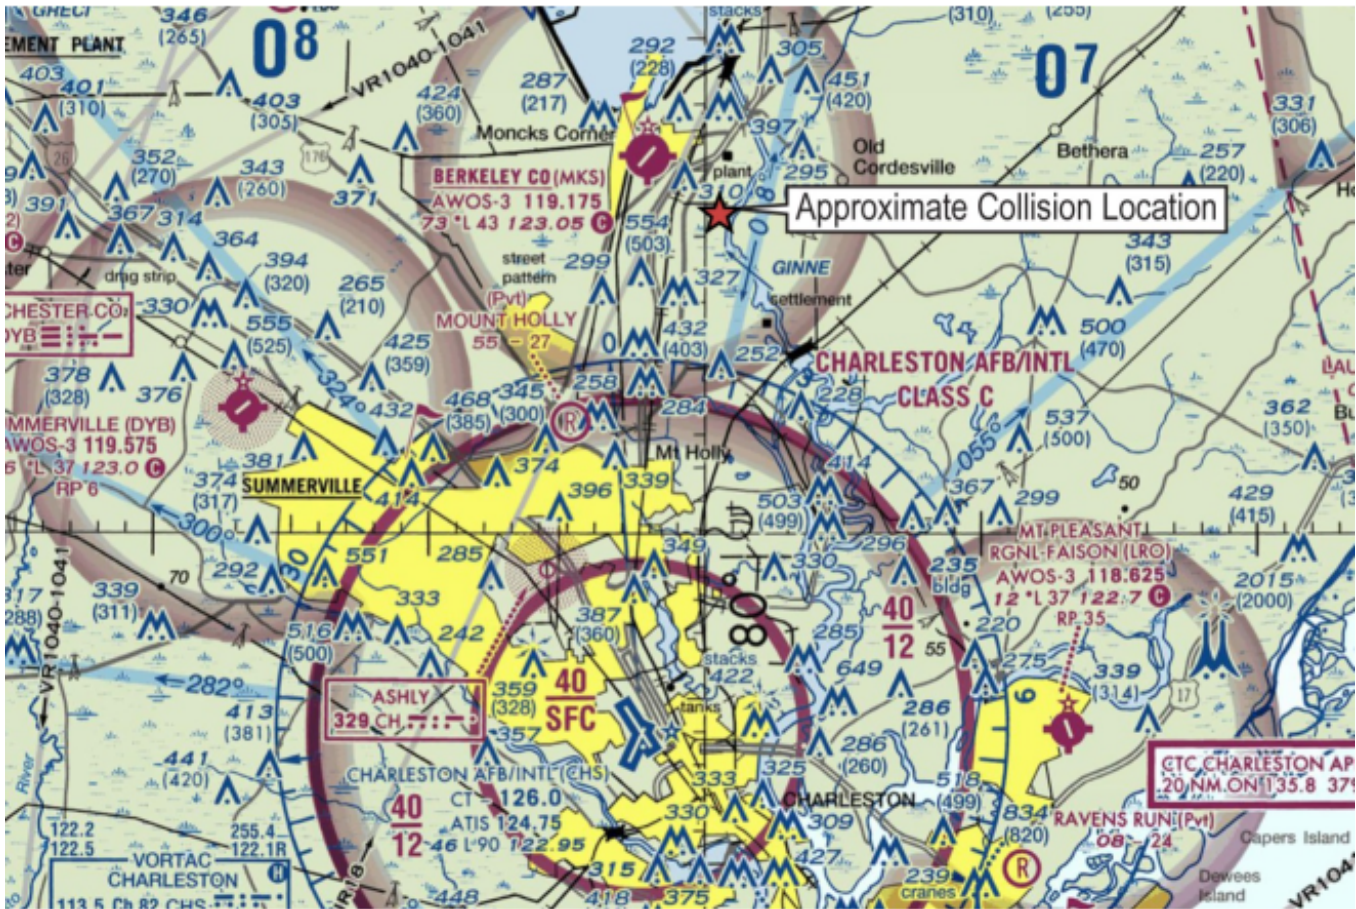
MKS, the Cessna's departure airport, is located about 17 nm north of CHS and is outside the CHS class C airspace. The airspace surrounding MKS and encompassing the collision location is designated as class E and extends from 700 ft agl to 17,999 ft msl. There are no two-way radio communication or transponder use requirements for operation in class E airspace. The established minimum vectoring altitude for ATC in this area is 1,600 ft, which represented the lowest altitude available to controllers when providing radar vectors to aircraft operating under IFR. Figure 2 shows an FAA sectional chart depicting CHS and class C airspace, MKS, and the approximate collision location.

Figure 2. FAA sectional aeronautical chart view depicting CHS and class C airspace, MKS, and the approximate collision location. (Not for navigational use.)
