Aviation Investigation Final Report

Location:	Reedsville, Wisconsin	Accident Number:	CEN16FA171
Date & Time:	May 4, 2016, 10:02 Local	Registration:	N629JK
Aircraft:	McDonnell Douglas Helicopter 369E	Aircraft Damage:	Substantial
Defining Event:	Loss of engine power (total)	Injuries:	1 Fatal
Flight Conducted Under:	Part 133: Rotorcraft ext. load

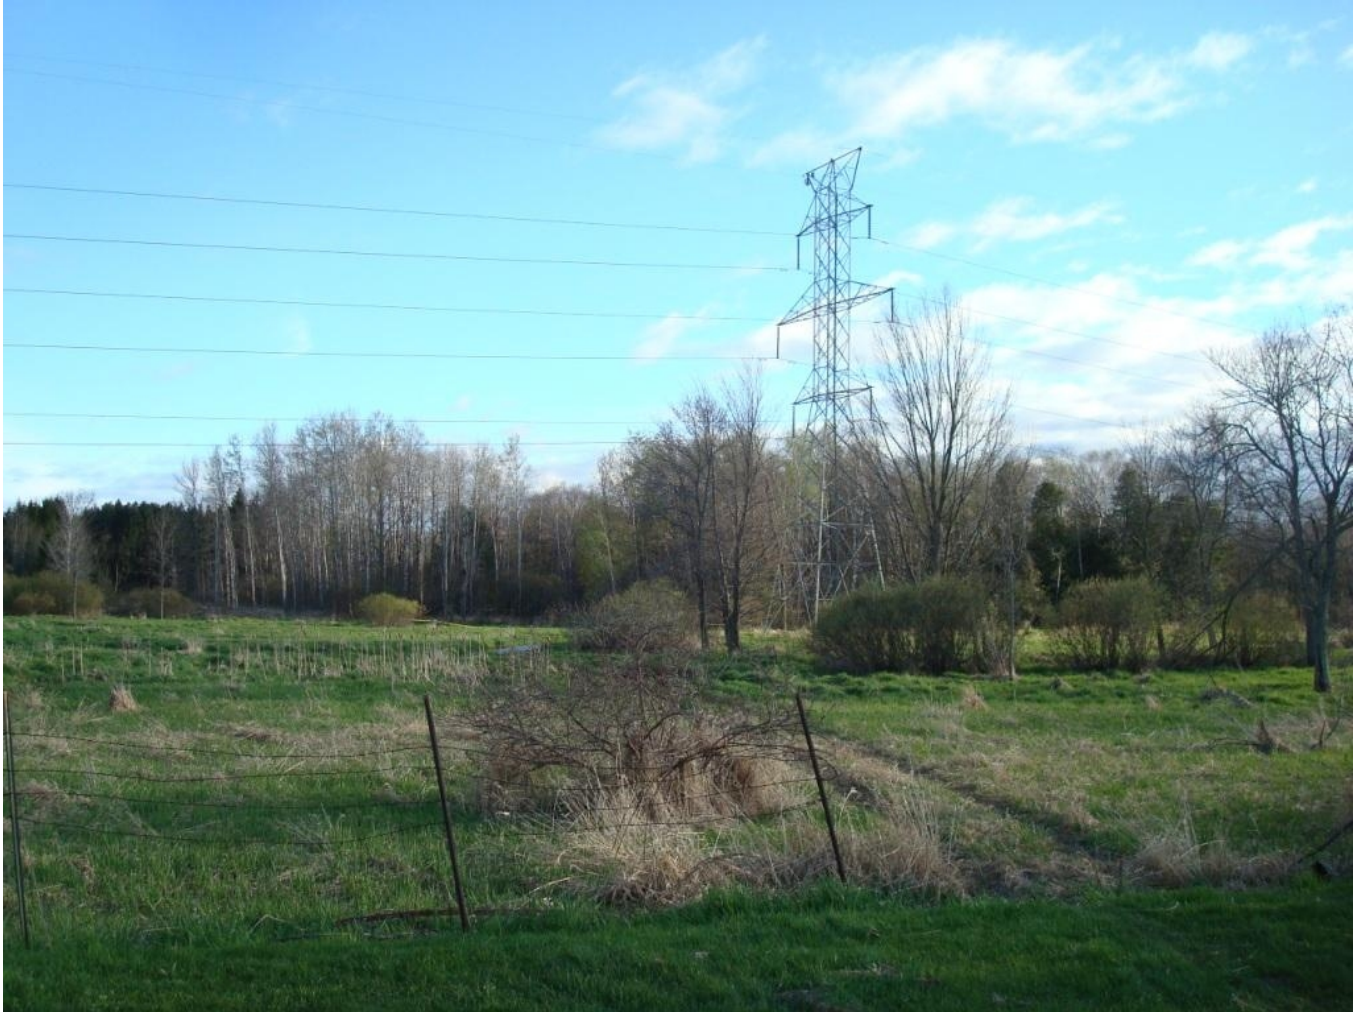
Two other project employees were about 150 yards north of tower 9904 (figure 2); they stated that, as the helicopter approached tower 9904 for the final time, the main rotor blades slowed down, the engine sound decreased, and the helicopter veered right toward the ground.

Figure 2 – View from project employee witness location, facing south toward tower 9904
