Aviation Investigation Final Report

Location:	Reedsville, Wisconsin	Accident Number:	CEN16FA171
Date & Time:	May 4, 2016, 10:02 Local	Registration:	N629JK
Aircraft:	McDonnell Douglas Helicopter 369E	Aircraft Damage:	Substantial
Defining Event:	Loss of engine power (total)	Injuries:	1 Fatal
Flight Conducted Under:	Part 133: Rotorcraft ext. load

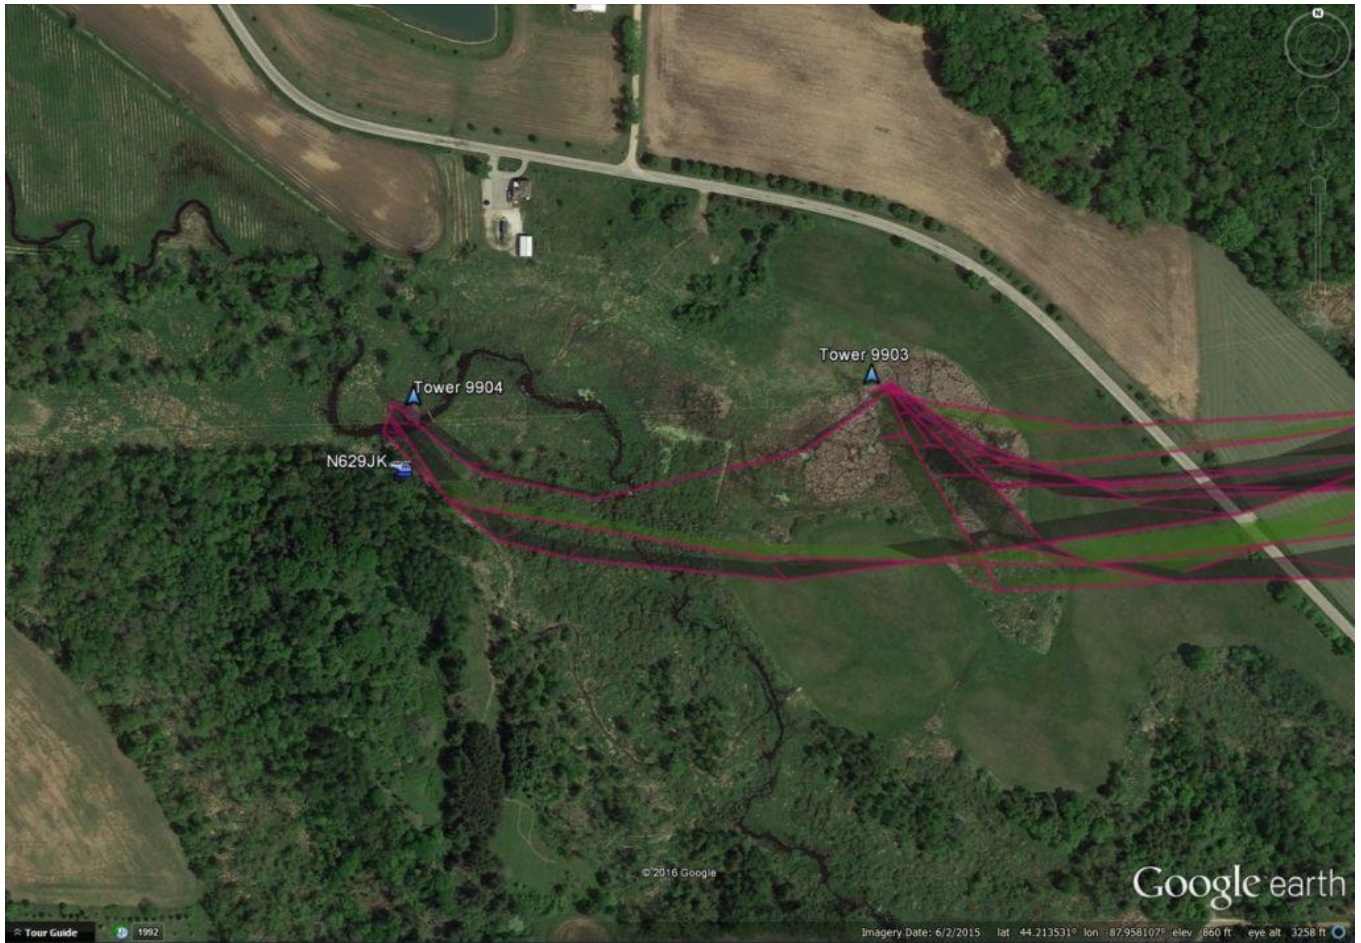
At 0949, the helicopter departed the LZ and transported two linemen from tower 9903 to the neighboring tower, 9904 (figure 1). When the linemen detached from the long line, the helicopter proceeded to the east and hovered for 2 to 3 minutes. The linemen requested that the helicopter come back to tower 9904 to pick up equipment and return to the LZ. The helicopter approached the tower from the southwest and faced northeast into the wind as the linemen presented hand signals to the pilot. The linemen stated that the end of the long line was about 20 ft laterally and 15 ft vertically from their reach when they noticed the helicopter's sound change and it descended suddenly. The helicopter veered to the right away from the tower, and the main rotor blades slowed noticeably. The helicopter continued into the trees and terrain south of the tower. The linemen climbed down from the tower and heard the helicopter's engine still producing noise. One lineman pulled the emergency fuel shutoff valve and turned off the battery.

Figure 1 – Google Earth overview of the accident area with GPS track downloaded from Garmin 496 onboard helicopter

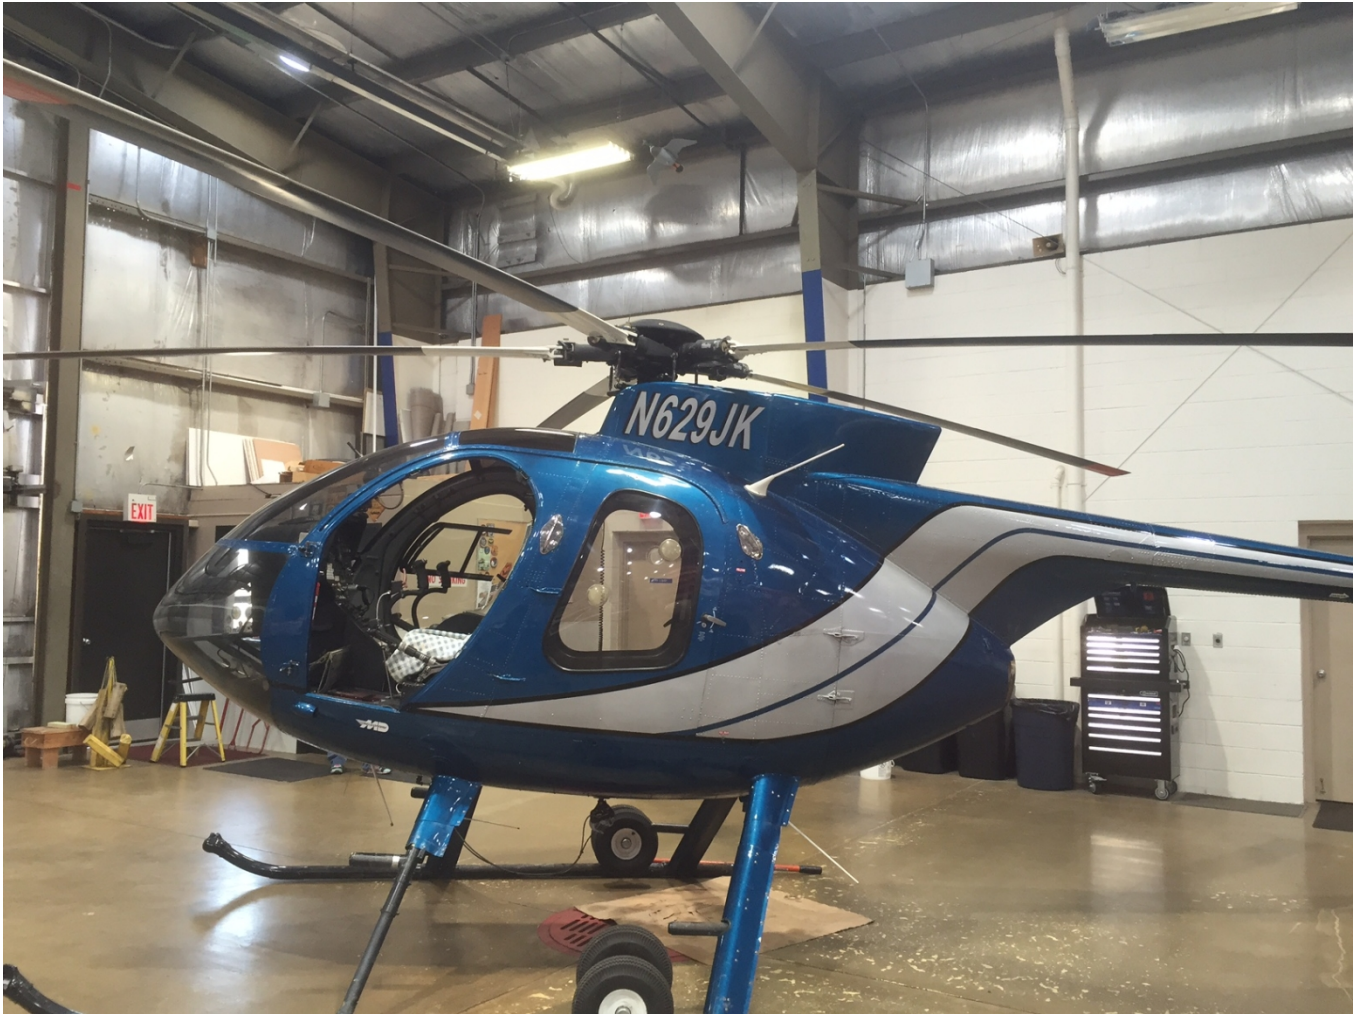
Figure 3 – Preaccident photograph of the helicopter
