# **Aviation Investigation Final Report**

Location:	Reedsville, Wisconsin	Accident Number:	CEN16FA171
Date & Time:	May 4, 2016, 10:02 Local	Registration:	N629JK
Aircraft:	McDonnell Douglas Helicopter 369E	Aircraft Damage:	Substantial
Defining Event:	Loss of engine power (total)	Injuries:	1 Fatal
Flight Conducted Under:	Part 133: Rotorcraft ext. load

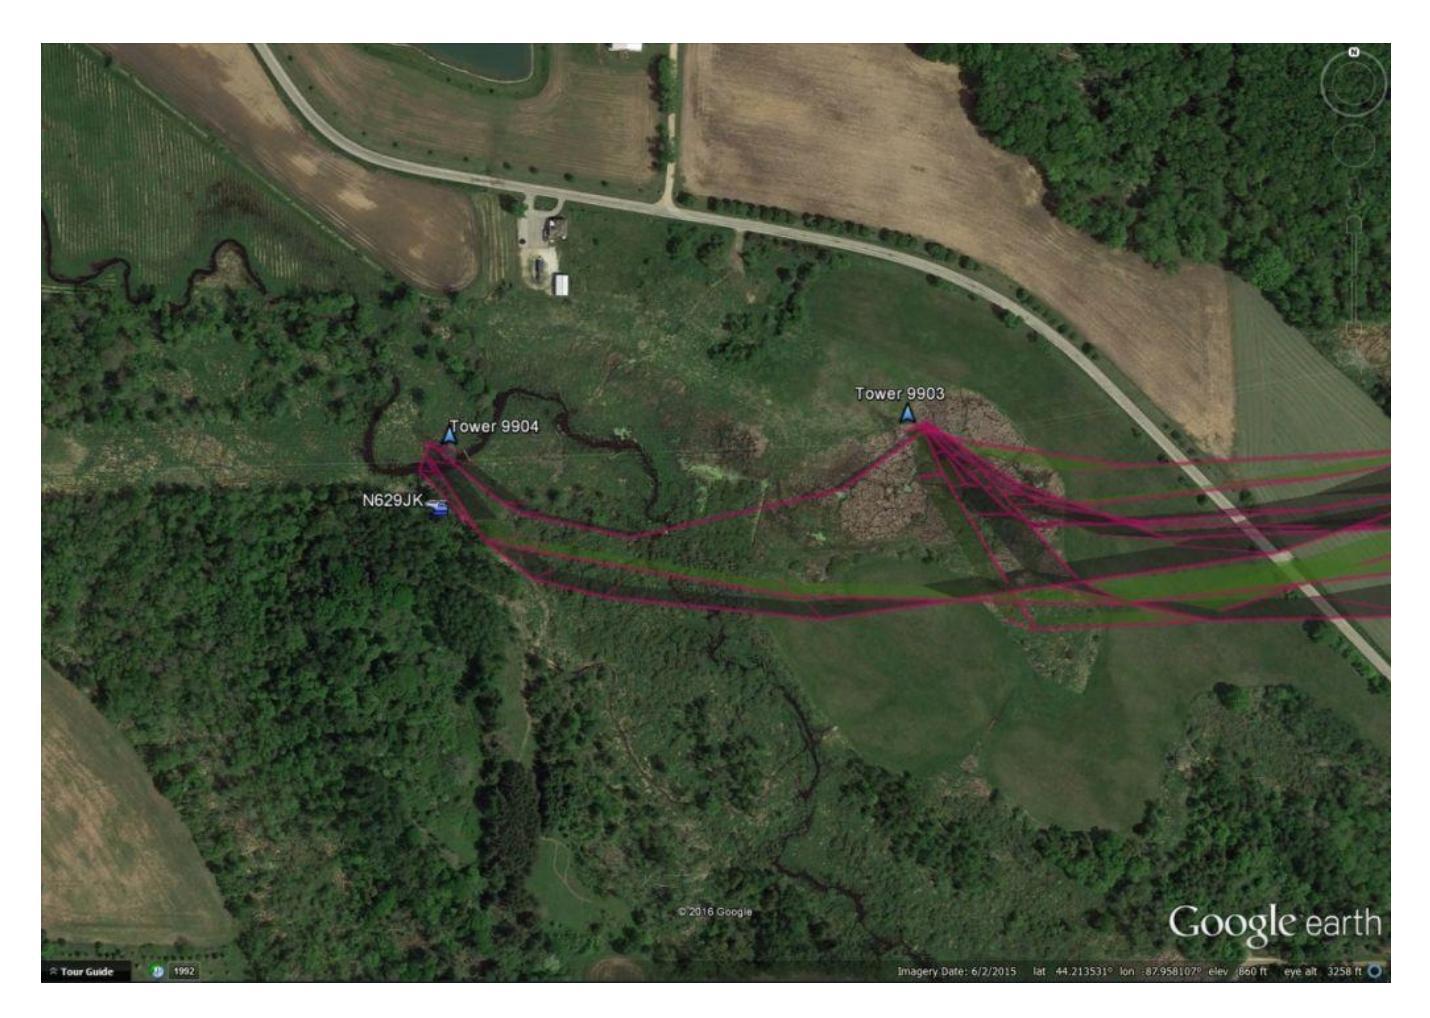
At 0949, the helicopter departed the LZ and transported two linemen from tower 9903 to the neighboring tower, 9904 (figure 1). When the linemen detached from the long line, the helicopter proceeded to the east and hovered for 2 to 3 minutes. The linemen requested that the helicopter come back to tower 9904 to pick up equipment and return to the LZ. The helicopter approached the tower from the southwest and faced northeast into the wind as the linemen presented hand signals to the pilot. The linemen stated that the end of the long line was about 20 ft laterally and 15 ft vertically from their reach when they noticed the helicopter's sound change and it descended suddenly. The helicopter veered to the right away from the tower, and the main rotor blades slowed noticeably. The helicopter continued into the trees and terrain south of the tower. The linemen climbed down from the tower and heard the helicopter's engine still producing noise. One lineman pulled the emergency fuel shutoff valve and turned off the battery.

Figure 1 – Google Earth overview of the accident area with GPS track downloaded from Garmin 496 onboard helicopter

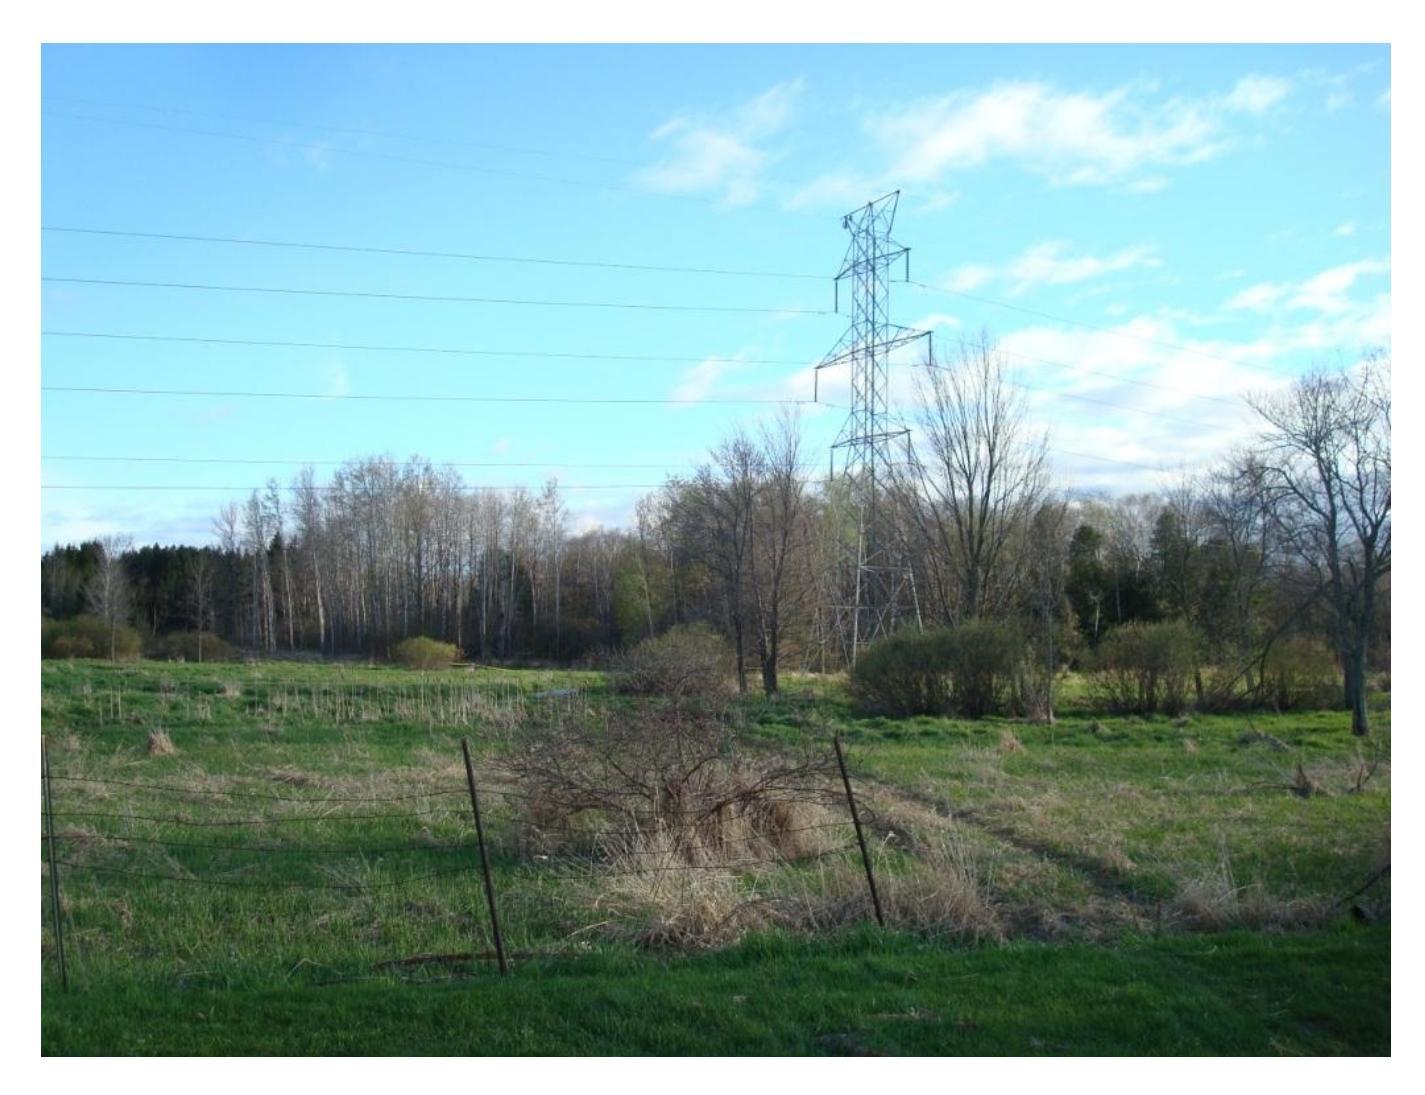
Two other project employees were about 150 yards north of tower 9904 (figure 2); they stated that, as the helicopter approached tower 9904 for the final time, the main rotor blades slowed down, the engine sound decreased, and the helicopter veered right toward the ground.

Figure 2 – View from project employee witness location, facing south toward tower 9904
