Aviation Investigation Final Report

Location:	Italy, Texas	Accident Number:	DCA16FA199
Date & Time:	July 6, 2016, 11:48 Local	Registration:	N525TA
Aircraft:	Bell 525	Aircraft Damage:	Destroyed
Defining Event:	Aircraft structural failure	Injuries:	2 Fatal
Flight Conducted Under:	Part 91: General aviation - Flight test

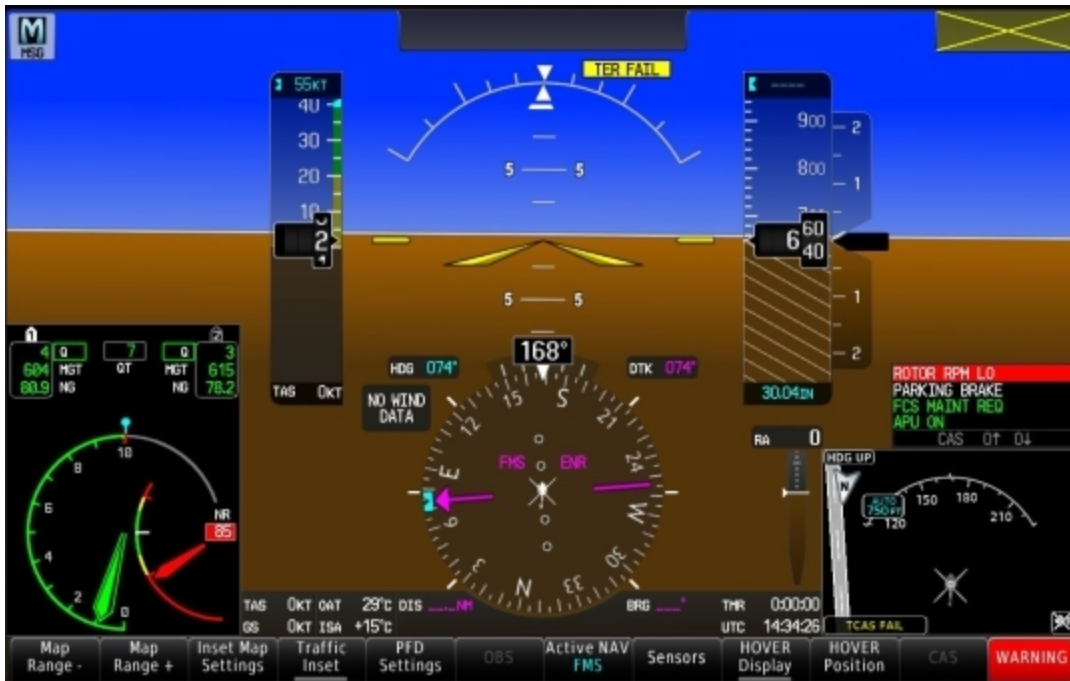
Figure 6. Example of PFD during "ROTOR RPM LO" warning.

The CAS was located in the middle right side of the PFD and displayed color-coded messages for status, advisory, caution, and warning alerts (see figure 5). The Bell 525 lead test pilot described warnings as items that need immediate attention and cautions as items that will need attention but not immediately. (Warnings were displayed as white text on red background, cautions were displayed as yellow text on black background, advisories were displayed as white text on black background, and status messages were displayed as green text on black background.) When warnings and caution alerts were triggered, the displayed messages would flash until either the cockpit master warning/caution push button annunciator (PBA) was pressed, the bezel button on the lower right corner of the PFD was pressed, or the triggered condition was inactive for more than 5 seconds. In addition, a caution/warning flag would appear in the lower right corner of the PFD, and a caution/warning light would illuminate on the PBA. For the accident helicopter, if Nr dropped below 90% (in AEO or OEI), a "ROTOR RPM LO" warning-level message appeared (see figure 6). Once the condition cleared, the message would immediately disappear.
