# Aviation Investigation Final Report

<b>Location:</b>	Fort Lauderdale, Florida	<b>Accident Number:</b>	DCA17MA022
<b>Date &amp; Time:</b>	October 28, 2016, 17:51 Local	<b>Registration:</b>	N370FE
<b>Aircraft:</b>	McDonnell Douglas MD 10-10F	<b>Aircraft Damage:</b>	Substantial
<b>Defining Event:</b>	Landing gear collapse	<b>Injuries:</b>	2 None
<b>Flight Conducted Under:</b>	Part 121: Air carrier - Non-scheduled

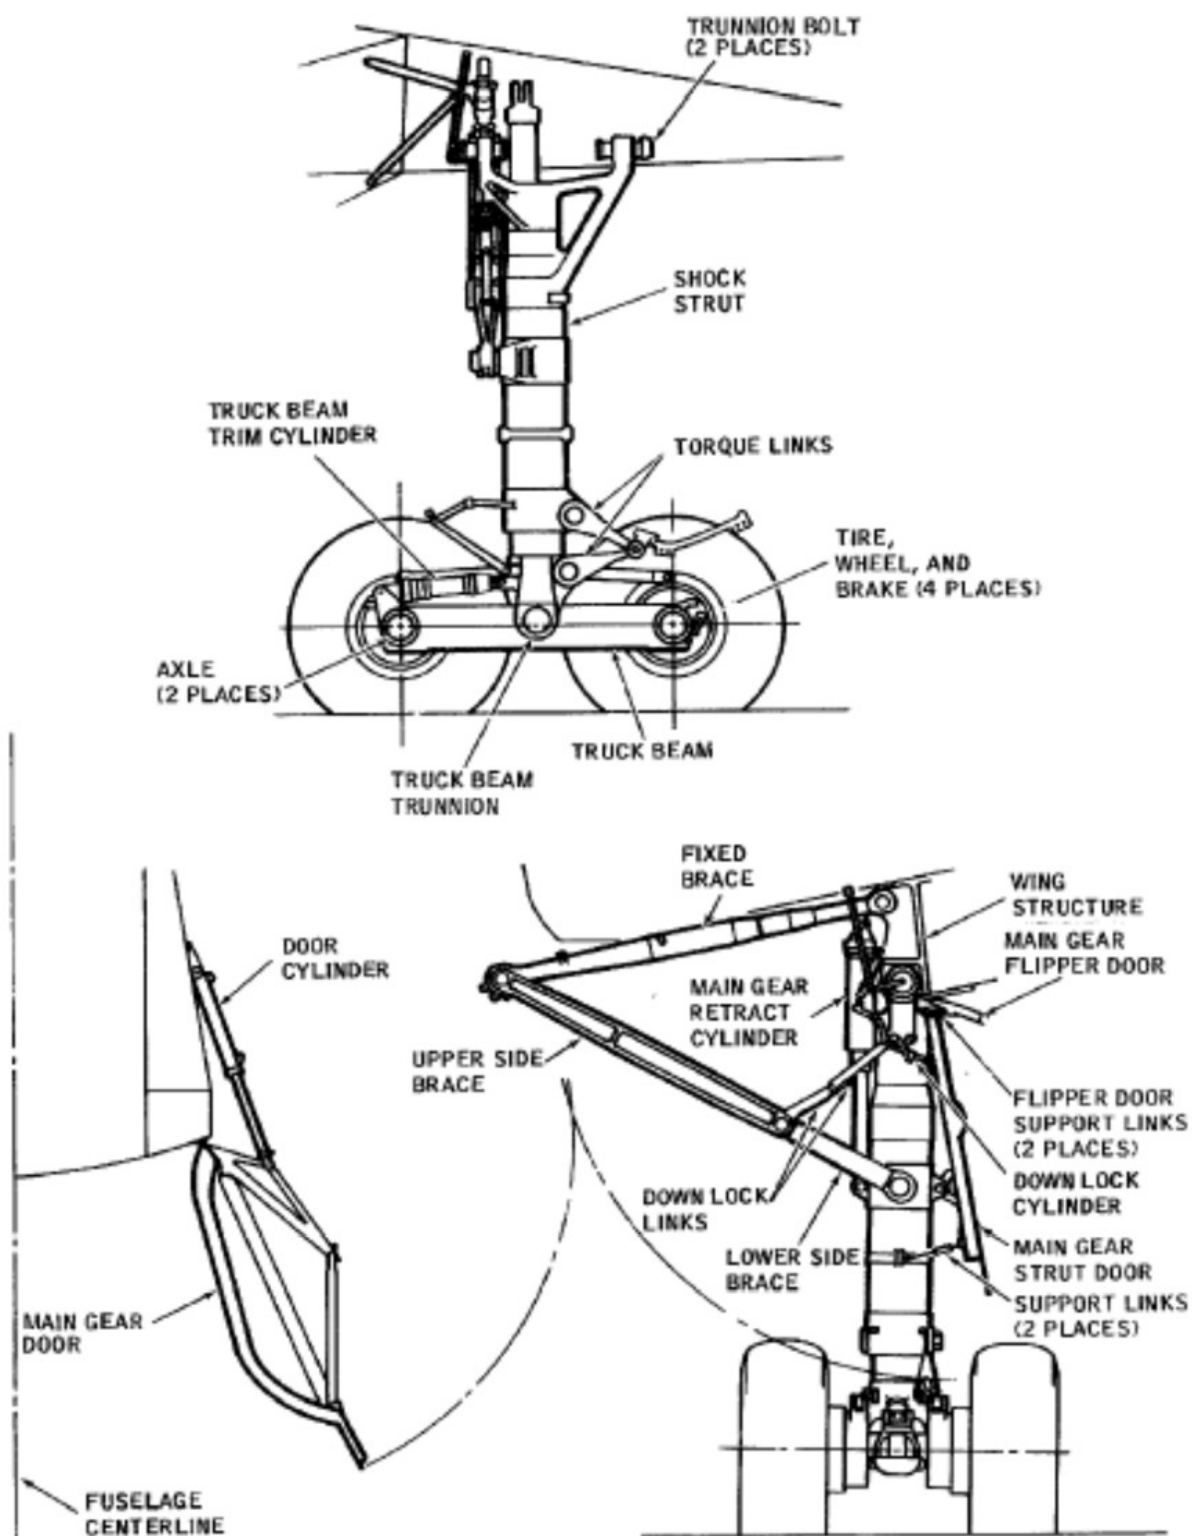
Figure 1. Diagram of MD-10-10F MLG (right shown)

The airplane came to rest off the left side of runway 10L near the A4 taxiway. The outer cylinder of the left MLG was fractured midway through the air filler valve bore on the aft side. The outer cylinder of the left MLG shock strut fractured around its entire circumference; the upper portion of the cylinder remained intact and attached to the airplane at the forward and aft trunnion lugs (figure 1 shows a diagram of an MD-10-10F MLG and figure 2 shows the upper portion of the accident MLG). No anomalies were noted with the trunnion lugs or trunnion bolt attachment points.

The inboard side lugs and bolt and nut for the retract actuator attach points and the fixed door attach points remained intact. On the aft side of the lower section of the fractured gear, about half of the upper charging bore was visible (see figure 3). On-scene examination identified features consistent with fatigue on the fracture surface of the outer cylinder in the area of the air filler valve bore (see Tests and Research for more information).

The lower segment of the landing gear was folded aft into the left side inboard flap. The lower portion of the gear remained attached to the MLG side brace assembly. The left MLG truck beam remained attached to the lower portion of the cylinder and shock strut at the pivot pin. The truck beam exhibited a crack running aft from the No. 1 wheel position axle to a 3-inch-long by 2-inch-wide hole on the top side near the pivot area (see MLG diagram in figure 3).
