Aviation Investigation Final Report

Location:	Fort Lauderdale, Florida	Accident Number:	DCA17MA022
Date & Time:	October 28, 2016, 17:51 Local	Registration:	N370FE
Aircraft:	McDonnell Douglas MD 10-10F	Aircraft Damage:	Substantial
Defining Event:	Landing gear collapse	Injuries:	2 None
Flight Conducted Under:	Part 121: Air carrier - Non-scheduled

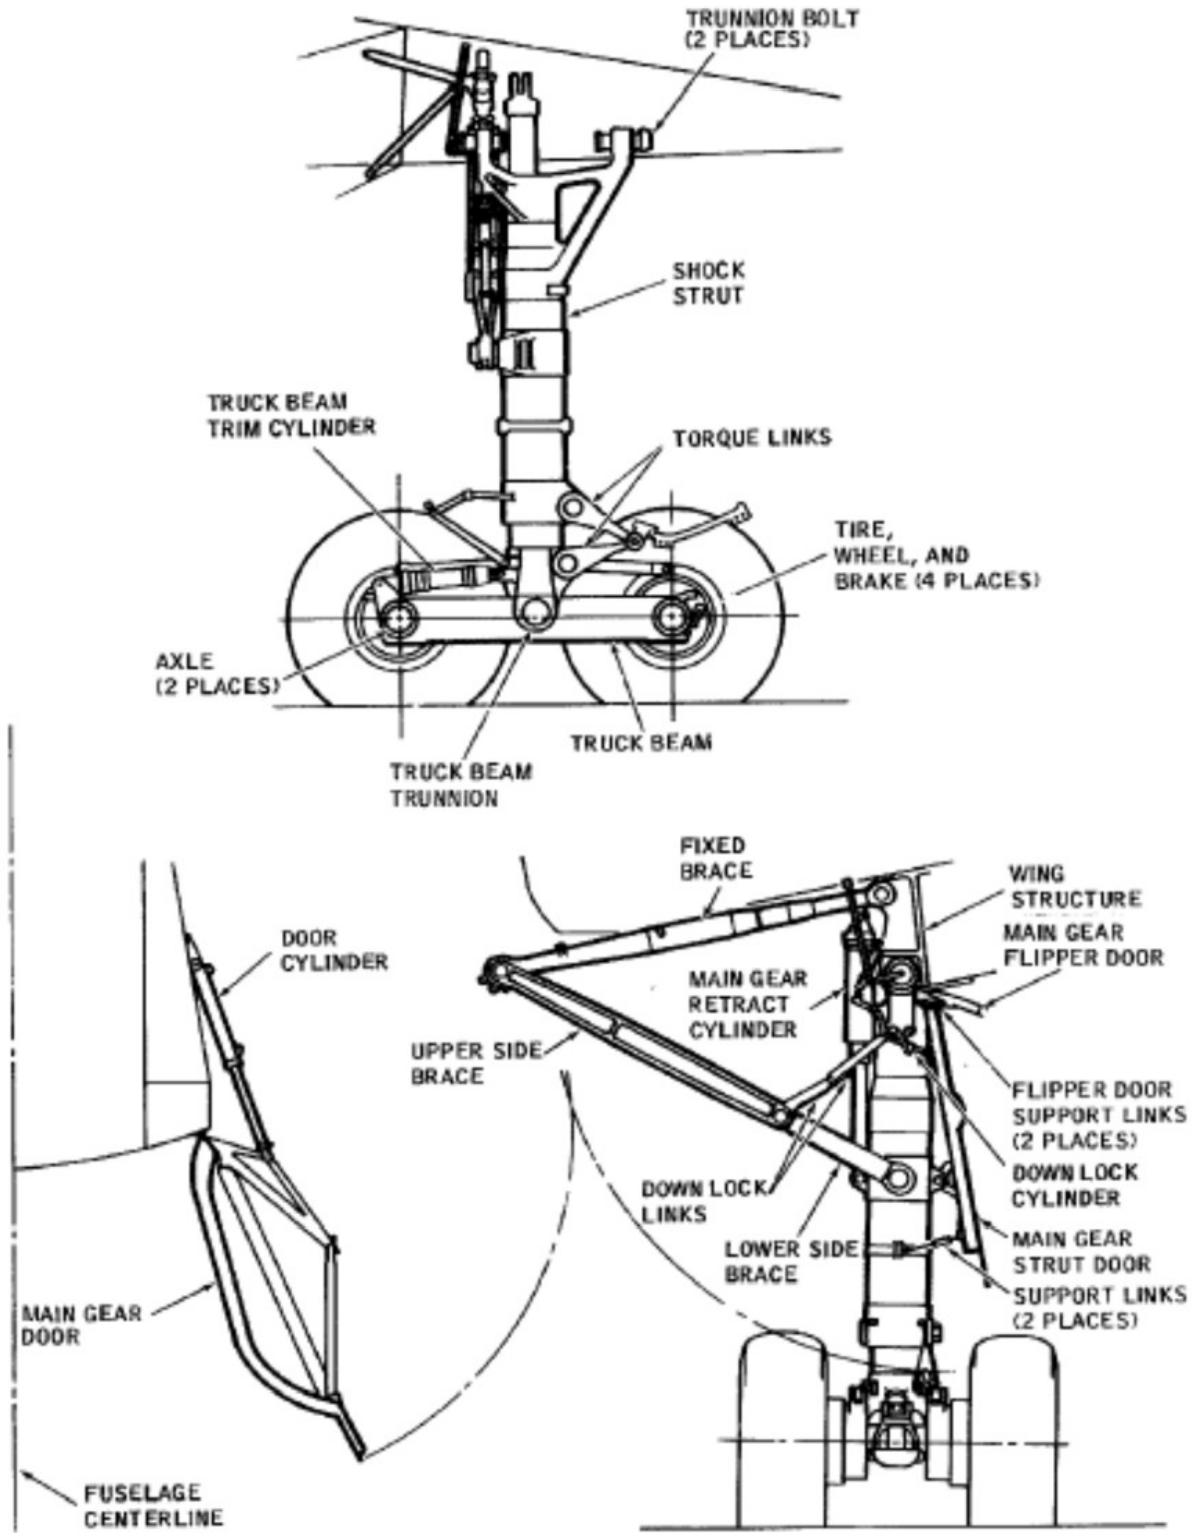
Figure 1. Diagram of MD-10-10F MLG (right shown)

The airplane came to rest off the left side of runway 10L near the A4 taxiway. The outer cylinder of the left MLG was fractured midway through the air filler valve bore on the aft side. The outer cylinder of the left MLG shock strut fractured around its entire circumference; the upper portion of the cylinder remained intact and attached to the airplane at the forward and aft trunnion lugs (figure 1 shows a diagram of an MD-10-10F MLG and figure 2 shows the upper portion of the accident MLG). No anomalies were noted with the trunnion lugs or trunnion bolt attachment points.
