Aviation Investigation Final Report

Location:	Hertford, North Carolina	Accident Number:	ERA17MA316
Date & Time:	September 8, 2017, 11:20 Local	Registration:	N146DU
Aircraft:	EUROCOPTER DEUTSCHLAND GMBH MBB BK 117	Aircraft Damage:	Destroyed
Defining Event:	Loss of engine power (partial)	Injuries:	4 Fatal
Flight Conducted Under:	Part 135: Air taxi & commuter - Non-scheduled - Air Medical (Discretionary)

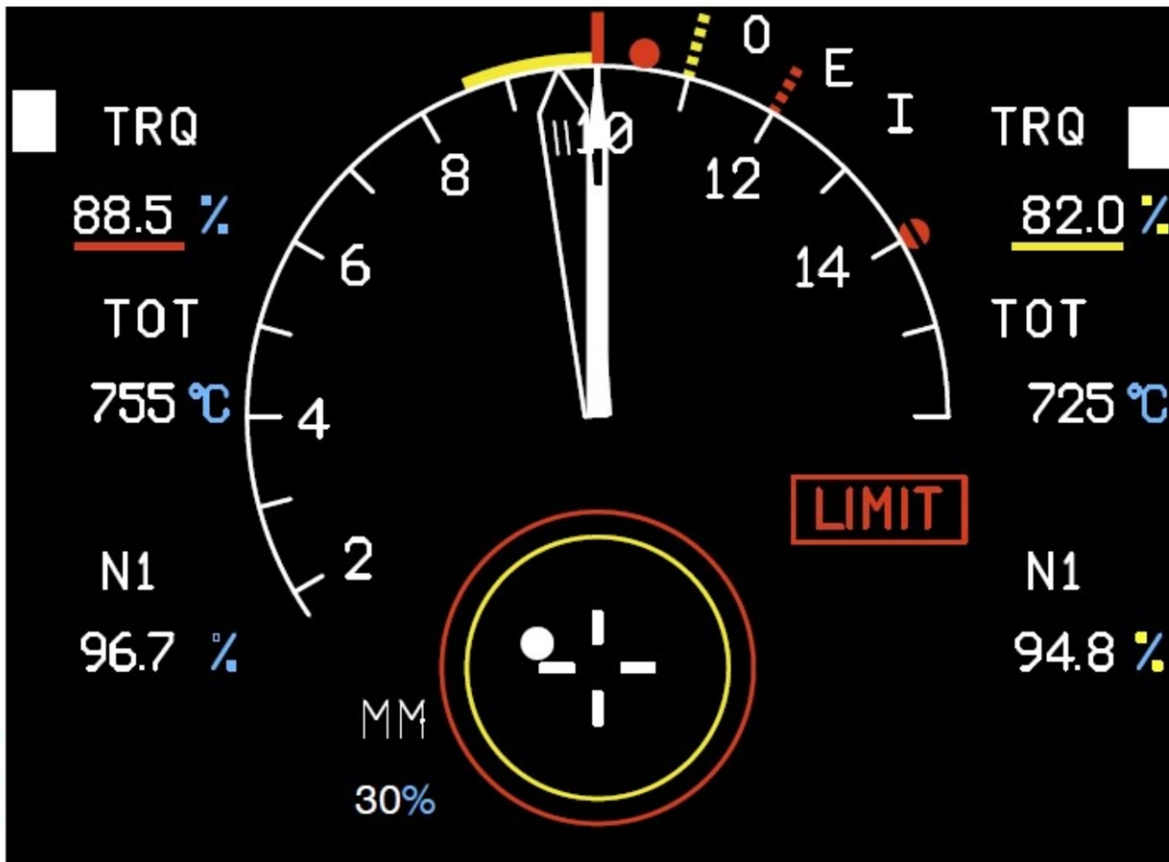
Figure 1 - First limit indicator. (Information from rotorcraft flight manual.)

Specifically, as the bearing failed, the FLI needle for the No. 2 engine would have changed from indicating torque (TRQ), to indicating turbine outlet temperature (TOT) due to a sudden rise in TOT in the No. 2 engine. Such a switch would have been unusual, because the needles normally reflect TOT during engine start only. The change in the position of the No. 2 FLI needle would have resulted in a large split between both needles.

The needles can represent TRQ, TOT, or N1, depending on which of these parameters is the closest to its operating limitation for each engine given the conditions at the time. For example, during cruise flight on the day of the accident, the needle for each engine (operating normally) would have corresponded to torque. In normal operation, both engines would have also remained torque matched by an automated variable rotor speed and torque matching system (VARTOMS). In this case, the “first limit” for both engines would be torque. The first limiting parameter is the parameter that is closest to its limit and does not mean that parameter has reached a limit. For example, as the pilot adds power, the engines would eventually reach one of the torque operating limits before reaching any of the turbine outlet temperature or gas generator speed limits. In different ambient conditions, such as operation at higher pressure altitudes, the first limiting parameter can instead be N1. Normally, both engines are limited by the same parameter.

The needles do not depict the value of the first-limited parameter (the scale inside the arc, numbered 2 through 14 in figure 1, is unitless, and standardized for comparison of the three limiting parameters) but rather the relationship of the parameter to several different limits that are shown on the outside of the arc as colored lines and symbols. These limits, including those for the OEI condition, are always displayed. The digital numeric values arranged vertically on the left side of the display show the values of TRQ, TOT, and N1 for the No. 1 engine; the numbers on the right side show the values for the No. 2 engine. These numbers, and the white boxes showing which parameter is currently closest to a limit for each engine, are also always displayed.

Should an engine be first limited by torque, its needles would depict engine torque with the various torque limits shown on the outside of the dial arc as red and yellow lines and circles. The white boxes that indicate the first-limit parameter for each engine (which in the example on Figure 1 is TRQ for both engines) also indicate that the respective needle is displaying that particular parameter. The needles in figure 1 show the No. 2 engine TRQ is in the yellow “AEO takeoff power range” and that the No. 1 engine TRQ is at the red “AEO max. takeoff power” limit. Additionally, the numeric value for the No. 1 engine TRQ is underlined with a red bar, indicating that it has reached the TRQ limit and is arriving to the transient range (meaning it can safely operate at that torque for a limited amount of time). If both engines are operating normally in cruise flight, both needles would indicate TRQ and would be positioned closely to one another with the same or about the same value, indicating that each engine is producing about the same amount of power. Small deviations in TRQ can be addressed manually by the pilot.
