# Aviation Investigation Final Report

<b>Location:</b>	Daytona Beach, Florida	<b>Accident Number:</b>	ERA18FA120
<b>Date &amp; Time:</b>	April 4, 2018, 09:53 Local	<b>Registration:</b>	N106ER
<b>Aircraft:</b>	Piper PA28R	<b>Aircraft Damage:</b>	Destroyed
<b>Defining Event:</b>	Aircraft structural failure	<b>Injuries:</b>	2 Fatal
<b>Flight Conducted Under:</b>	Part 91: General aviation - Instructional

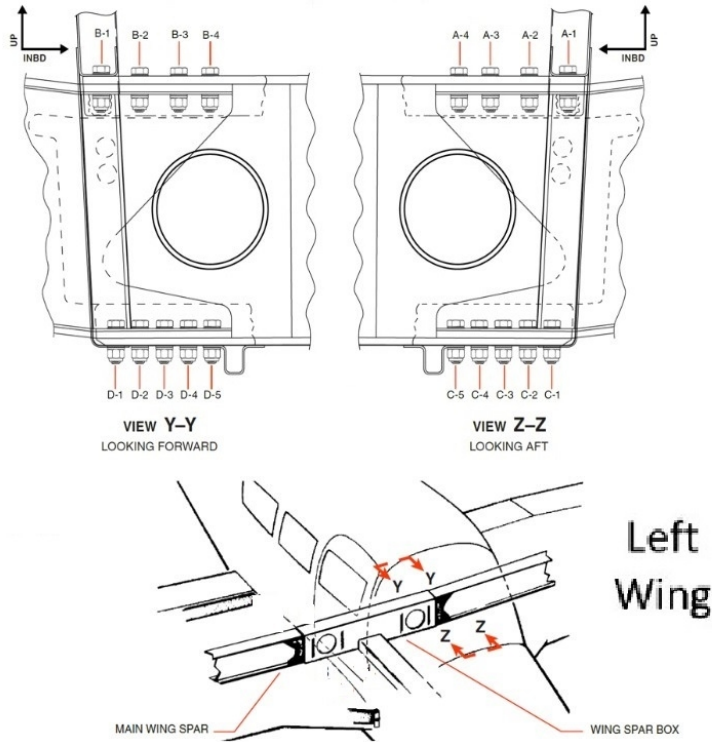
Figure 1. Diagram showing forward and aft side of wing main spars and associated attachment bolt designator map

Each wing main spar on a Piper-28R-201 airplane is attached to the center wing box with 8 attachment bolts through the main spar upper cap and 10 through the main spar lower cap. As shown in figure 1, the locations on the lower spar cap forward of the spar web are identified as C-1 through C-5, and the locations on the main spar lower cap aft of the spar web are identified as D-1 through D-5 (later in this report, we use L [for the left wing] or R [for the right wing] in addition to the spar cap location identifiers where appropriate [for example, LC-1]). Doublers are riveted to the forward and aft sides of the spar at the attachment location and outboard beyond the bend in the spar that forms the wing dihedral. Flanges for the doublers extend over the main spar upper and lower caps at the forward side of the spar and over the lower cap at the aft side of the spar.
