Aviation Investigation Final Report

Location:	Honolulu, Hawaii	Accident Number:	WPR18LA221
Date & Time:	August 8, 2018, 09:20 Local	Registration:	N369MH
Aircraft:	Hughes 369	Aircraft Damage:	Substantial
Defining Event:	Flight control sys malf/fail	Injuries:	4 None
Flight Conducted Under:	Part 135: Air taxi & commuter - Non-scheduled - Sightseeing

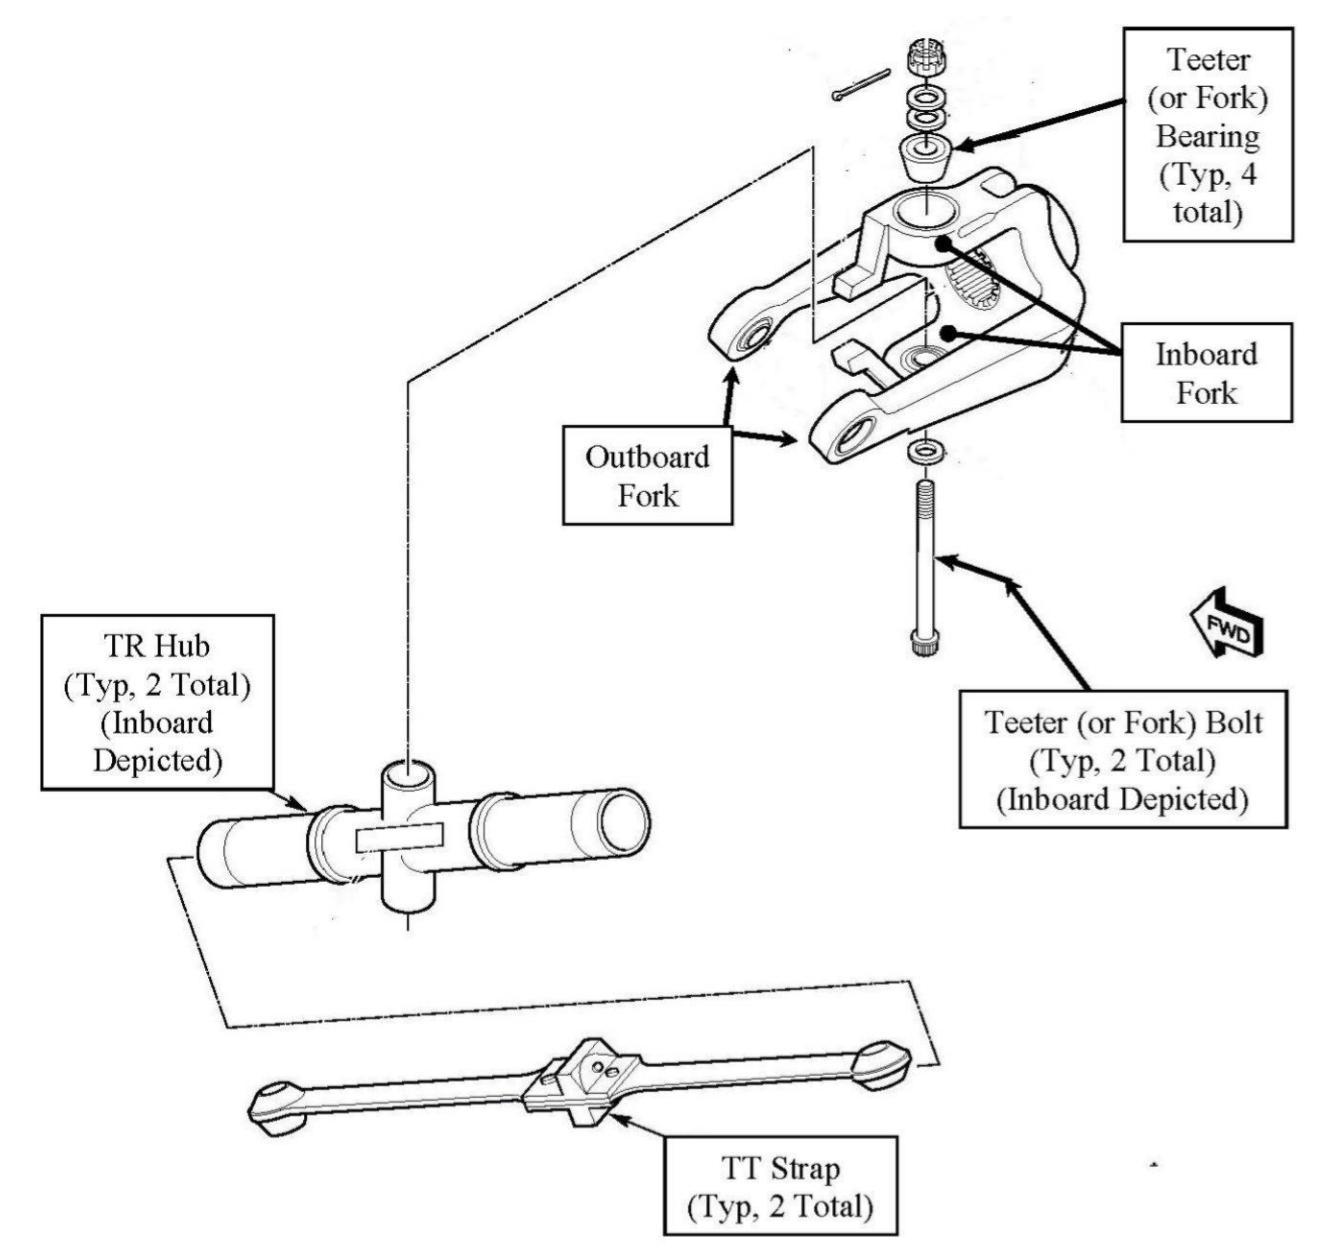
All four TR blades remained attached to the fork, but the outer (furthest from the transmission) blade pair remained only partially attached to the fork. The outer teeter bolt was fractured and only a portion of it was recovered. Of the two teeter bearings that were normally mounted in the outer pair of fork arms, one was absent and presumed lost in flight. The remaining outer teeter bearing had debonded from its fork arm, and both it and its fork arm seat exhibited fretting damage on their mating surfaces. The fretting indicated that there was relative motion between the bearing and its seat, caused by helicopter operation with a debonded bearing.
