Runway Overrun During Rejected Takeoff
Ameristar Air Cargo, Inc.,
dba Ameristar Charters, flight 9363
Boeing MD-83, N786TW
Ypsilanti, Michigan
March 8, 2017

Accident Report

NTSB/AAR-19/01
PB2019-100293

Aircraft Accident Report

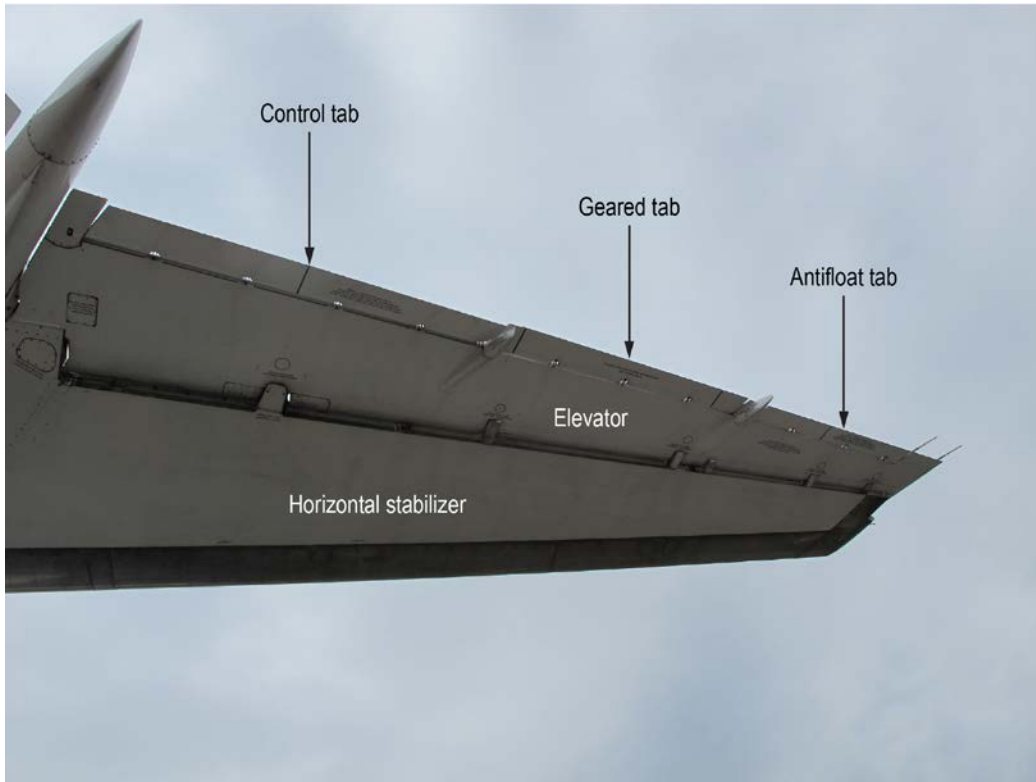
Figure 3. Right elevator and relative locations of control, geared, and antfloat tabs.

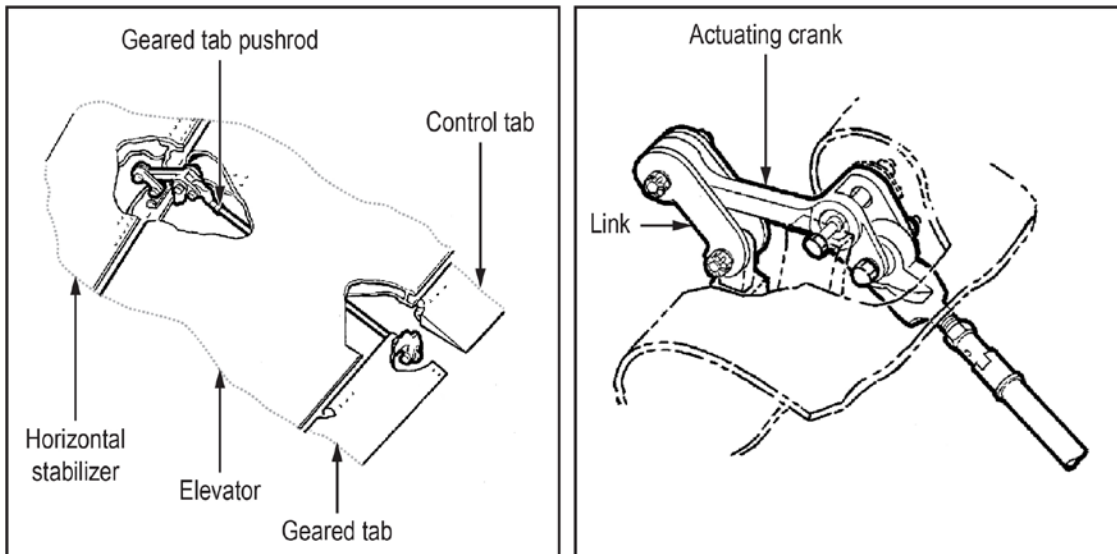
Elevator geared tabs, which mechanically deflect in response to elevator movements, are attached to the horizontal stabilizer through a system of drive linkages. The geared tab drive linkage consists of a pushrod that is attached to the horizontal stabilizer spar by means of an actuating crank and links (see figure 5). The antifloat tabs are connected to the horizontal stabilizer through mechanical linkages and deflect based on stabilizer position to prevent down-float of the elevator when the horizontal stabilizer position exceeds certain criteria.

Figure 5. Drawing of installed location of geared tab linkage components (left) and closer view of the links and actuating crank (right).

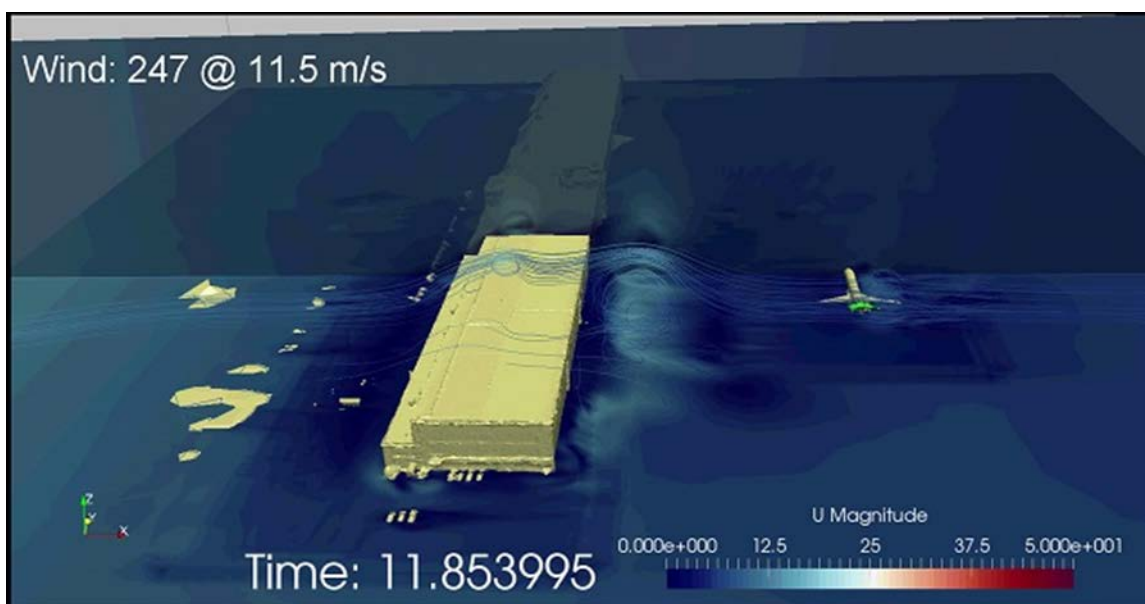
Because the airplane was parked downwind of a large hangar and other structures that could affect wind flow, the CFD study was used to determine a plausible scenario of the wind flow pattern at the airplane's parked location.

Figure 11. 3-D visualization of wind simulation results for a discrete time showing the locations of the hangar and airplane. Wind flow from the west (left side of image) is disrupted downwind of the hangar.

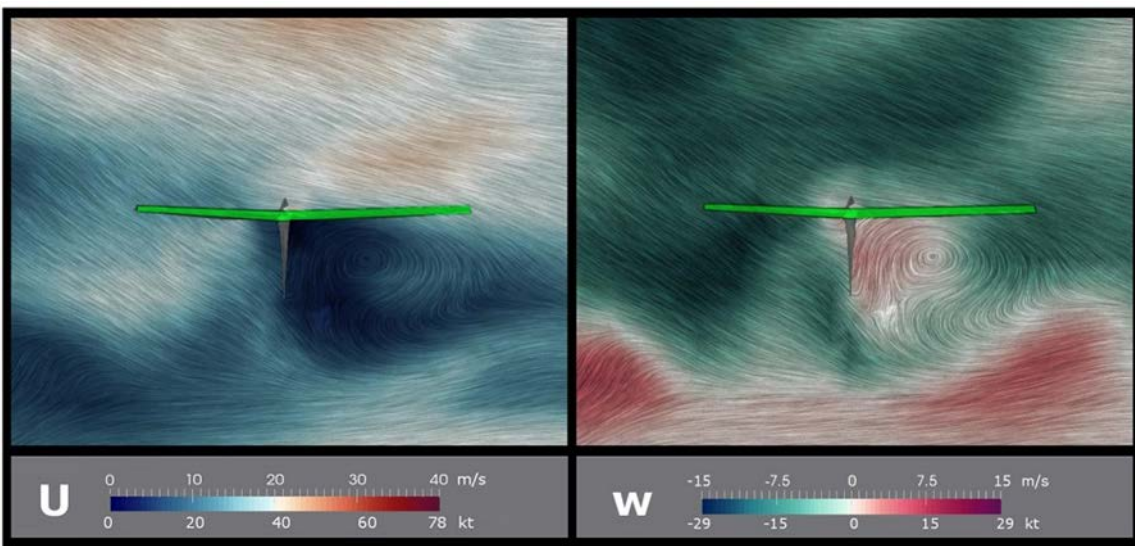
Figure 13. Vertical cross-section visualization of wind simulation results for a discrete time showing flow pattern and horizontal (“U”) and vertical (“w”) wind magnitudes near the accident airplane’s elevators (view from behind looking forward).

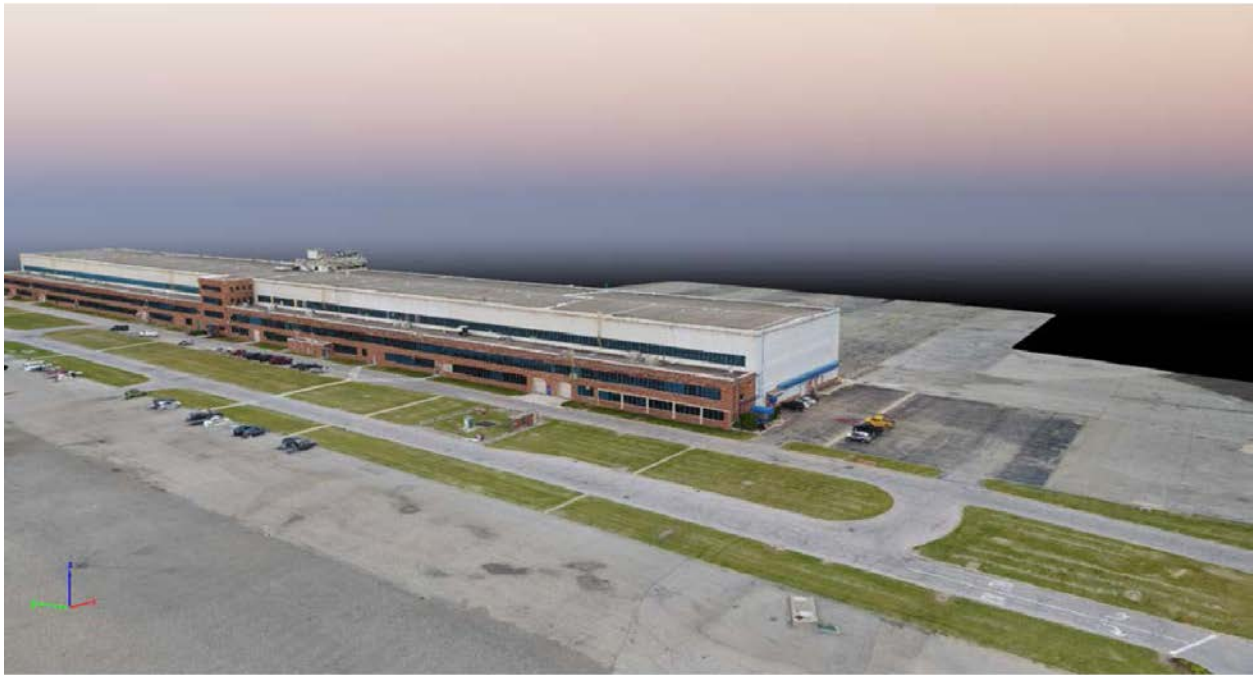
Figure 17. Screenshot of one view of the hangar 3-D model created from sUAS-captured imagery.
