Aviation Investigation Report AIR-24-07

In-Flight Collision During Air Show Commemorative Air Force Boeing B-17G, N7227C, and Bell P-63F, N6763

Dallas, Texas
November 12, 2022

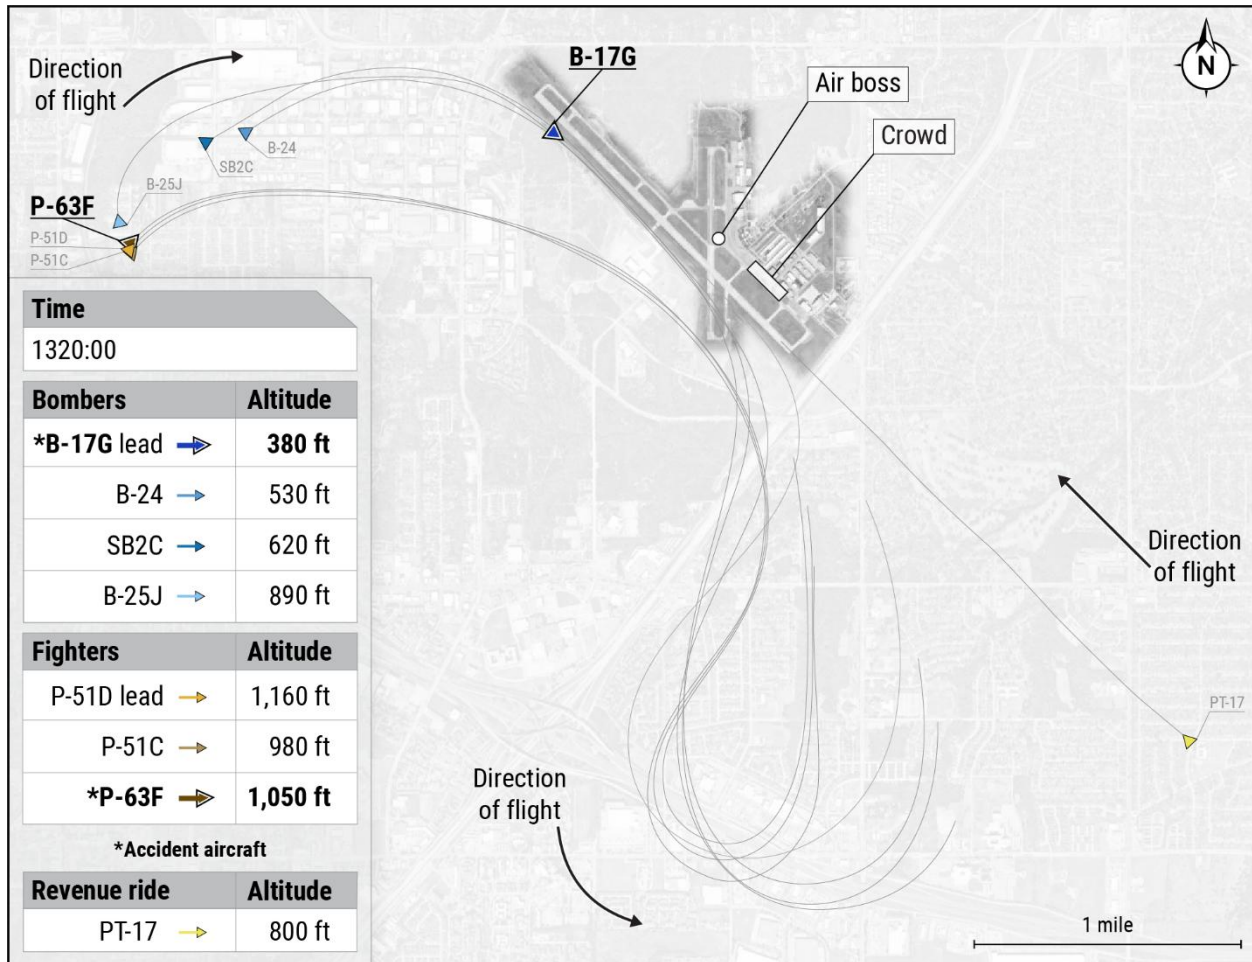
Figure 2. Positions and altitudes (in agl) of seven of the eight airplanes in the performance and one revenue ride flight airplane at 1320:00.

The performance study showed that, at 1320, the accident Boeing B-17G had begun a pass from show right to left (that is, right to left from the crowd's perspective), heading southeast, parallel to runway 13, with the other bombers spaced variously in trail. The fighter formation with the accident Bell P-63F was inbound from the northwest (see figure 2).

Note: Their future flight paths for the next 2 minutes before the collision are shown in gray.

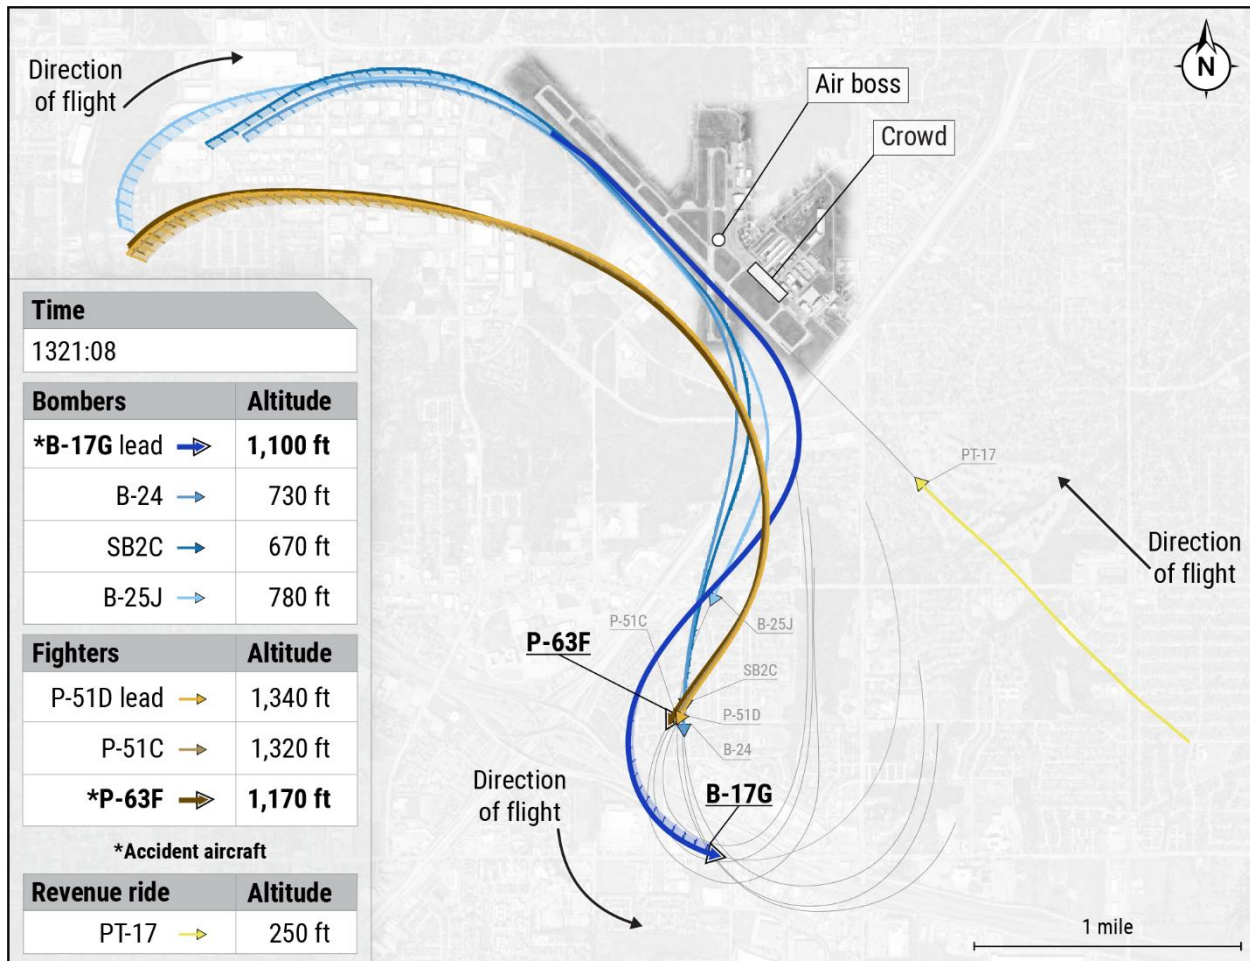
Figure 5. Position and altitude of each airplane at 1321:08.

At 1320:51, the air boss stated, "There ya go, B-17. Yup. Gentle flat roll it around 1,000-ft line," and a Boeing B-17G crewmember acknowledged, "1,000-ft line for Raiders." At 1320:58, the air boss stated, "Fighters, roll it back to the left. Lead fighter, roll it back to the left, and y'all get in trail," and the fighter lead pilot replied, "Okay, fighters in trail." The air boss continued, "Yeah, and Gunfighter, look out your left side and find the B-17," and the fighter lead pilot replied, "We see the B-17." The performance study showed that, at 1321:08, the fighter formation was entering the left 270° turn, having flown past and above the position 3 bomber, with the position 2

bomber and the Boeing B-17G to the fighter pilots' left, also at lower altitudes than the fighters (see figure 5).⁹

After completing the pass that preceded the accident, the pilots of all eight airplanes performed repositioning turns (a 90° right turn followed by a 270° left turn) on the south side of the extended show lines to set up for the next pass, as directed by the air boss. Based on the radio communications, the next pass was intended to be from show left to right in front of the crowd (heading northwest, parallel to runway 31); the air boss directed the fighter formation to pass the bomber group and fly the 500-ft show line, and he directed the bombers to fly the 1,000-ft show line. Compliance with this directive required the fighter formation to pass off the left side of the bomber group, then cross laterally in front of the Boeing B-17G. (Figure 5 shows the beginning of this maneuver.)

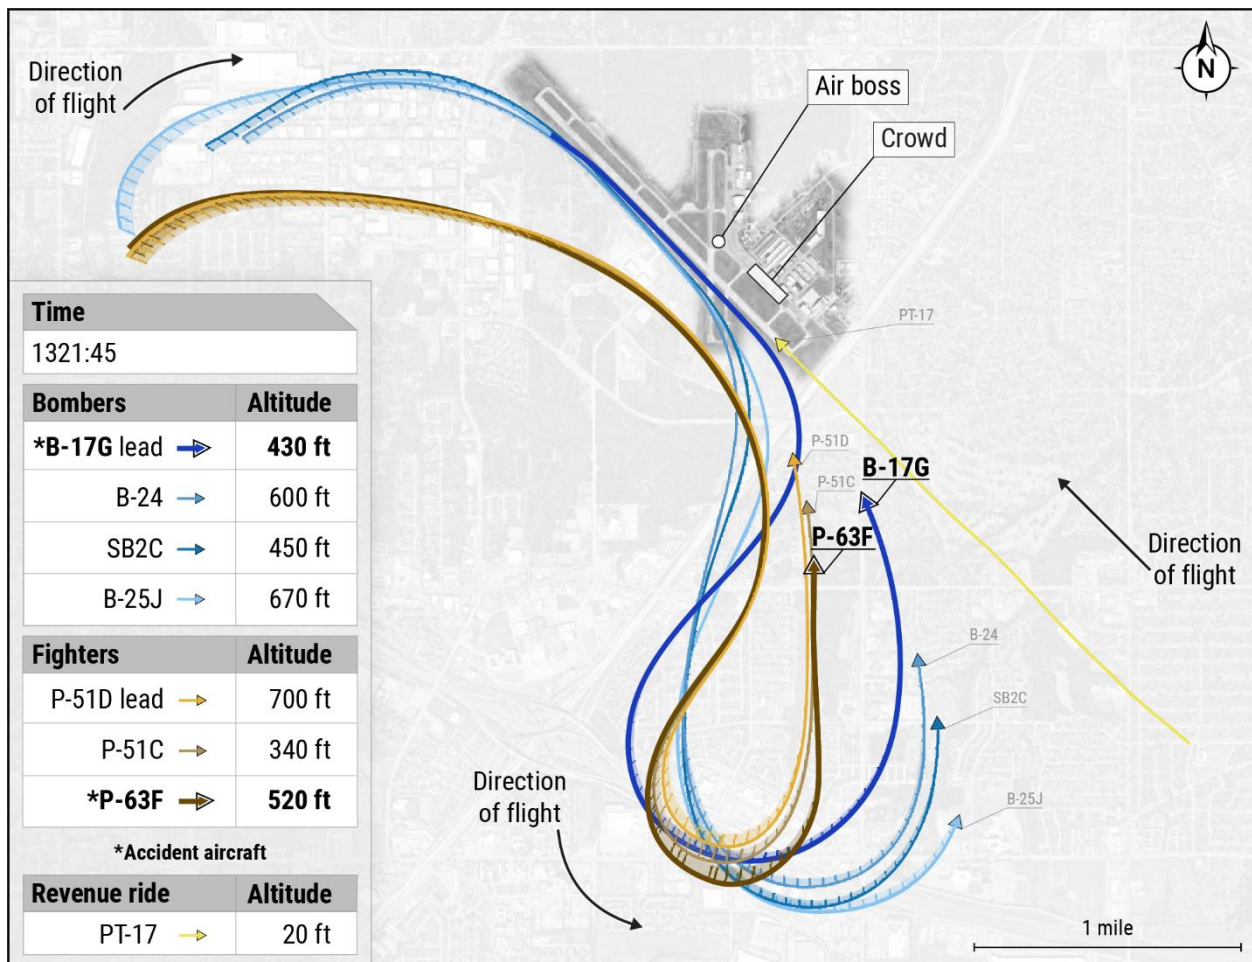
Figure 6. Position and altitude of each airplane at 1321:45.

At 1321:31 (during the fighters' descent), the air boss stated, "Nice job, fighters, you're coming through first. That will work out. B-17 and all the bombers on the 1,000-ft line," then asked, "B-17, you got the fighters in front of you off your left?" There was an unintelligible transmission before the air boss stated at 1321:45, "Nice job, fighters, come on through." The performance study determined that, at the time, the fighter lead had passed off the Boeing B-17G's left side and was ahead of it, the fighter in position 2 was passing off its left side, and the Bell P-63F was in trail (see figure 6).

The performance study determined that the fighter lead and the fighter in position 2 were coming onto the 1,000-ft show line.¹⁰ The Bell P-63F's flight path closely followed the fighter in position 2 until about 1321:47, when its flight path no longer curved toward the 1,000-ft show line but became somewhat straighter. The Bell P-63F was descending at a rate of 1,500 ft per minute, and its airspeed was about 230 kts. The Boeing B-17G's flight path was curving toward the 1,000-ft show line.

The position data showed that the flight path for the fighter lead and position 2 fighter airplanes passed the bomber group airplanes off the bombers' left side then crossed in front of the Boeing B-17G, as directed, but subsequently aligned with the 1,000-ft show line (instead of continuing farther across to the assigned 500-ft show line). The position data showed that the flight path of the Boeing B-17G (with the other bombers in trail) aligned with the 1,000-ft show line. (Figure 6 shows this alignment.)

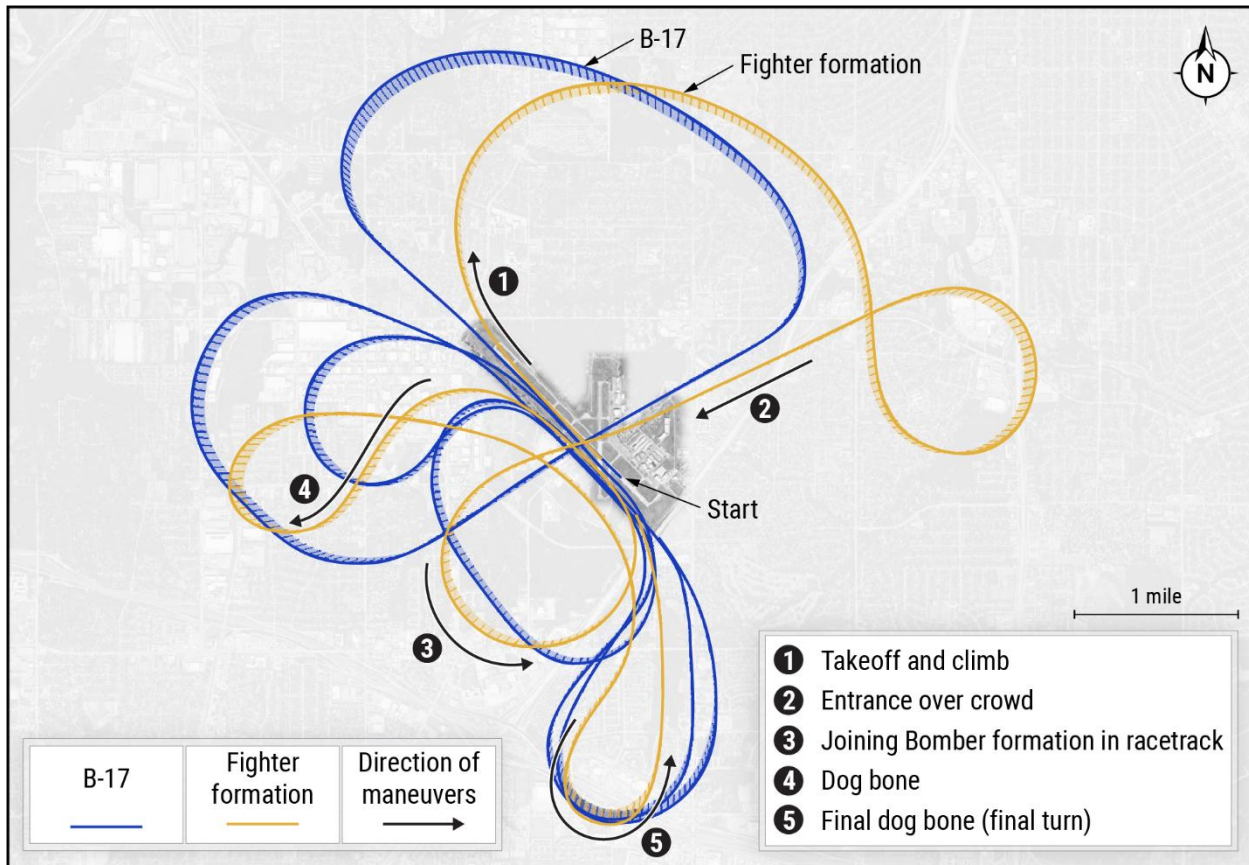
Figure 12. Boeing B-17G flight path (blue) and fighter formation flight path (yellow) during the performance.

study. Figure 12 shows the flight paths of the Boeing B-17G and the fighter formation from takeoff to the time of the collision.

Note: Repositioning maneuvers are labeled in sequence and with directional arrows.
