Fire aboard Roll-on/Roll-off Passenger Vessel *Caribbean Fantasy*
Atlantic Ocean, 2 Miles Northwest of San Juan, Puerto Rico
August 17, 2016

Marine Accident Report

NTSB/MAR-18/01
PB2018-101068

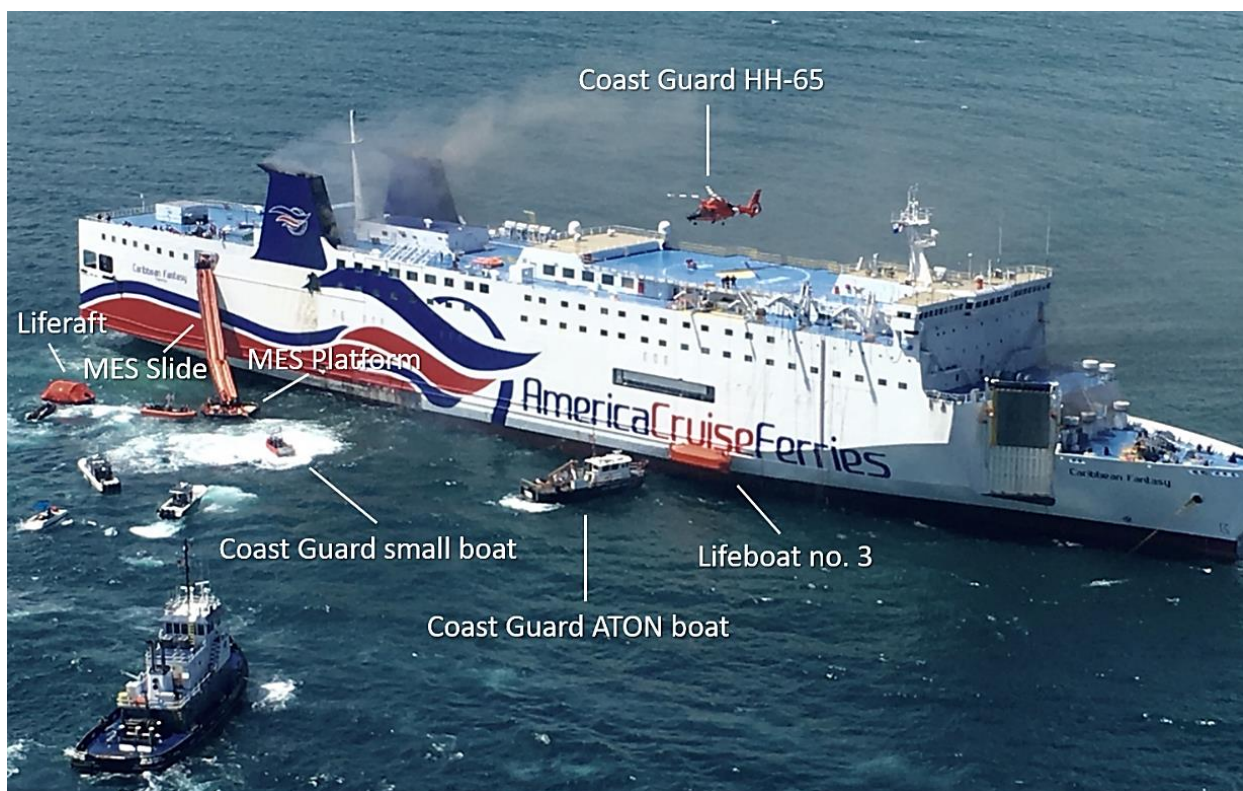
Figure 10. *Caribbean Fantasy*, about 1015, during the final stage of abandonment, with its starboard anchor down. (Photo by Coast Guard)

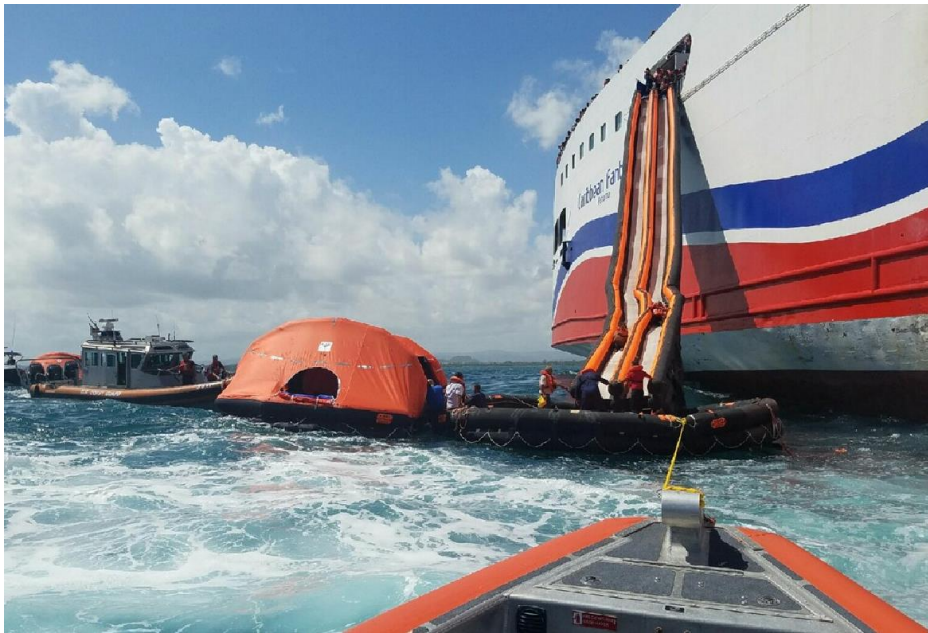
The master also requested that a vessel pull the MES platform forward (toward the *Caribbean Fantasy* bow) to make a better angle for the slide, noting that there were injuries because of the existing steep angle. About 1009, a Coast Guard small boat attached a line from its bow to the MES platform. Operating in astern propulsion, the small boat pulled the platform forward as requested by the master. About 2 minutes later, upon seeing an improvement in the angle of the slide, the master ordered the staff captain to send the remaining passengers and crew down.

Figure 11. Bow of Coast Guard small boat, about 1012, as it began to pull the starboard-side MES platform forward, with another small boat holding a liferaft to the platform. Two evacuees with lifejackets are on the slide, while many others are looking over the ship's side from the deck above the MES embarkation landing. (Photo by Coast Guard)

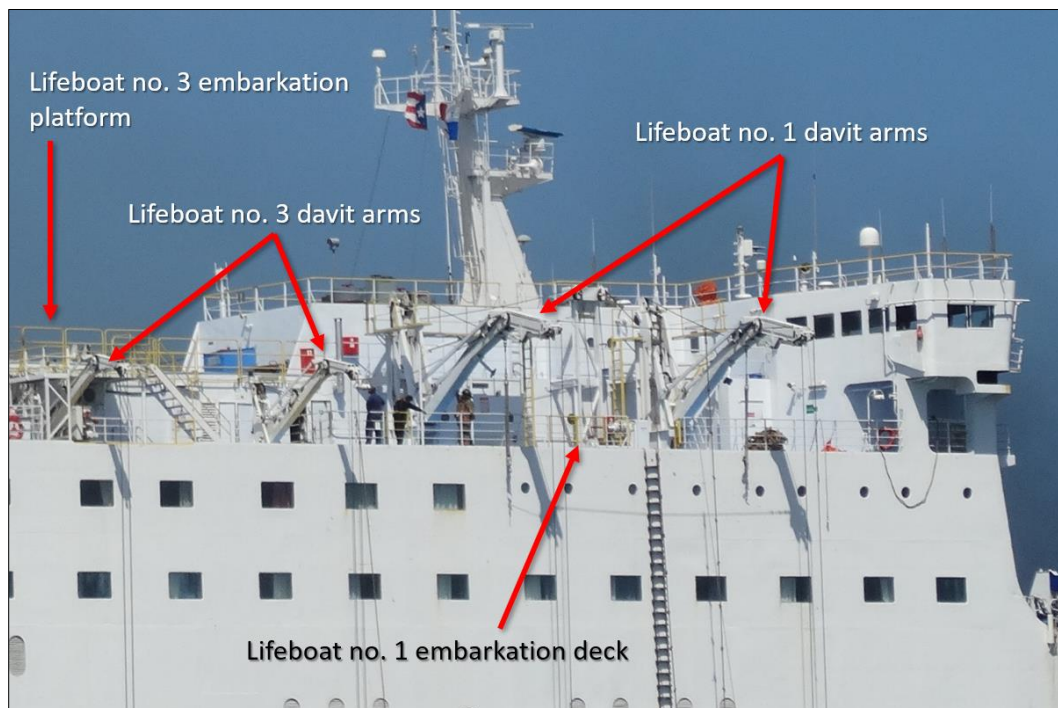
Figure 21. *Caribbean Fantasy* starboard side (Photo by Coast Guard)
