National Transportation Safety Board

Left Engine Failure and
Subsequent Depressurization
Southwest Airlines Flight 1380
Boeing 737-700
Philadelphia, Pennsylvania
April 17, 2018

Powerplants and Materials
presentation

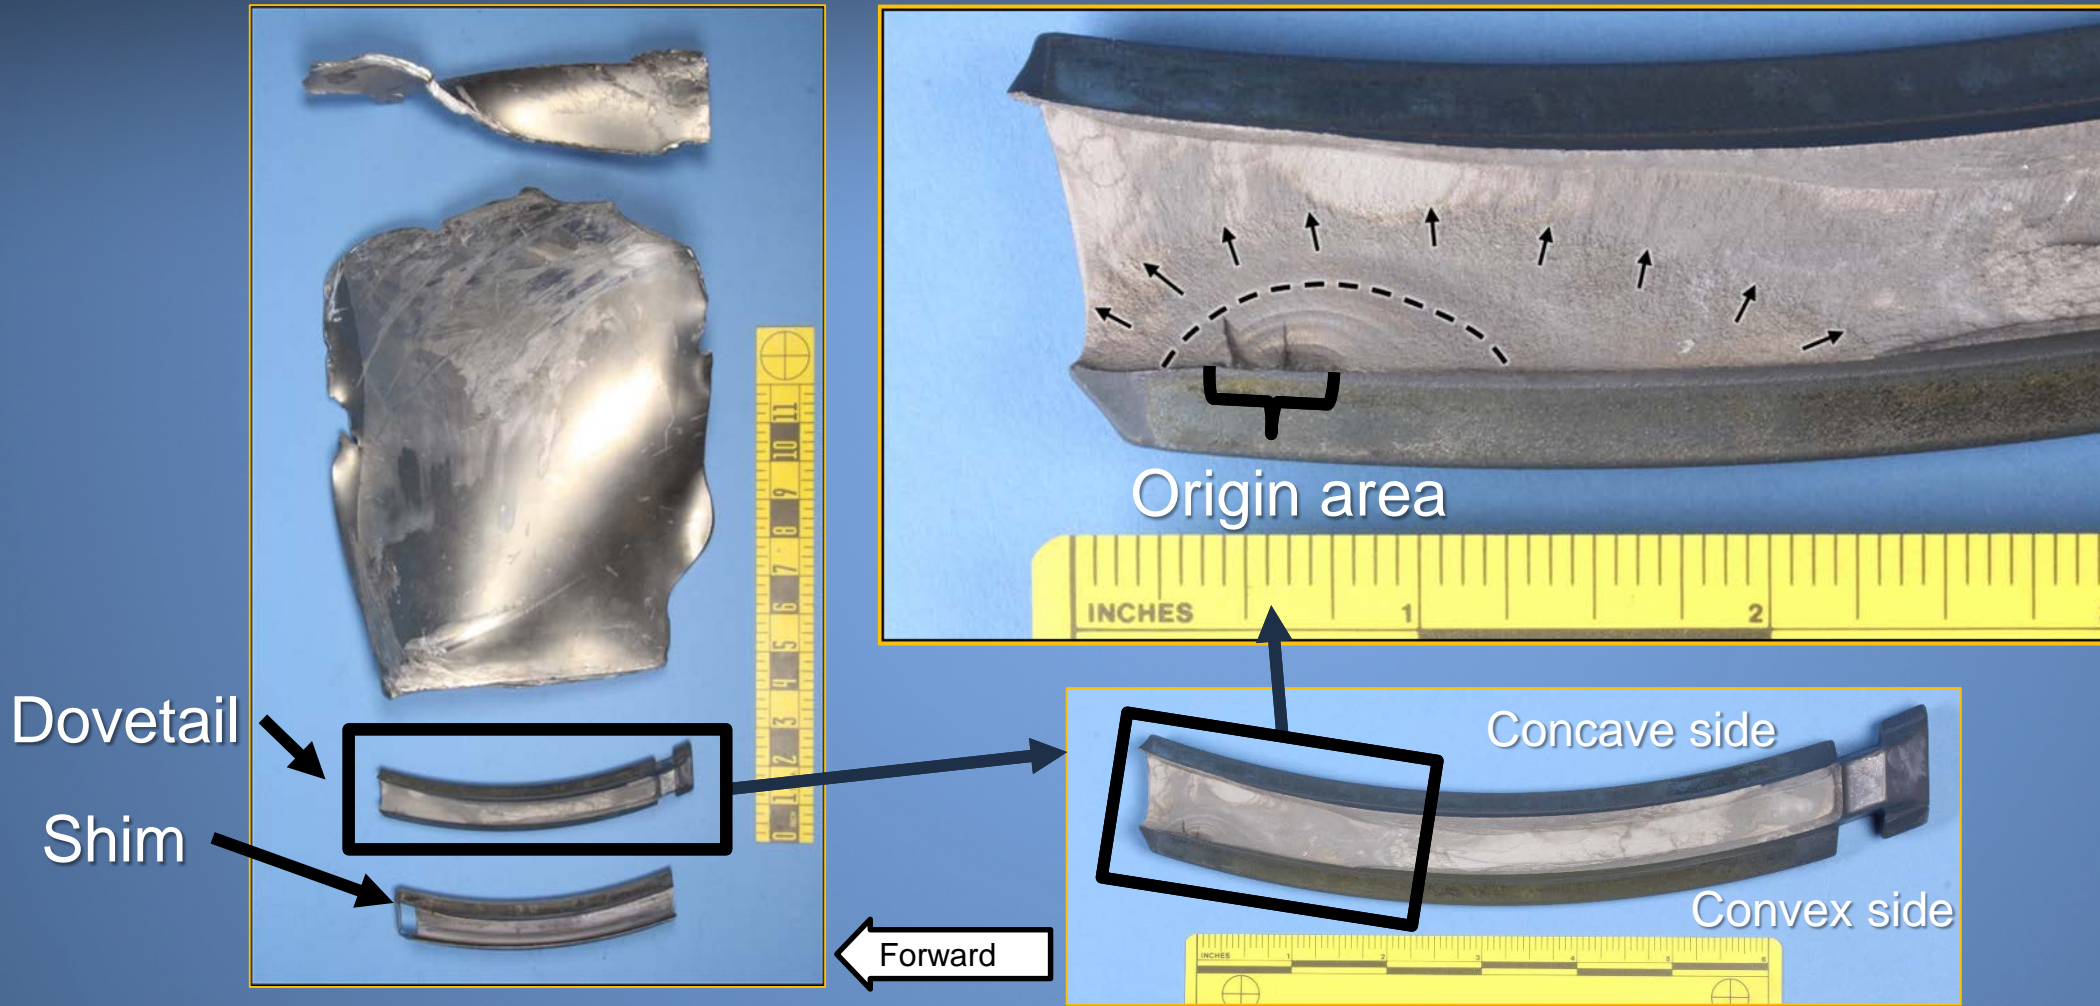
Fatigue Fracture

Likely Cause of Fatigue Crack Initiation

- Dovetail stresses greater than expected
- Dovetail coating damage and thickness variations
- Pressure face friction and edge loading
- Loss or relaxation of compressive residual stress

Fatigue Crack Growth

- One fatigue striation approximates one flight cycle
- Estimated 20,000 flight cycles total crack growth
- 10,712 flight cycles since last overhaul
- Crack likely not detectable by FPI at last overhaul or by visual inspections at relubrication

Overhaul Shop Corrective Action

- Two new nondestructive inspection techniques developed to detect dovetail cracks: eddy current inspection (ECI) and ultrasonic testing (UT)
- ECI requirement added in November 2016
- ECI performed with dovetail coating removed (FPI still required)

On-Wing Corrective Action

- UT introduced by CFM in March 2017
 - On-wing inspection with coated dovetail
- FAA and EASA issued total of 10 airworthiness directives mandating on-wing UT inspections
