# National Transportation Safety Board

Capsizing and Sinking of Commercial Fishing  
Vessel *Scandies Rose*  
Sutwik Island, Alaska  
December 31, 2019

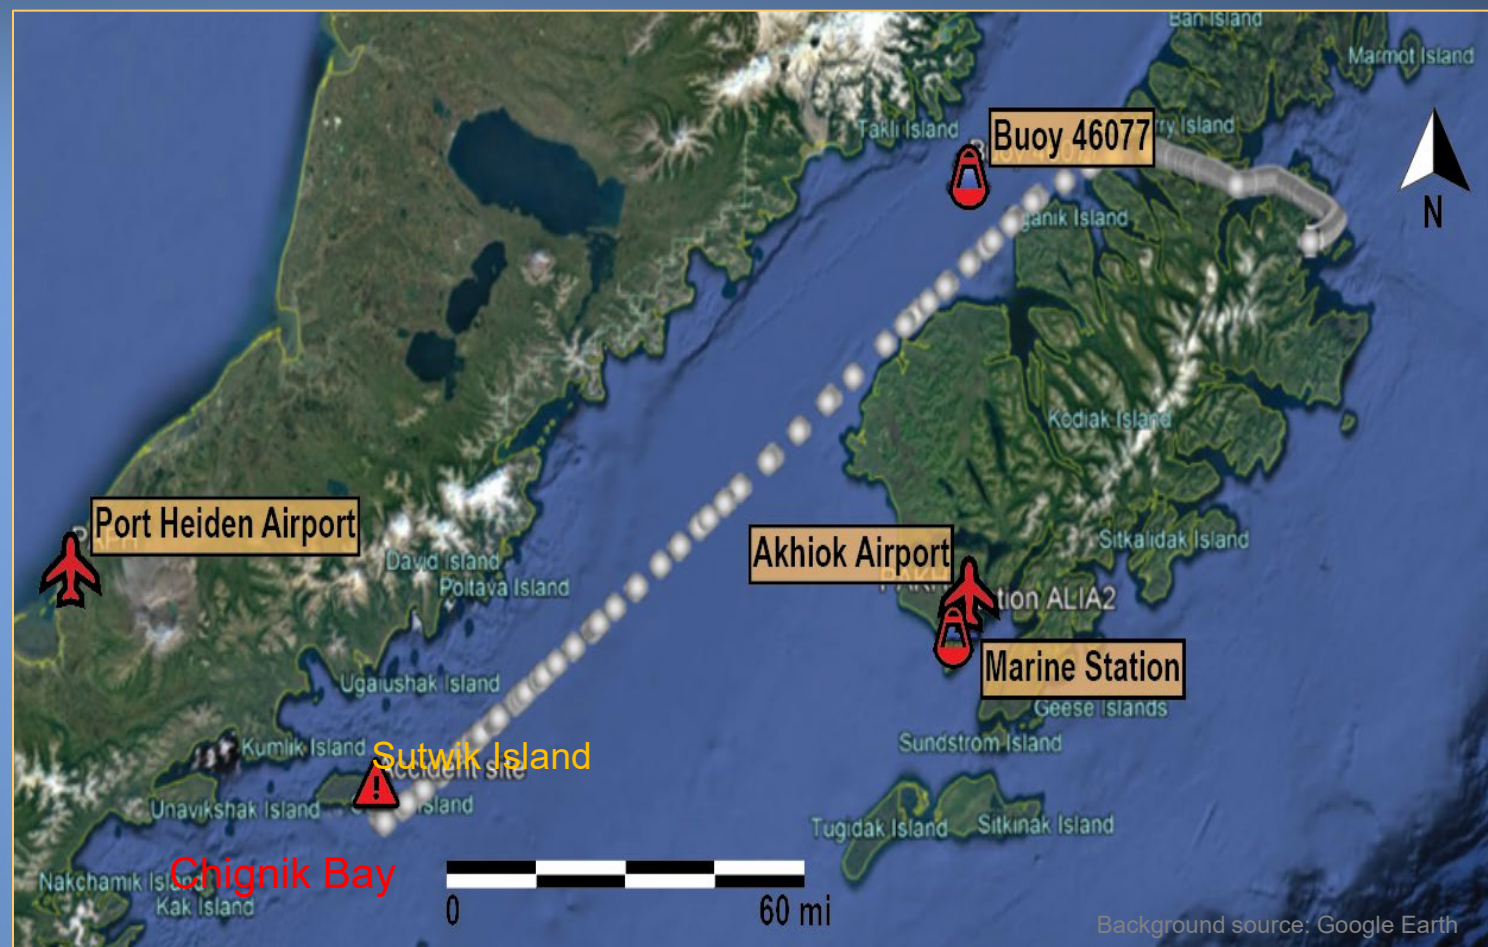
# Lack of Weather Observations

- Weather forecast matched the observation sites but not the weather reported at the accident site
- Recommendation proposed to National Oceanic and Atmospheric Administration (NOAA)

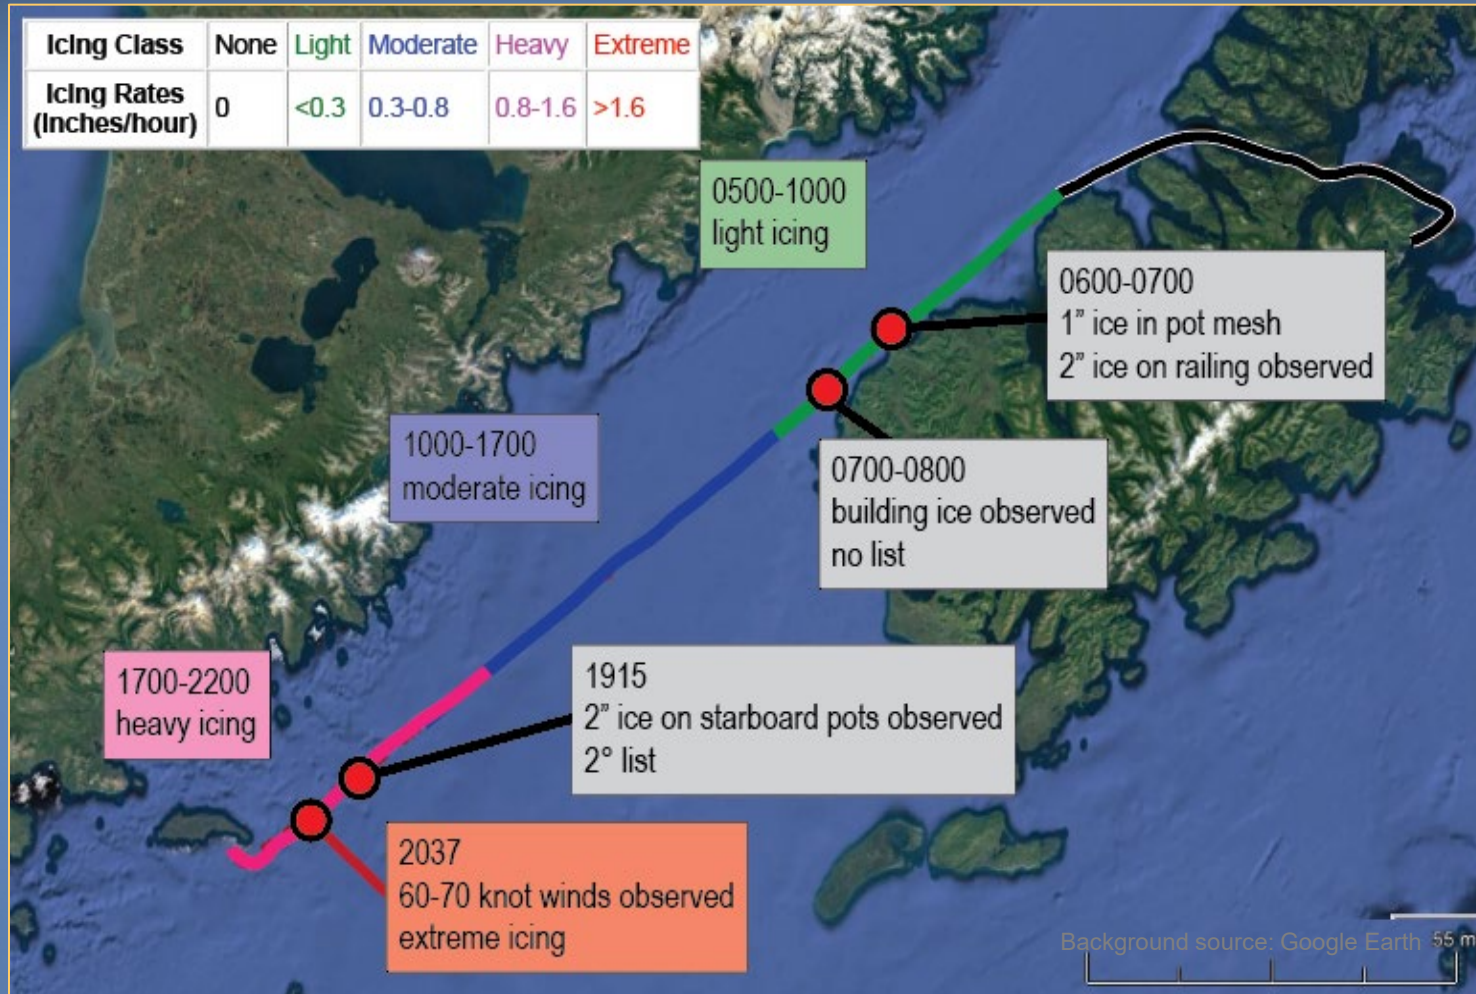
# Effects of Extreme Icing on Vessel Stability

# Asymmetric Ice Accumulation

- Starboard list created by ice accumulation
- Initially wind and waves counteracted list
- Following vessel heading change, wind and waves exacerbated list

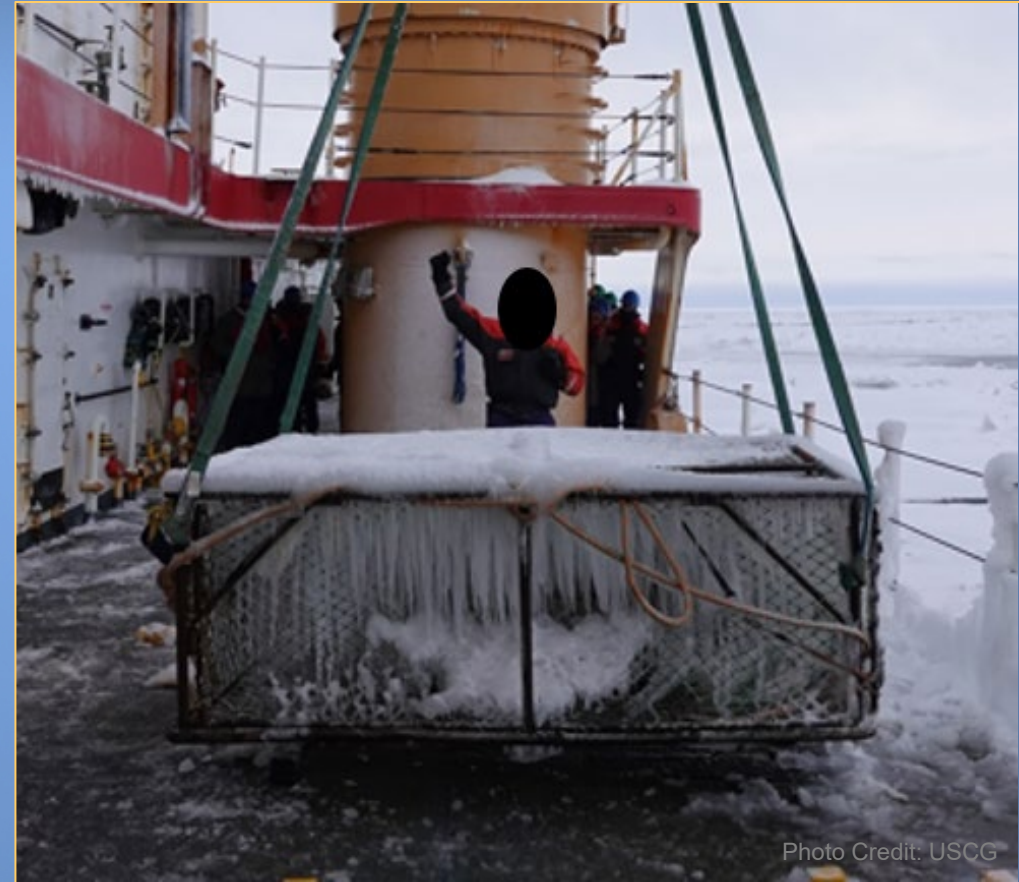
# Regulatory Guidelines for Calculating Icing

- Current guidance on icing
- Pot stack – “shoebox” icing calculation
- Regulations negate internal icing

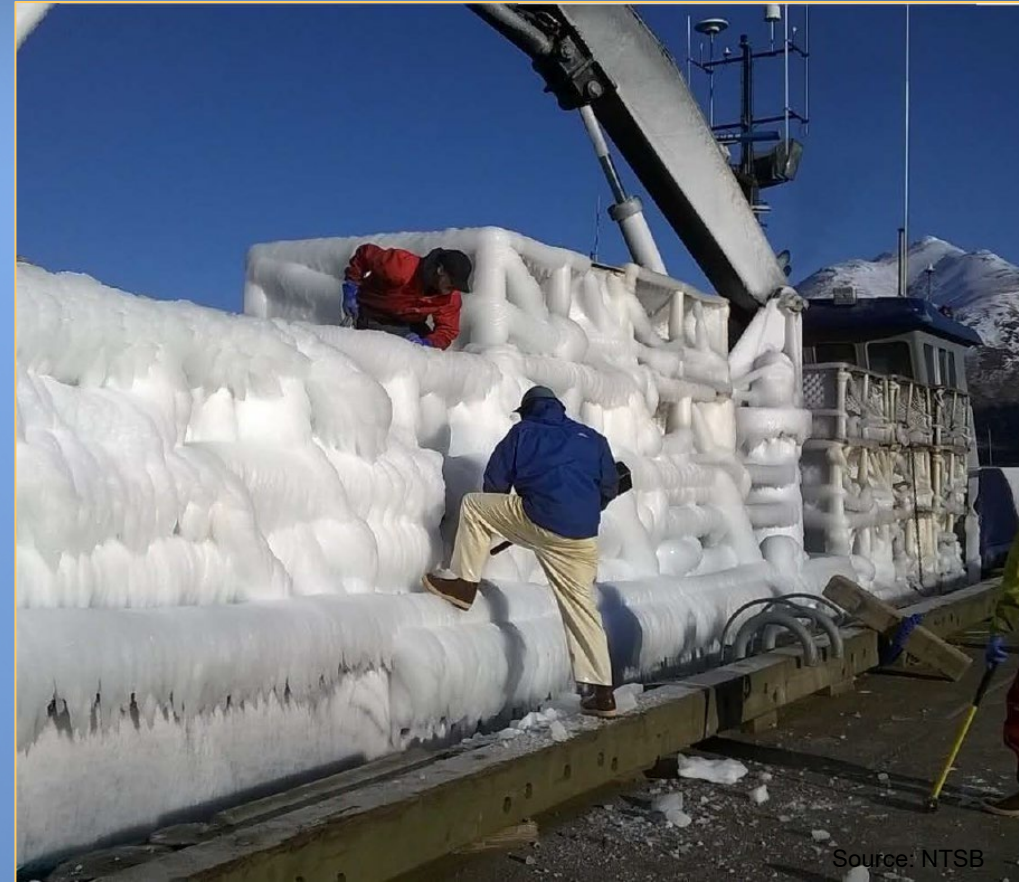
# Icing Accumulation Amounts

- Industry use of stability instructions
- Regulations
  - 1.3 inches on horizontal surfaces
  - 0.65 of an inch on vertical surface
- Industry knowledge and common practice
