National Transportation Safety Board

Atmos Energy Corporation
Natural Gas-Fueled Explosion
Dallas, Texas
February 23, 2018

Investigation Overview
Dallas, Texas
February 23, 2018

Examination of Gas Main

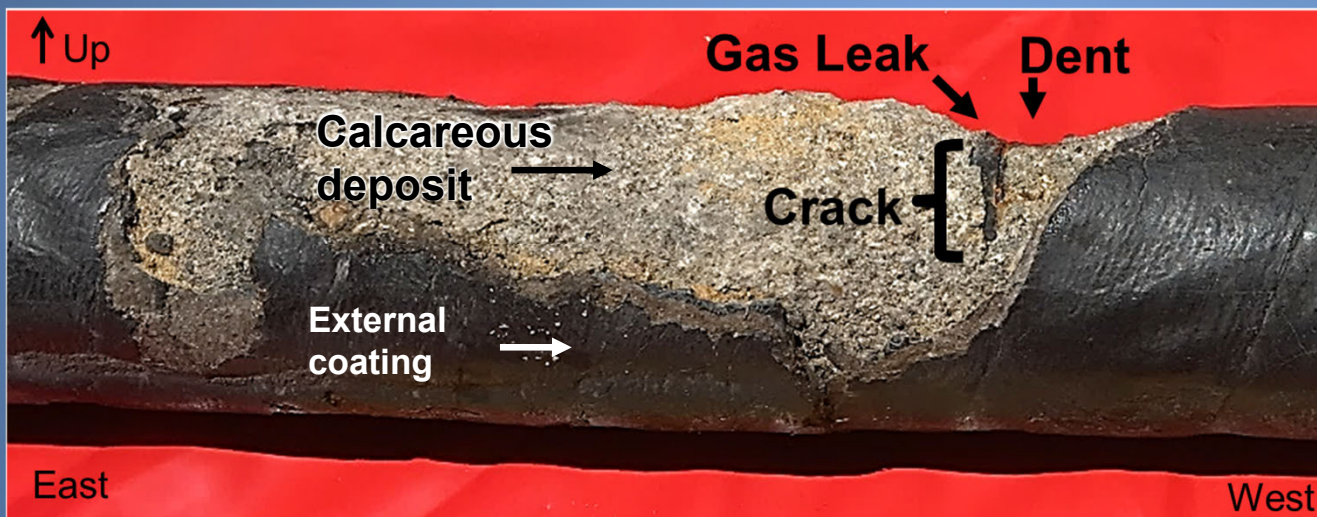
Side Profile

Dent and gouges

- Typical of damage from digging operation
- Consistent with those caused by excavation equipment (not from a shovel)
- Most likely resulted when sanitary sewer lateral was replaced in 1995

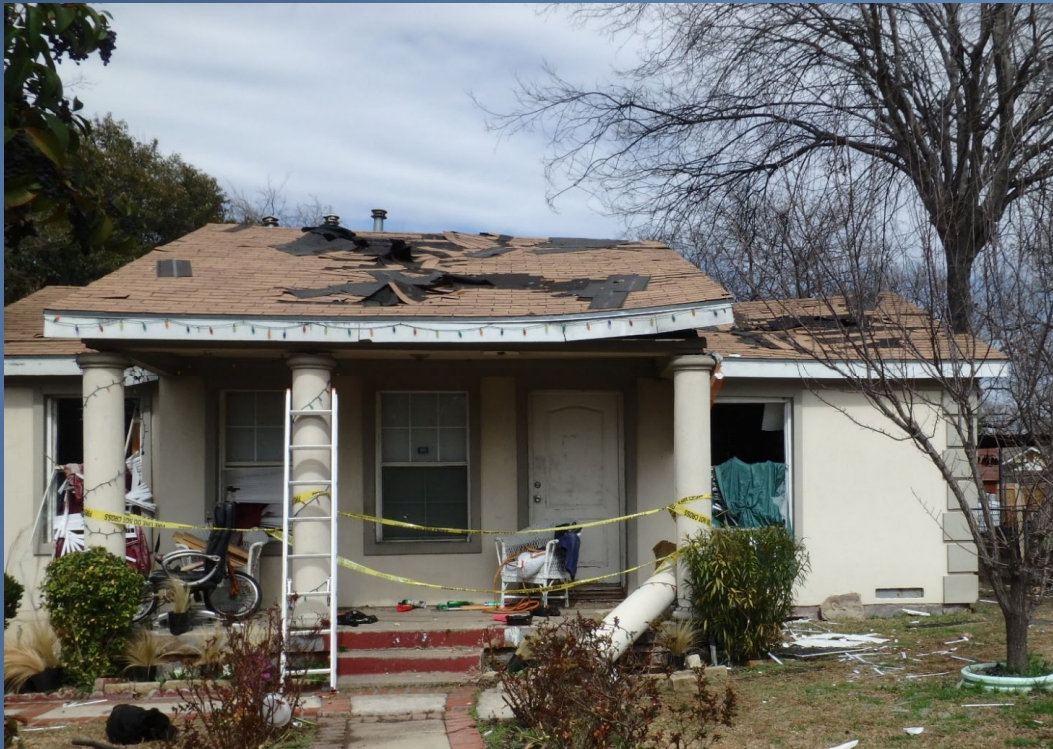
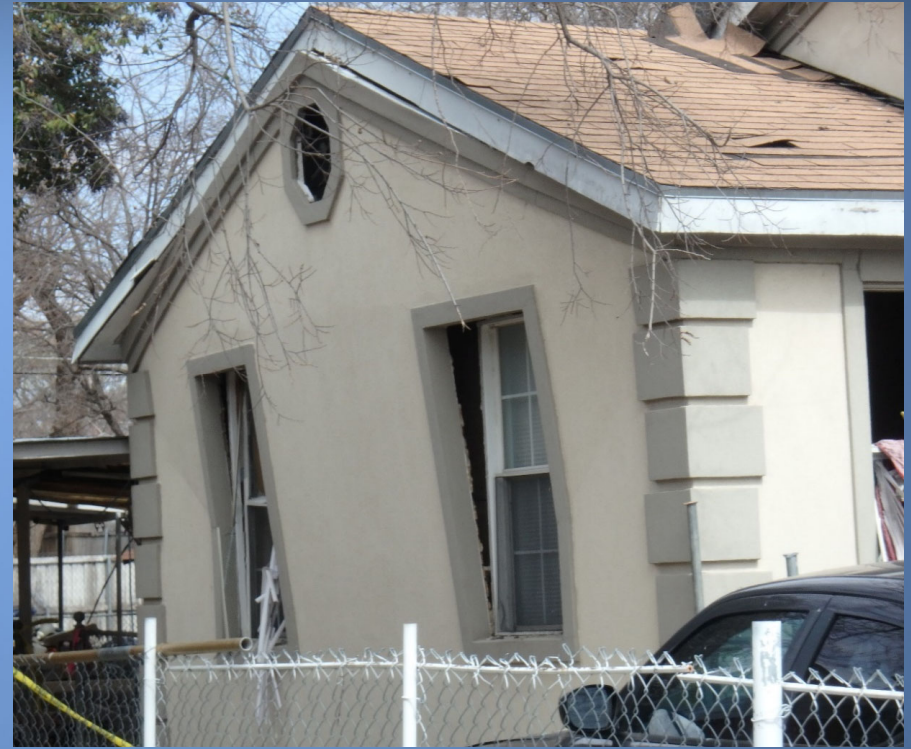
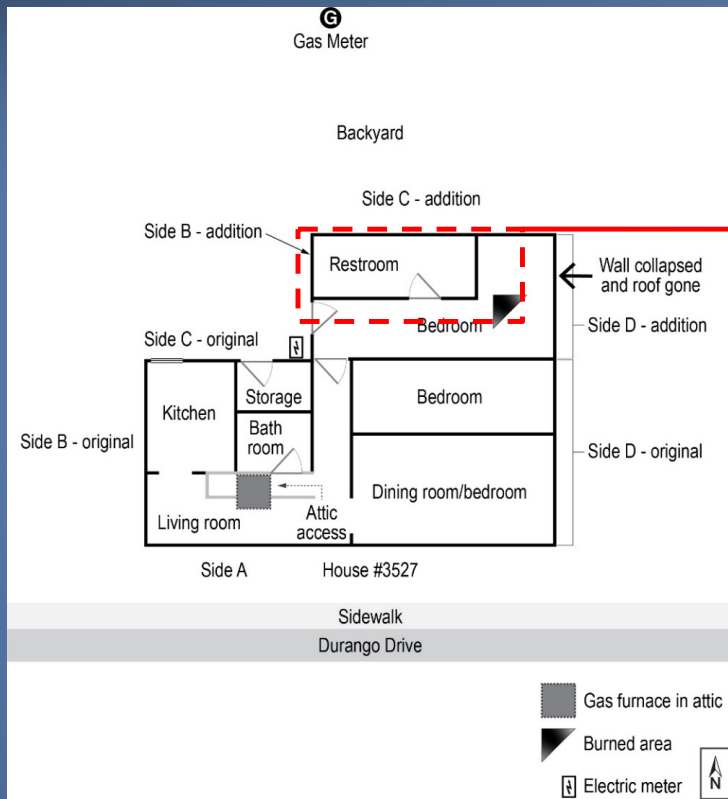
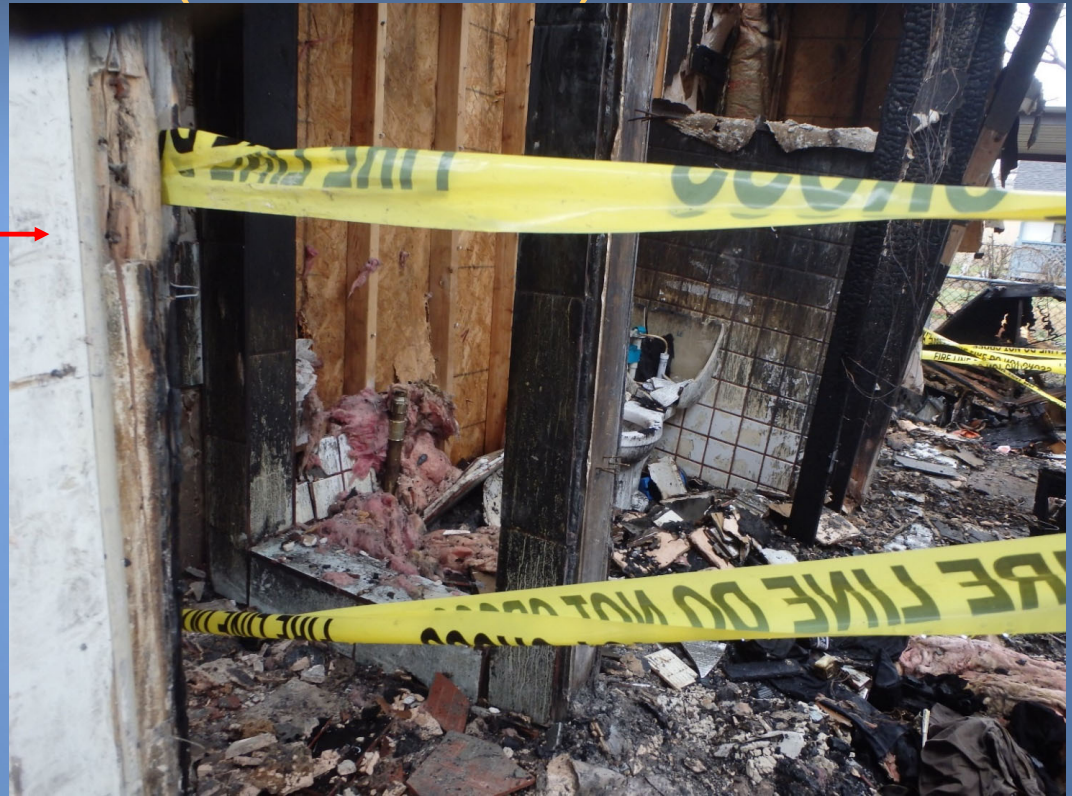
3527 Durango Drive (Incident 1)

- Damage consistent with a fuel gas/air mixture explosion
- Gas entered the structure through the new addition and spread up into the attic
- Most likely source of gas was Atmos-owned gas lines
 - Gas range, hot water heater, customer piping excluded
- HVAC the most likely ignition source

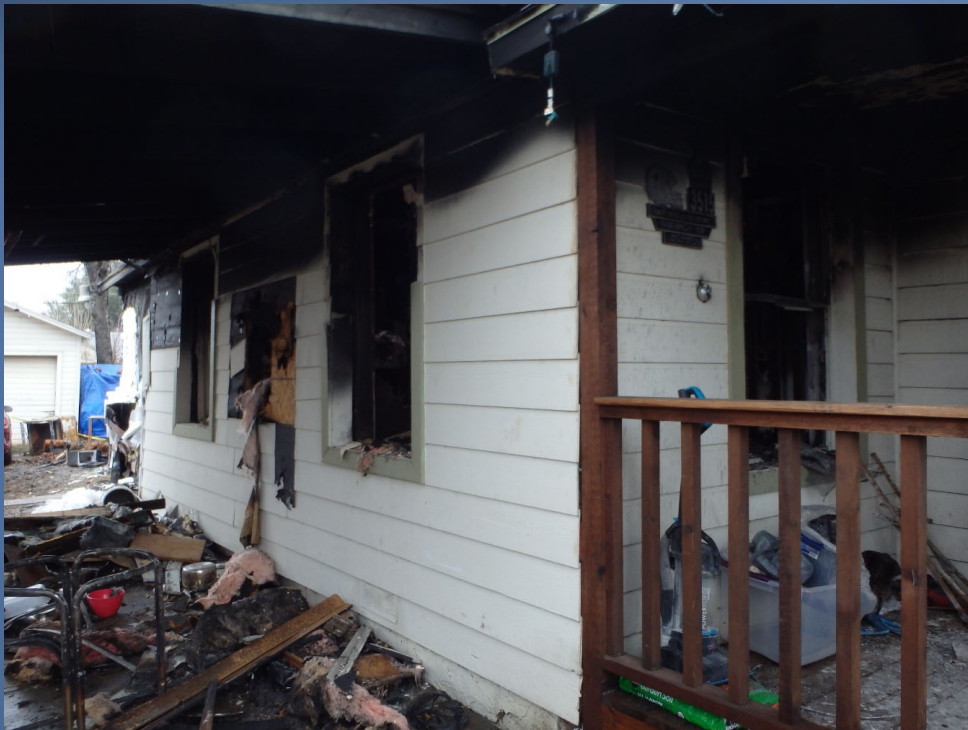
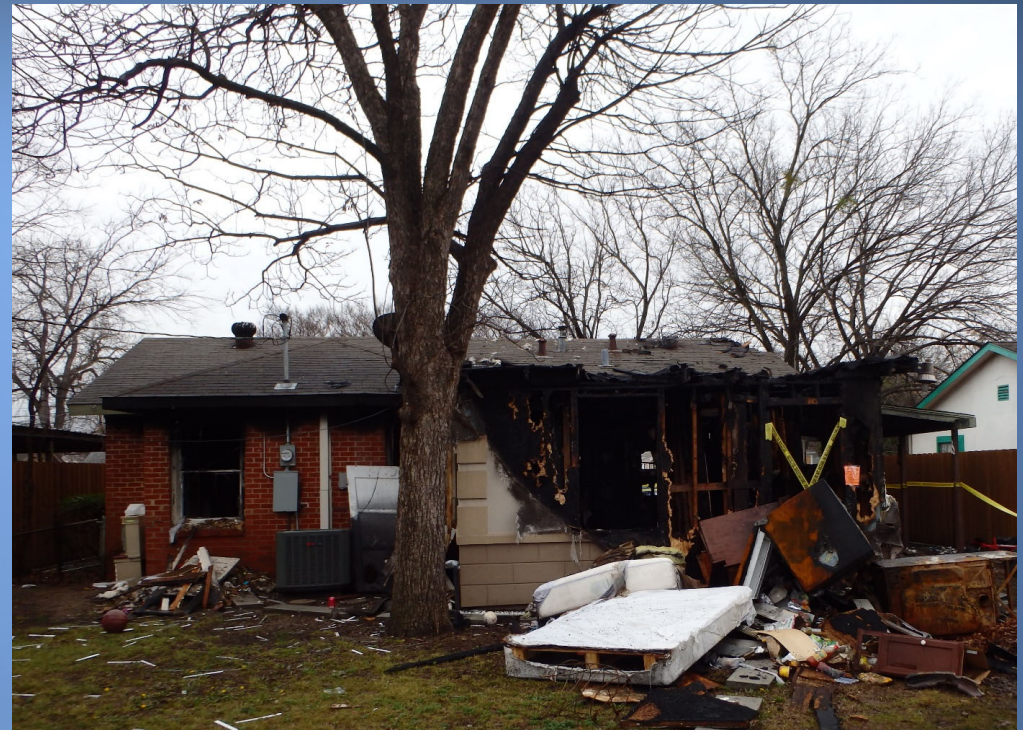
3515 Durango Drive (Incident 2)

- Gas range sooted and exhibited thermal damage
- Although not tested, no obvious signs of failure or malfunction found during visual examination
- Neighbor reported similar incident

- Kitchen most likely origin of fire
- Damage not consistent with structure fire
 - Firefighting efforts not ruled out
- Exact cause of the incident could not be determined
 - Evidence that natural gas existed within the structure
 - Not all accidental causes could be excluded

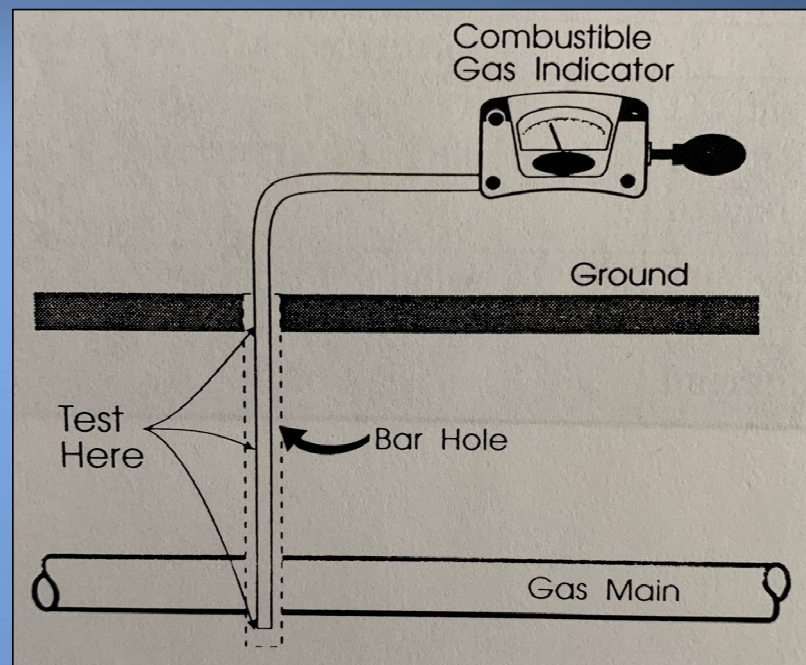
- Atmos technicians responded on February 21 and 22
- Bar hole made in ground
- Atmosphere in the bar hole sampled for gas

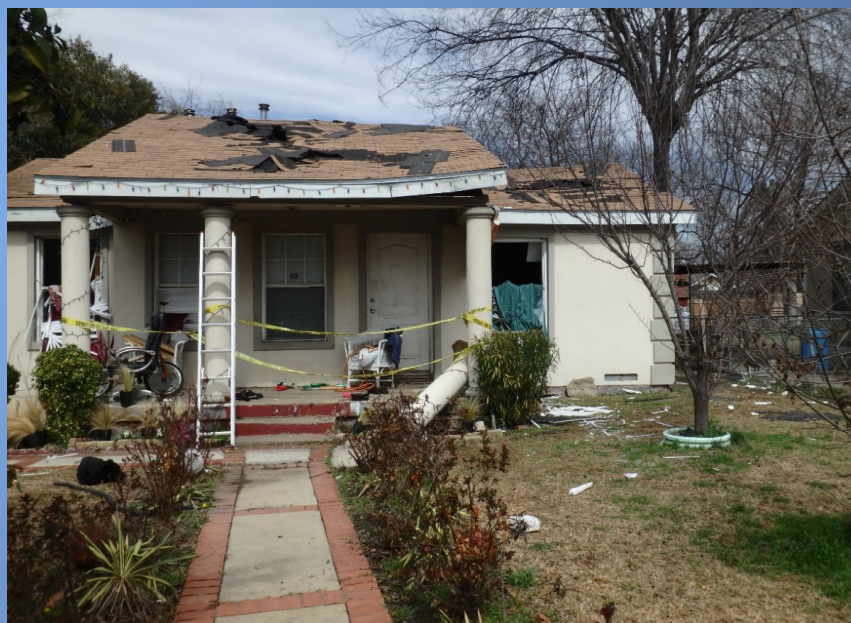
First Incident (3527 Durango Dr.)

- One bar hole test
- Surveyed for gas over the top of the soil
- DFR arson investigator indicated gas-related fire from inside the house
- Customer piping not tested

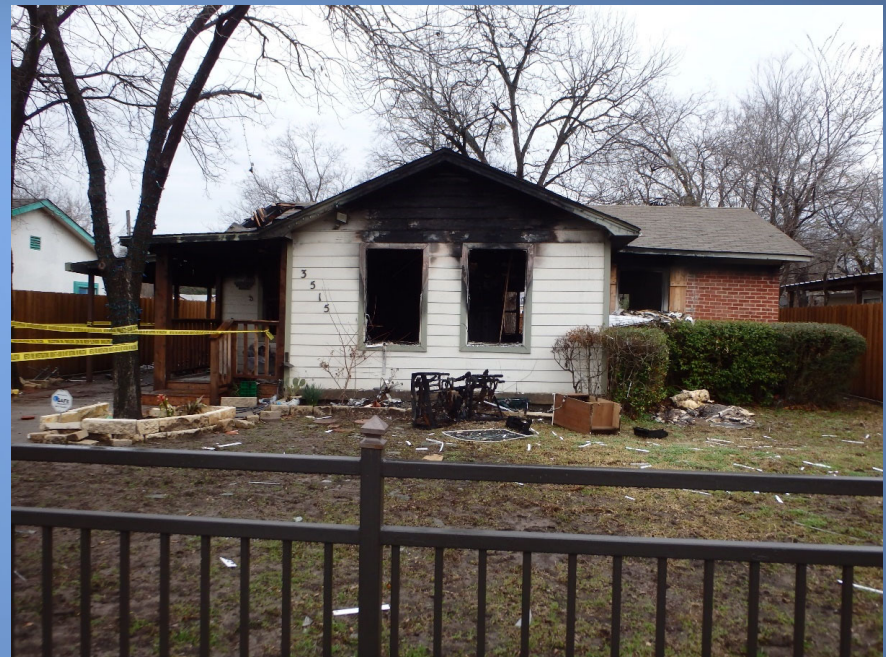
Second Incident (3515 Durango Dr.)

- Multiple bar hole tests
- Modified measurement technique
- Bubbles observed near meter
- Customer piping not tested

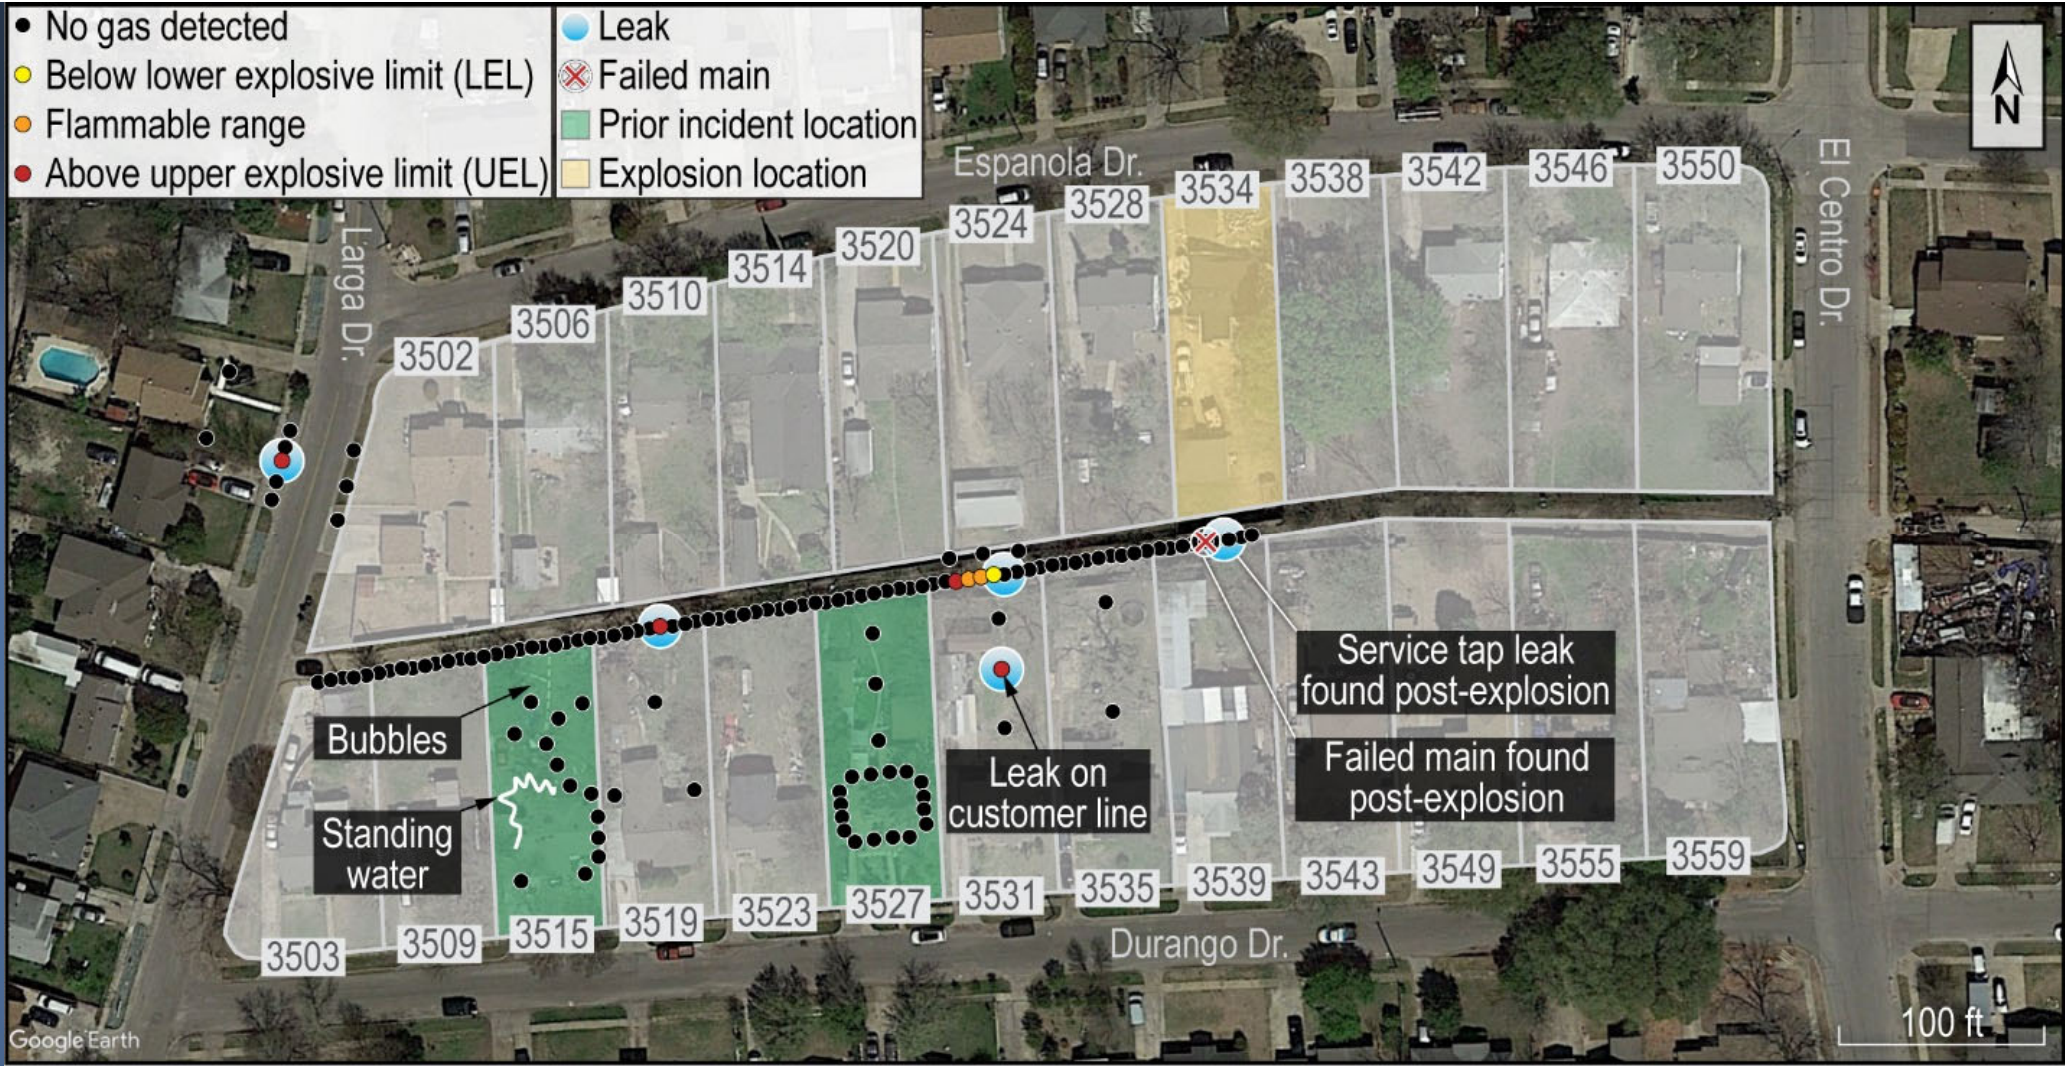
- No gas detected
- Below lower explosive limit (LEL)
- Flammable range
- Above upper explosive limit (UEL)
- Leak
- Failed main
- Prior incident location
- Explosion location
