**DOCKET NO.: SA-517**  
**EXHIBIT NO. 13D**

**DON BATEMAN WITNESS PRESENTATION**  
**(41 Pages)**

# **Guam B747**

**NTSB Public Hearing**

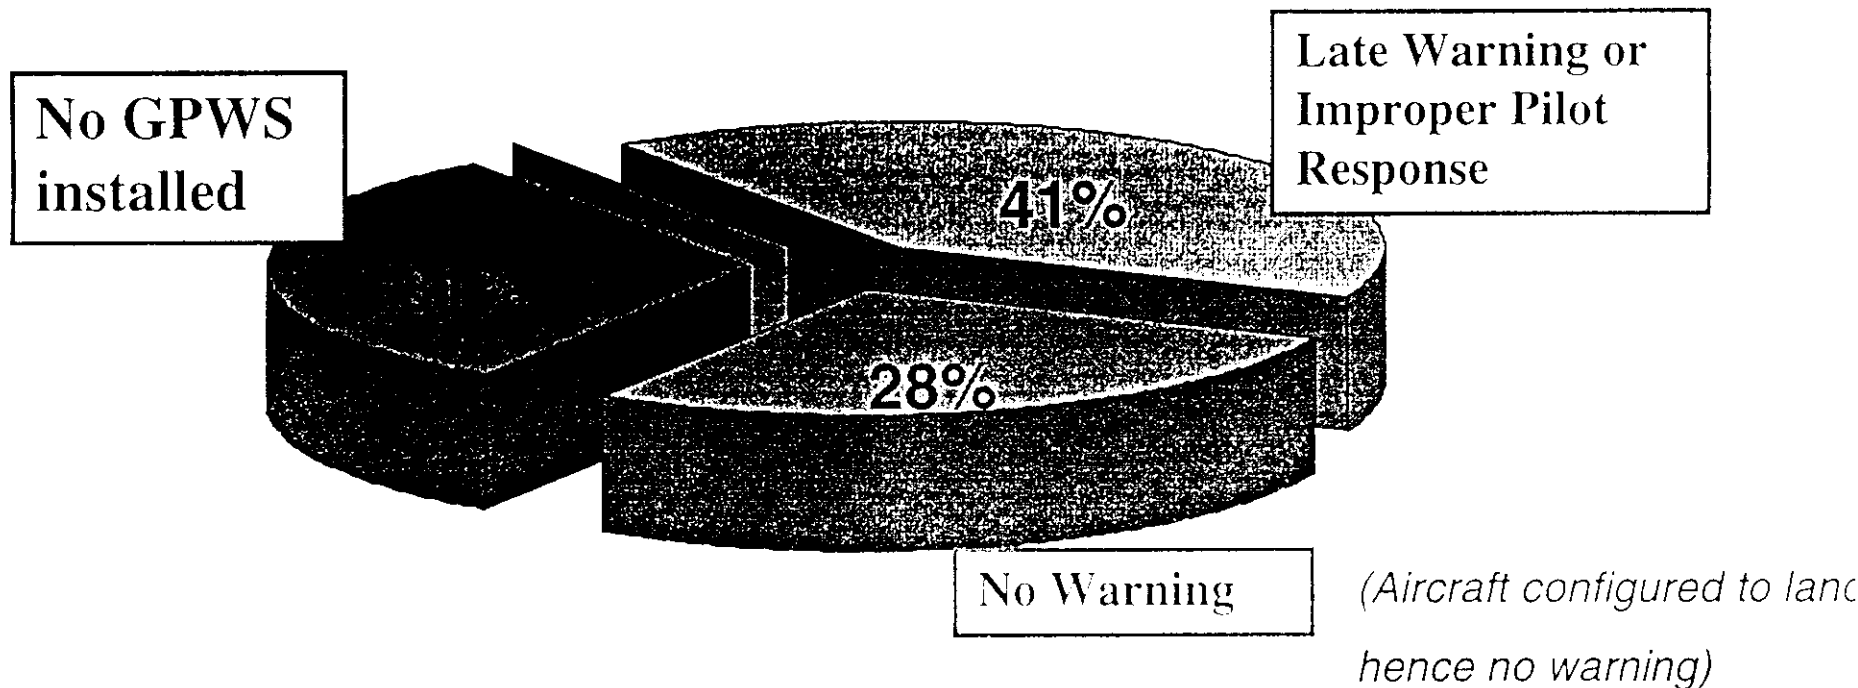
# COMMERCIAL JET AIRCRAFT ACCIDENTS

1988 - 1995

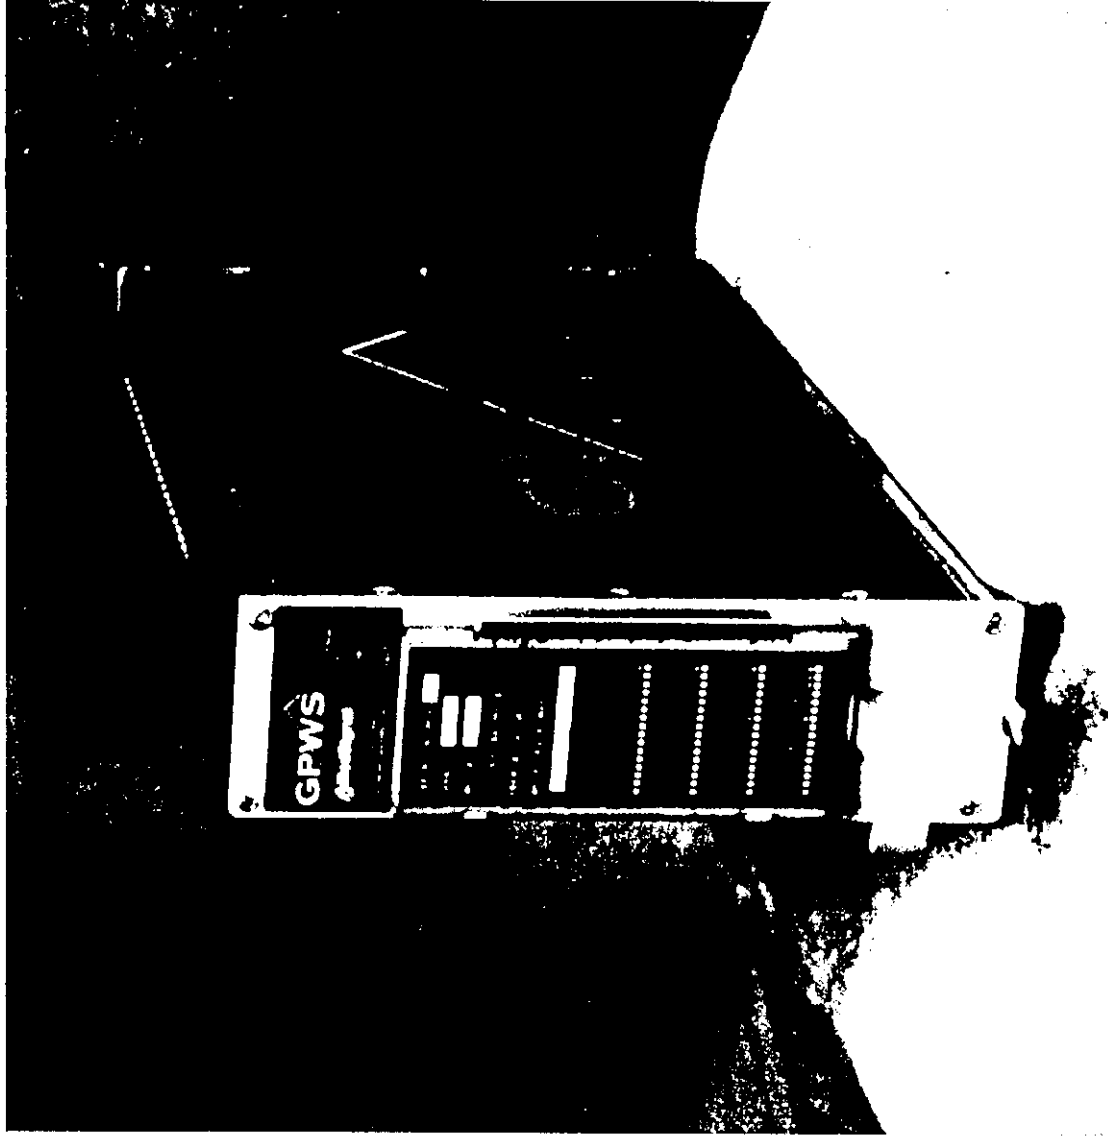
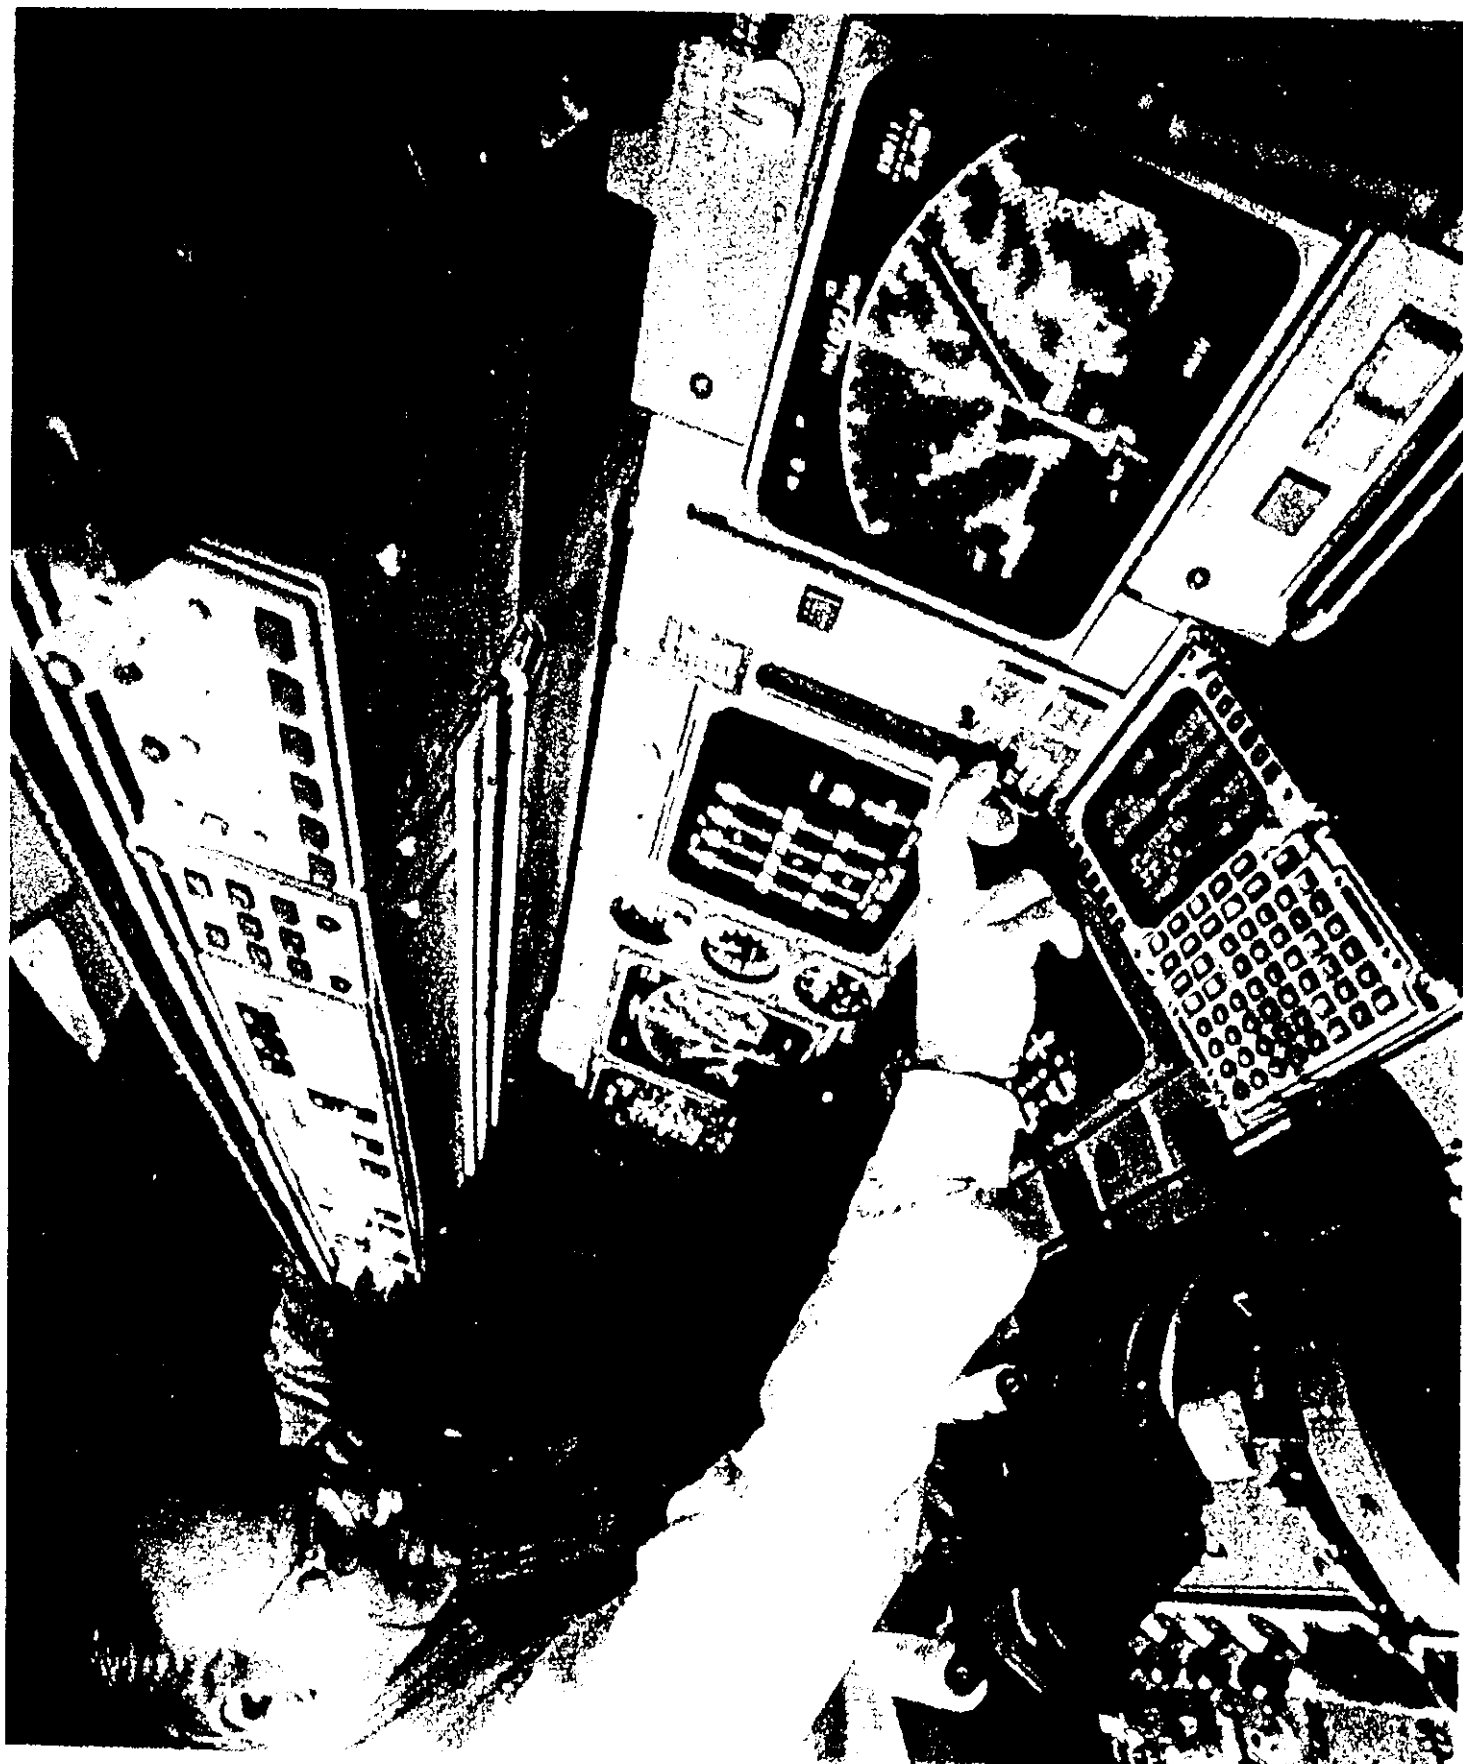
# ENHANCED GPWS

- SAME FORM FACTOR AS EXISTING GPWS.
- UTILIZES EXISTING PROVISIONS
- EXISTING GPWS FUNCTIONS MAINTAINED/IMPROVED
- DATABASE: PCMCIA ACCESSABLE

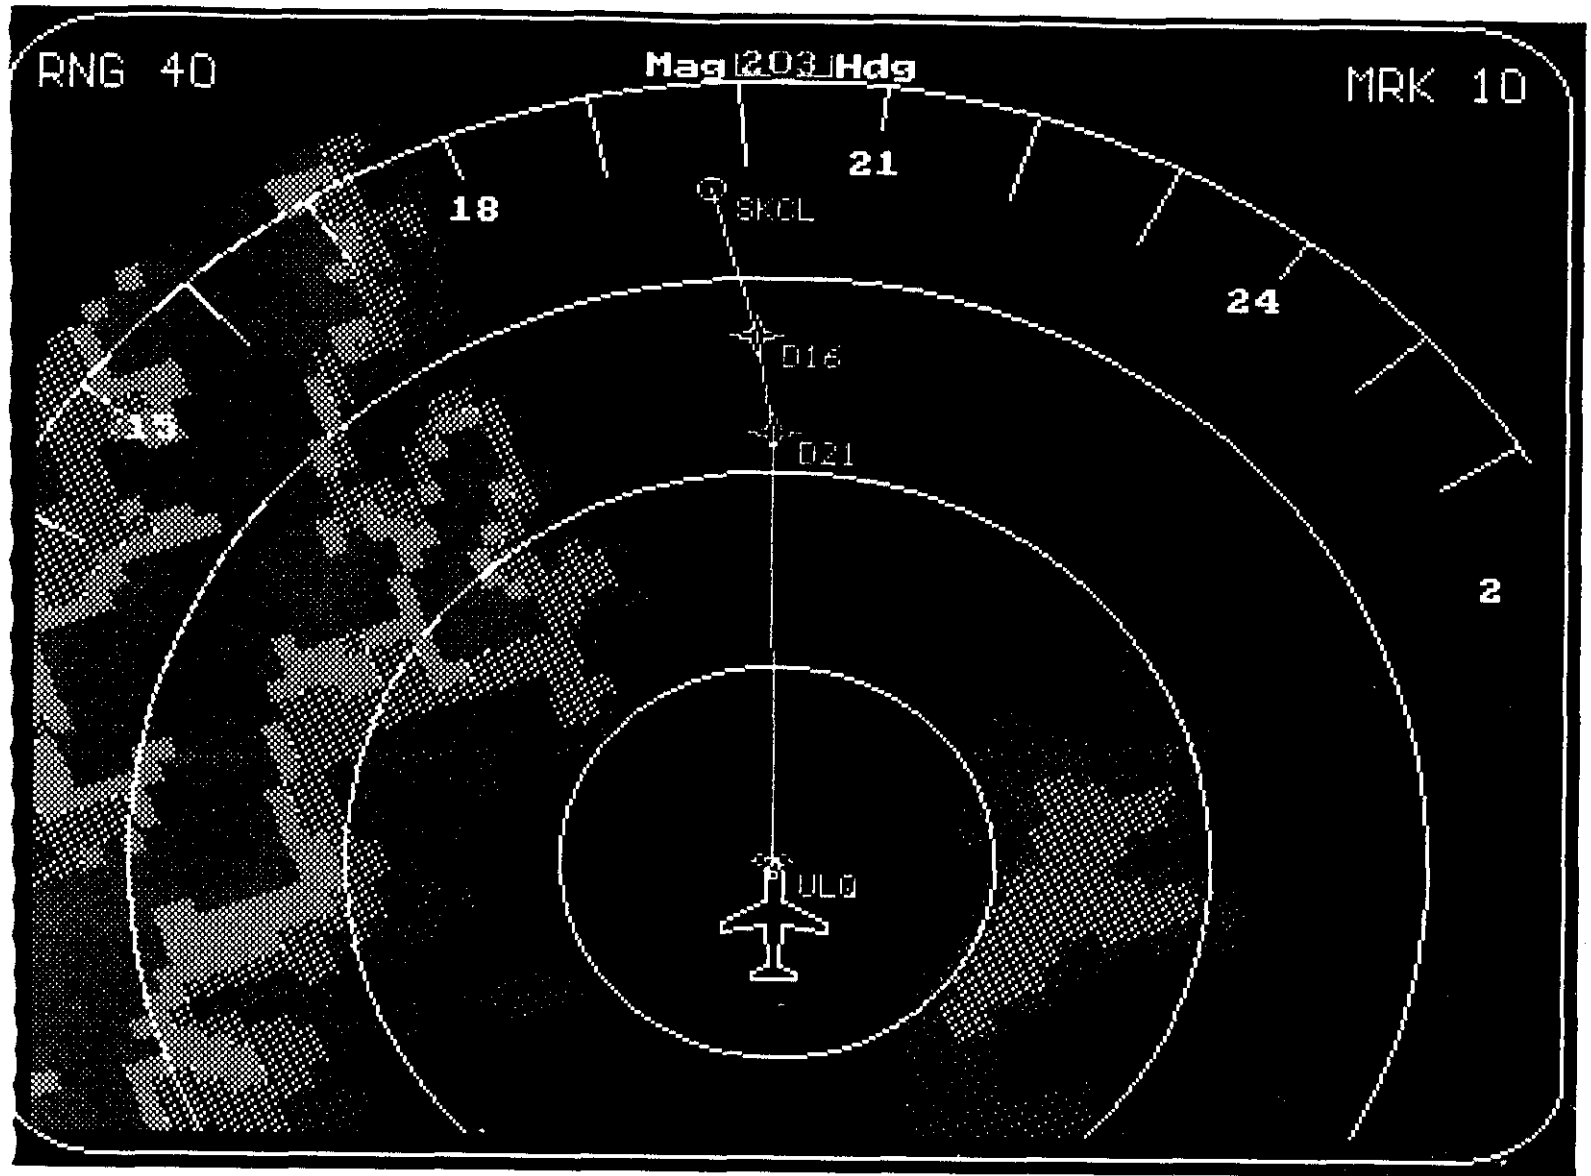
# EGPWS DISPLAY COLOR CODING

(SIMPLIFIED)

ALERT: 100% RED  
CAUTION: 100% YELLOW

Aircraft Elevation

# EGPWS TERRAIN SITUATIONAL DISPLAY

NORMAL APPROACH (VORDME 19)  
TO CALI, COLUMBIA

AIRCRAFT INBOUND AT TULUA VOR AT 9000 FEET MSL

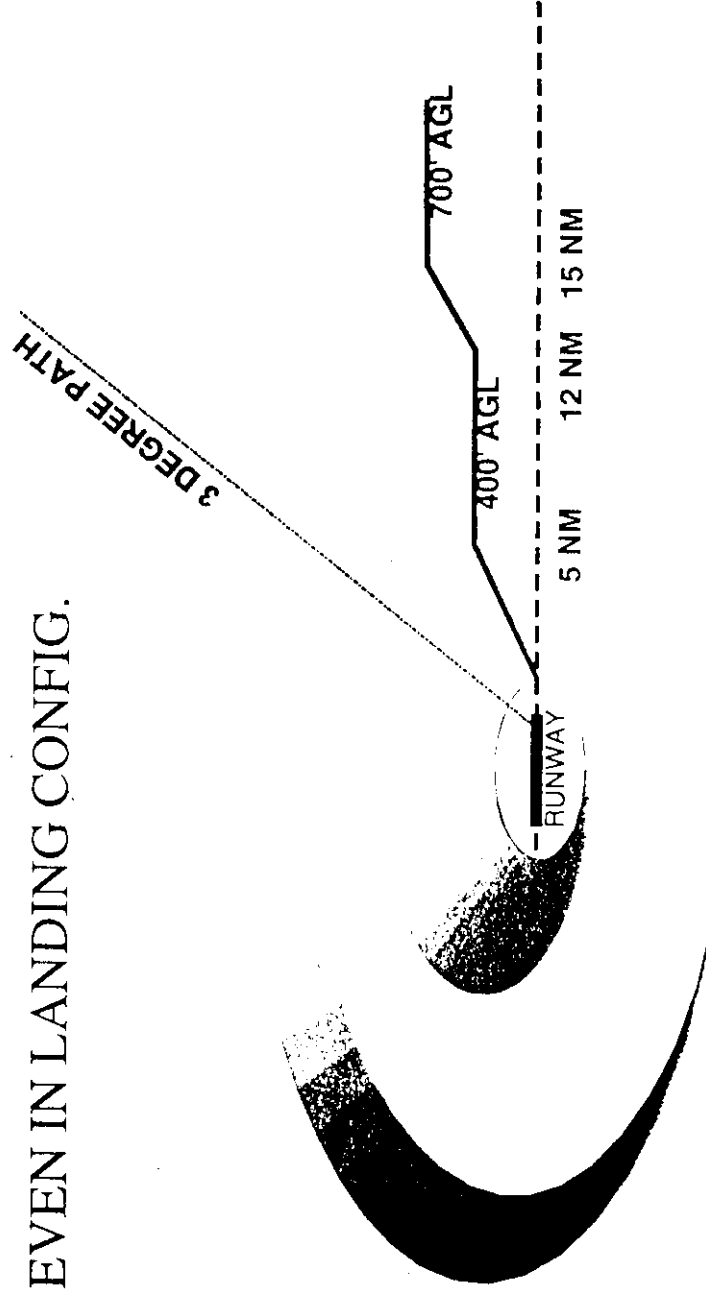
# TERRAIN CLEARANCE FLOOR

- AIRCRAFT POSITION / HEADING VS.
- AIRPORT LOCATION DATABASE, TO GIVE
- PROTECTION EVEN IN LANDING CONFIG.

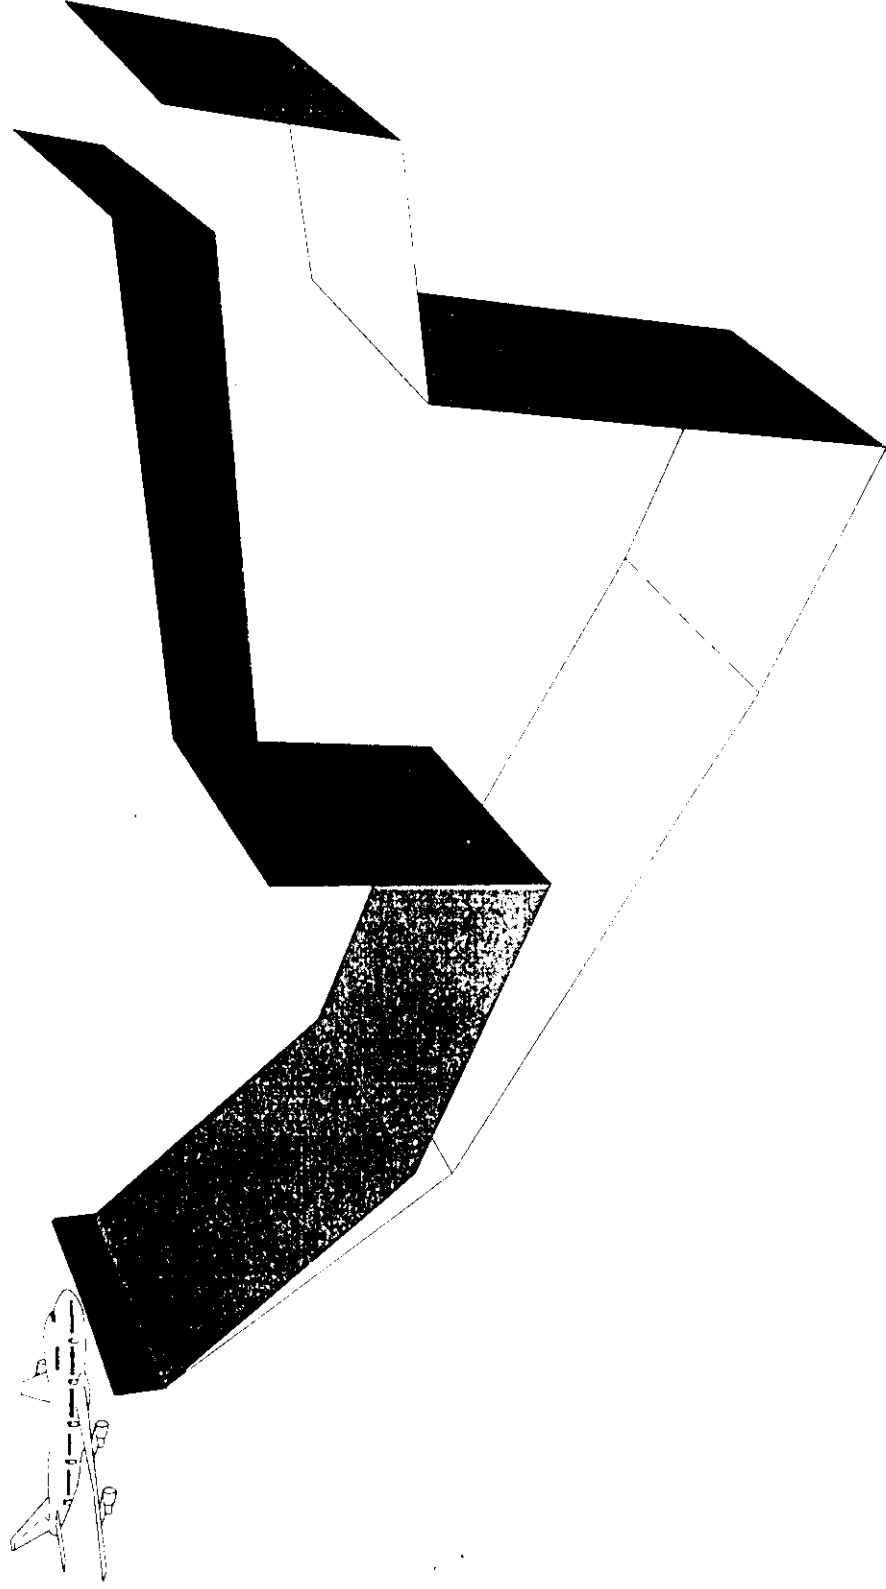
# TERRAIN ALERTING ALGORITHMS

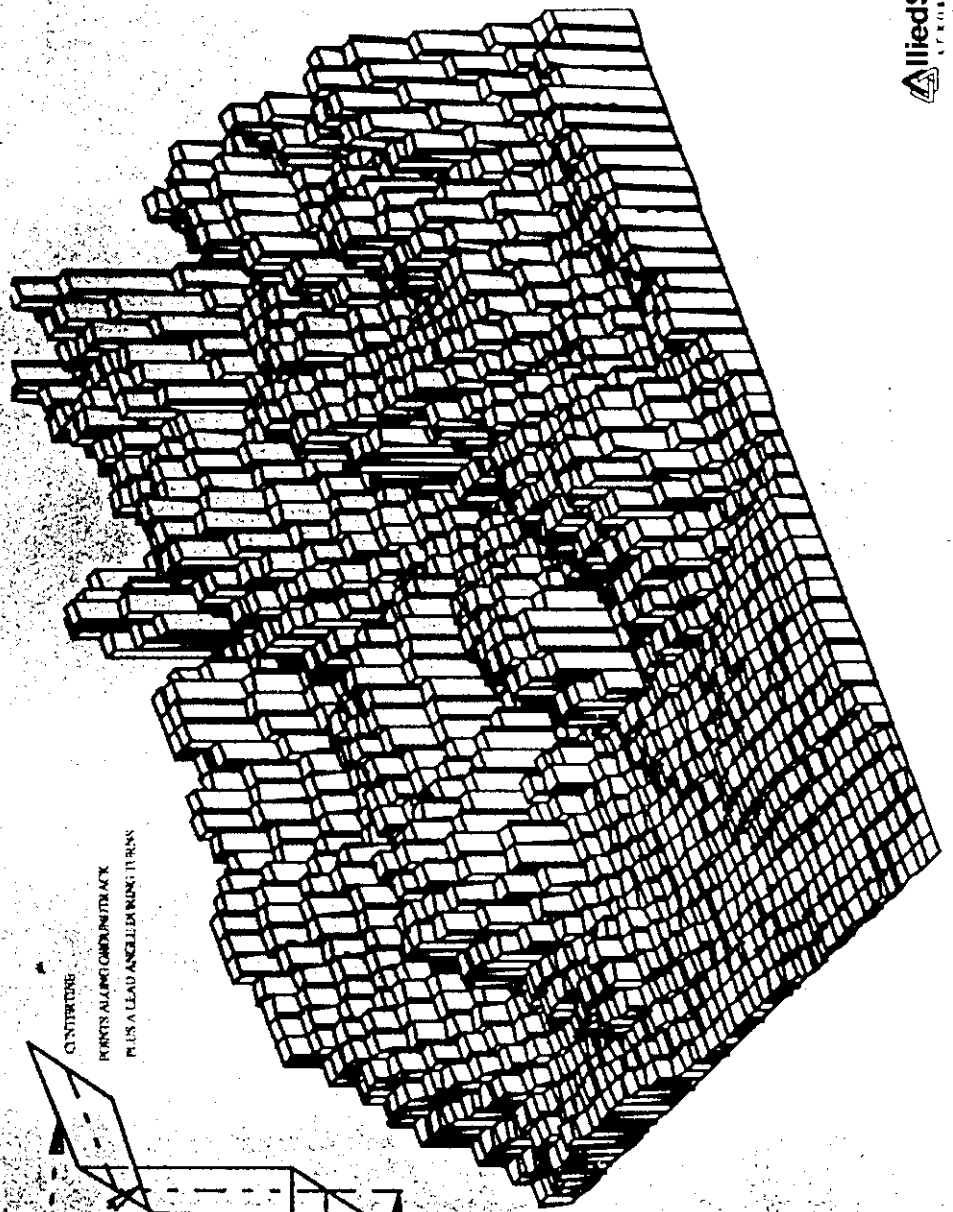
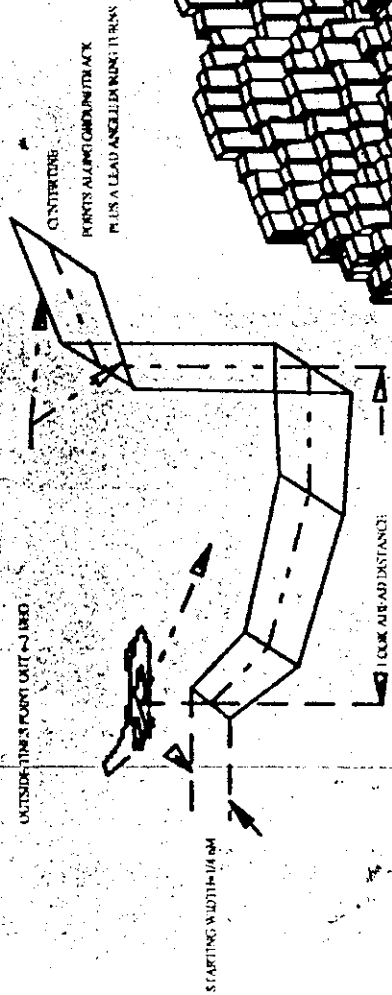
# LOOK AHEAD INTO TERRAIN

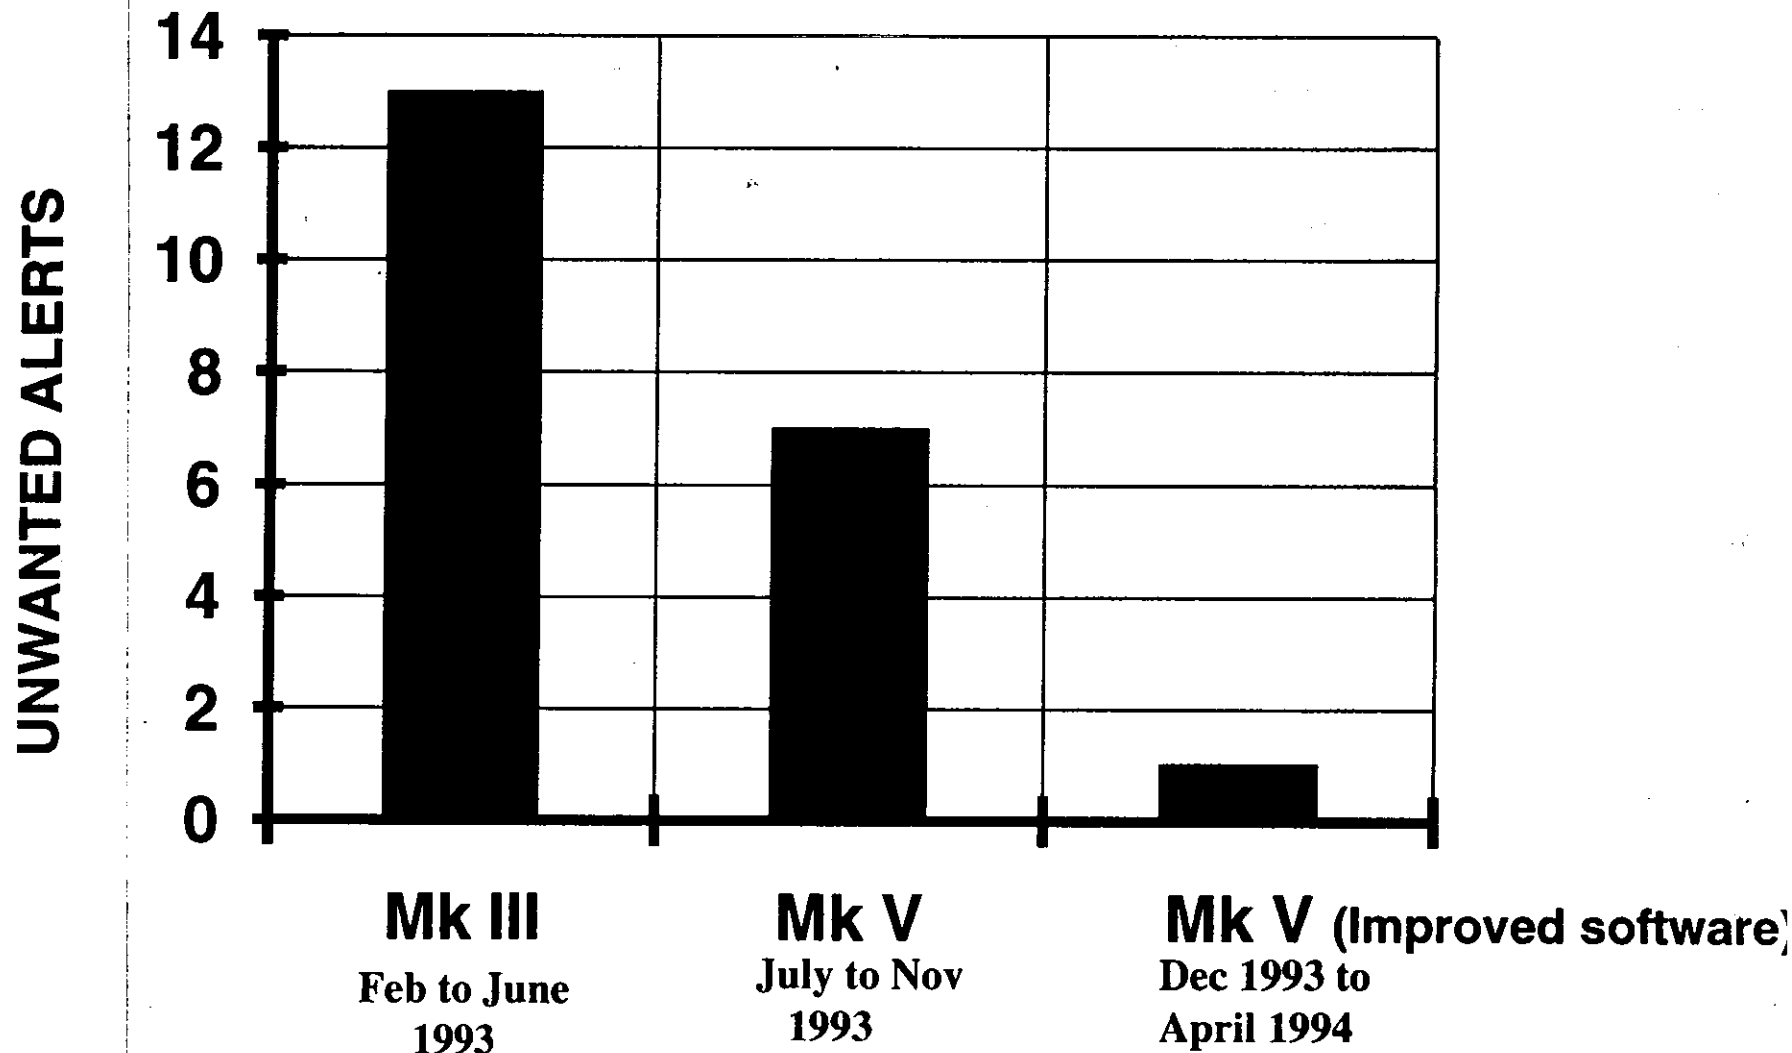
# REDUCTION IN GPWS UNWANTED ALERTS

## BRITISH AIRWAYS A320 FLEET

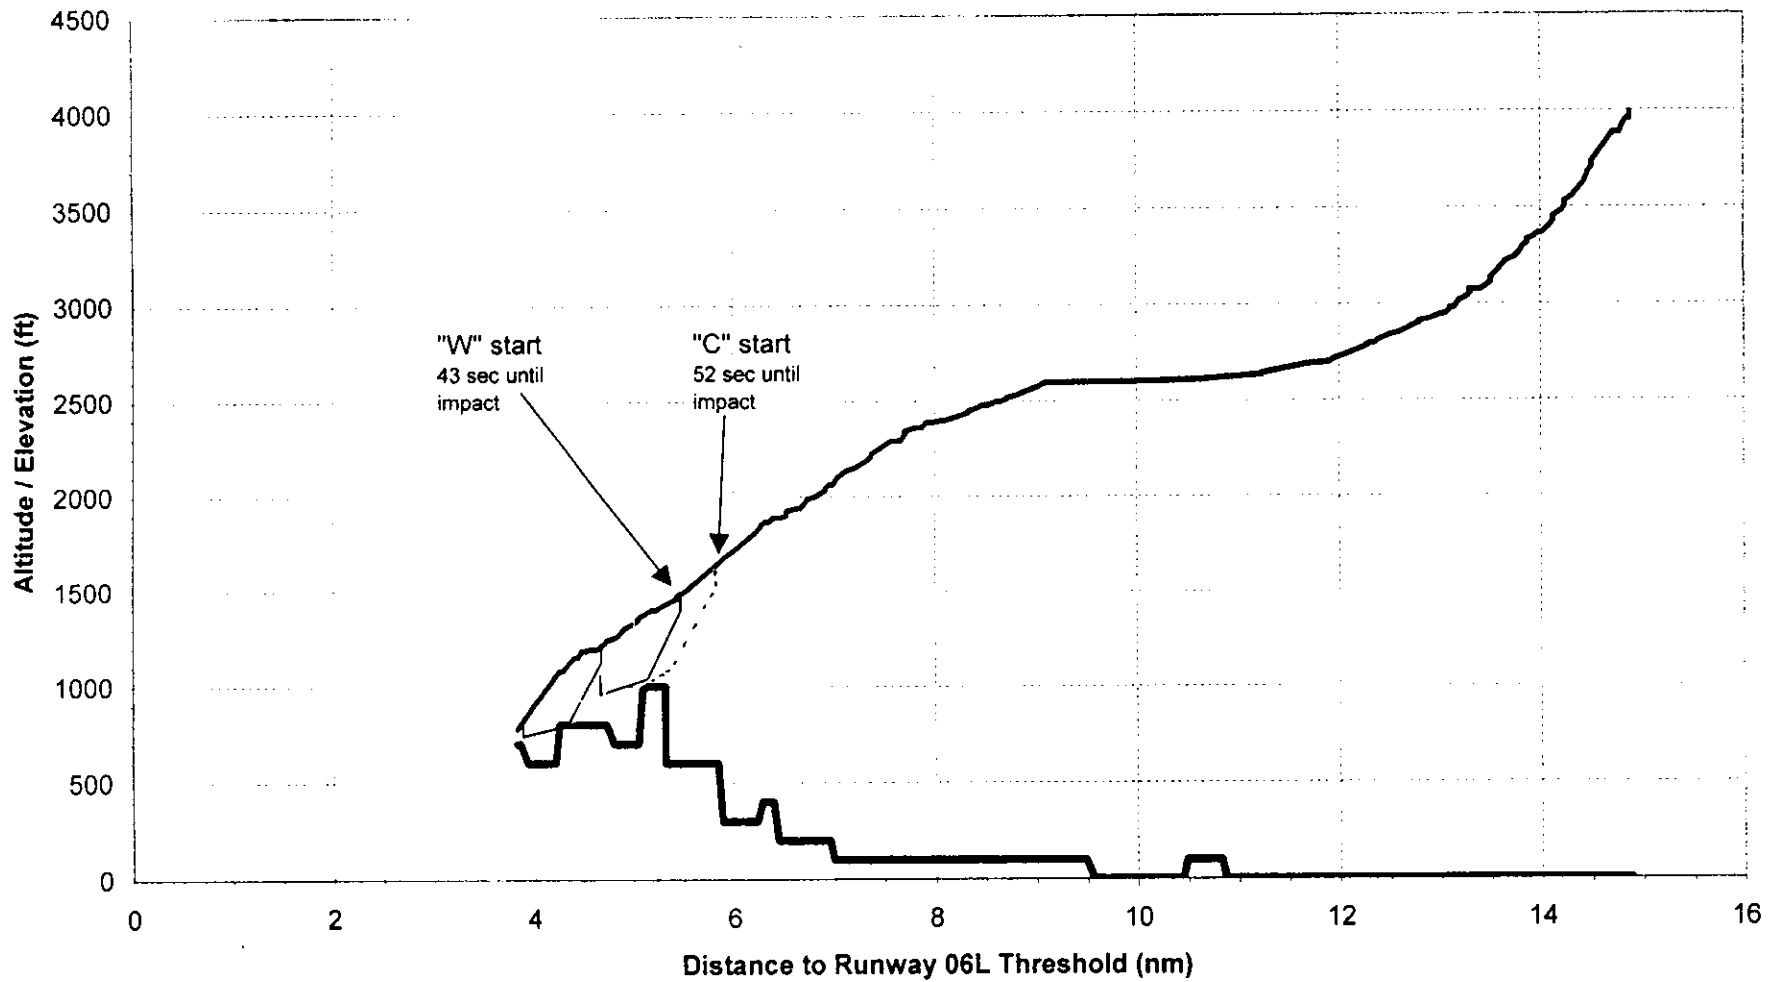
Agana, Guam  
Accident: Aug. 04 1997  
KAL 801 B747-300  
Flight Path Profile

- A flight path profile constructed from FDR data and a radio altitude (derived from aircraft altitude and a topographical charts) was used to perform a simulation of the Mark VII performance.
- The single 'sinkrate' correlated within a 0.5 second to the actual recorded time.

- With Aircraft in Landing Configuration, and Stable Descent Into Terrain Short Of the Runway, with No Glideslope, there would be No Warning or Alerts
- Radio Altitude Callouts Probably Reinforced Pilot's Situational Perception of Distance to DME on the Runway. Unfortunately, the DME was not on the Runway.
- Smart '500' with Procedure Apparently Not Used

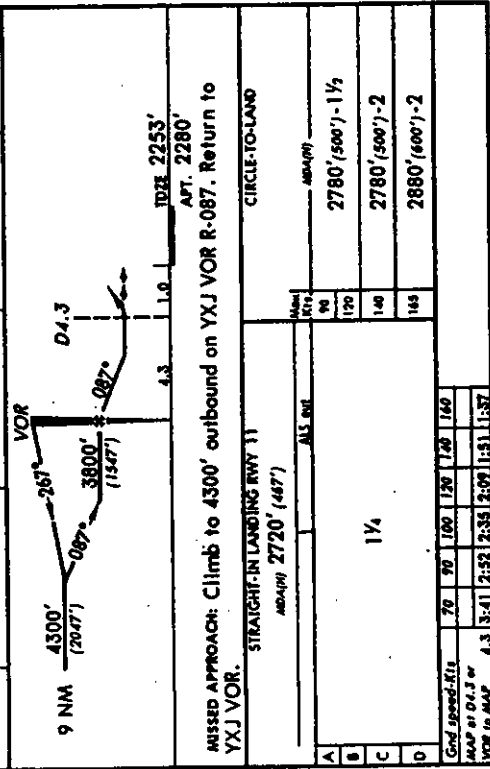
EDMONTON Center 132.6  
 FT ST JOHN Tower 118.5  
 \*Ground 121.9  
 \*FT ST JOHN Radio A/F 118.5 unless Trans. Impg.  
 Alt Set: INCHES

**CIRCUMSTANCES:** During a VOR/DME approach to runway 11, the aircraft prematurely descended towards the MDA, before reaching the VOR (FAF). A mis-set VOR radial apparently was part of the decision to descend. A MK II GPWS warning alerted the crew in time to climb, just missing a short tower and the ground.

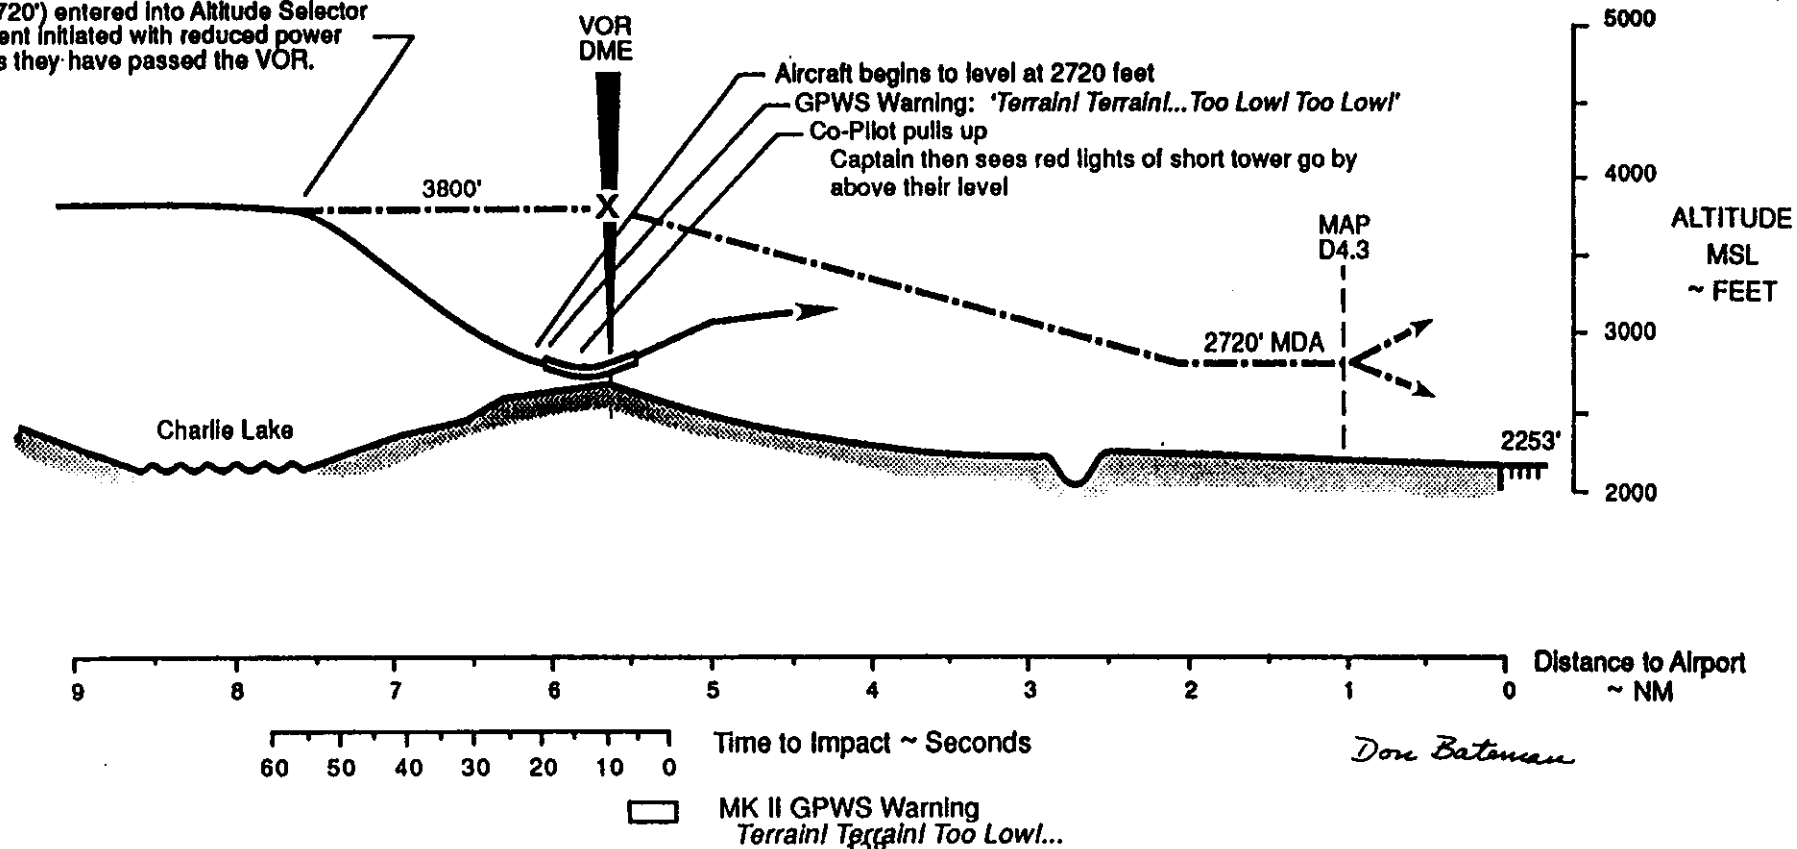
# Incident Flight Path Profile DHC-8 FT. ST. JOHN B.C., CANADA January, 1994

IDA altitude (2720') entered into Altitude Selector  
remature descent initiated with reduced power  
s crew believes they have passed the VOR.
