NATIONAL TRANSPORTATION SAFETY BOARD

**AIRWORTHINESS GROUP CHAIRMAN'S FACTUAL ADDENDUM
FOR MAINTENANCE RECORDS**

A. **ACCIDENT:** ANC10MA068
 LOCATION: Near Aleknagik, Alaska
 DATE/TIME: August 9, 2010
 AIRCRAFT: DeHavilland Canada DHC-3 "Turbine Otter", N455A

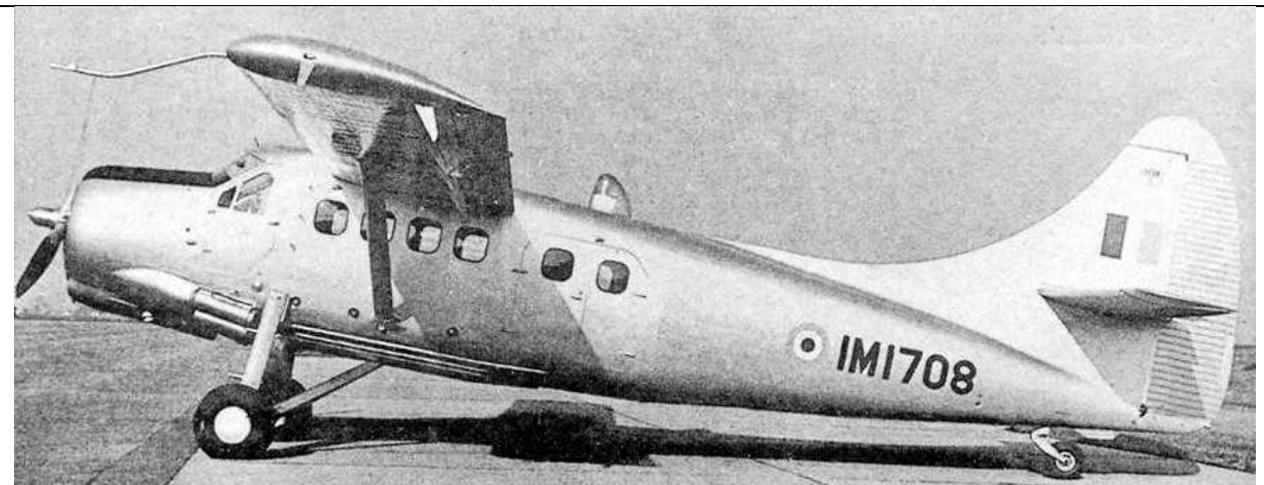
Figure 1. Image of a DHC-3 Otter with registration marking IM1708 in India. The caption states "A DHC-3 Otter [IM1708] lies parked at Palam AFS. Circa late 1950s. These aircraft entered service with the IAF in 1956 and the last of the type was retired in 1991." Source: <http://www.bharatprakshak.com/IAF/Images/Vintage/Transports/Otter/IM1708.jpg>.

The airplane's date of manufacture was January 17, 1957, and it was registered as Canadian registration C-FWYF.¹ The airplane was delivered with registration marking IM-1708 to the India Supply Mission on August 11, 1957, as one of 27 DHC-3 Otter airplanes. The interior was configured with 11 seats, and the engine was a Pratt & Whitney R-1340 piston engine. (See Figure 1)

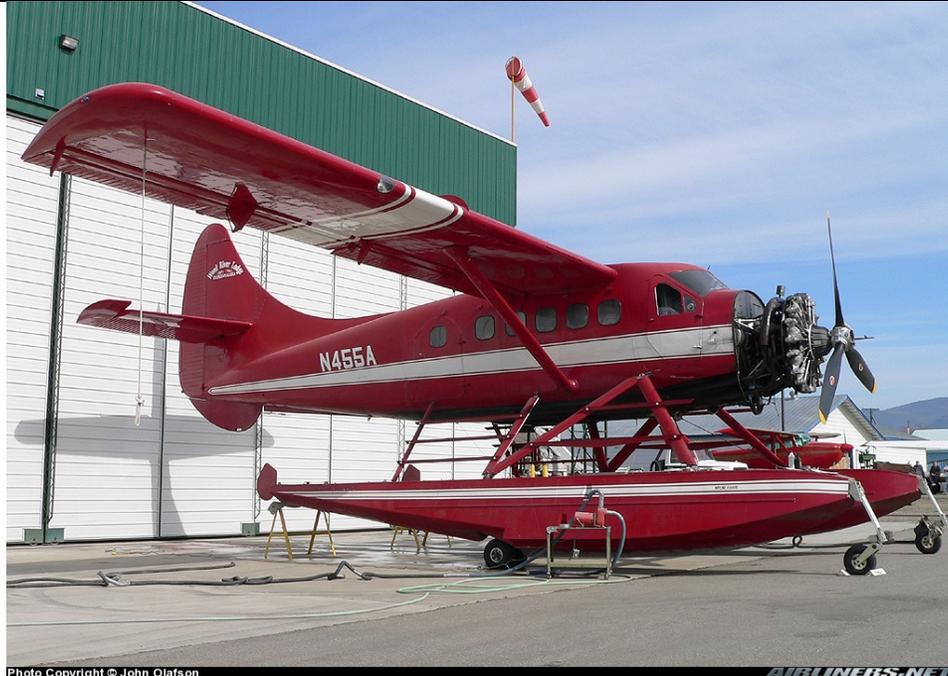
Figure 2. A caption states that “This Otter is about to receive the Texas Turbine conversion. It will return to its home base in Alaska.” Source:

The airplane was flown as part of the Wood River Lodge operation and known as “Big Red,” which was painted on the left cockpit door. (See Figures 2 and 3) Personnel working for GCI related that Wood River Lodge was later purchased by GCI and the airplane was part of the purchase.

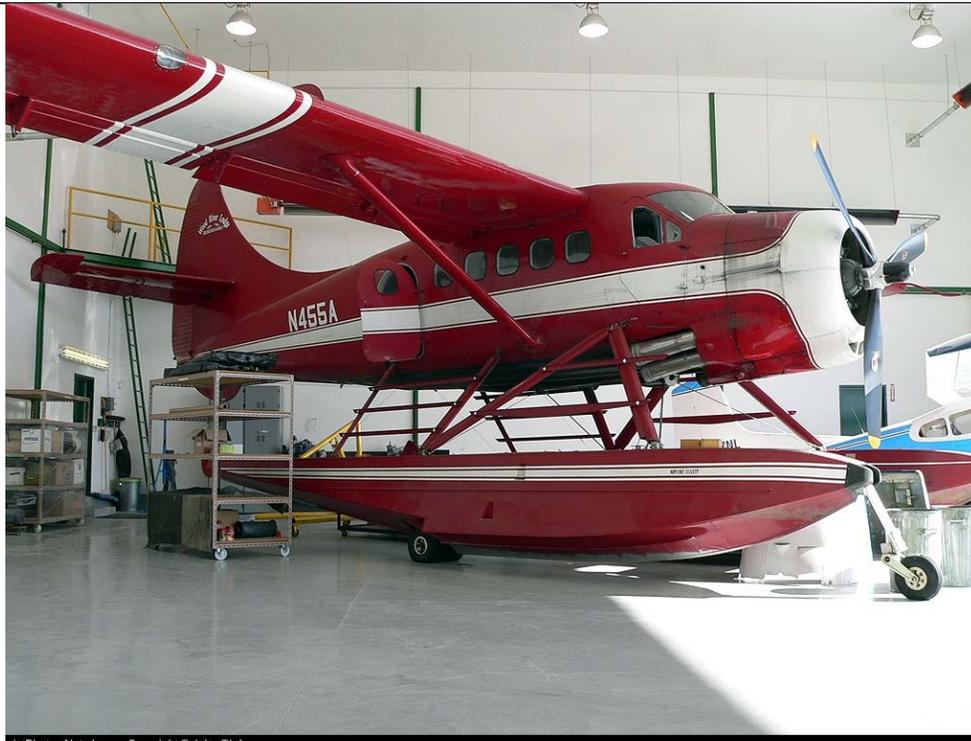
Figure 3: Photo dated February 13, 2005, captioned “This Otter, named "Big Red" has come to Kal Air Repair to be converted to the Texas Turbine engine, then it will return to Alaska.” Source: <http://jetphotos.net/viewphoto.php?id=436236&nseq=4>

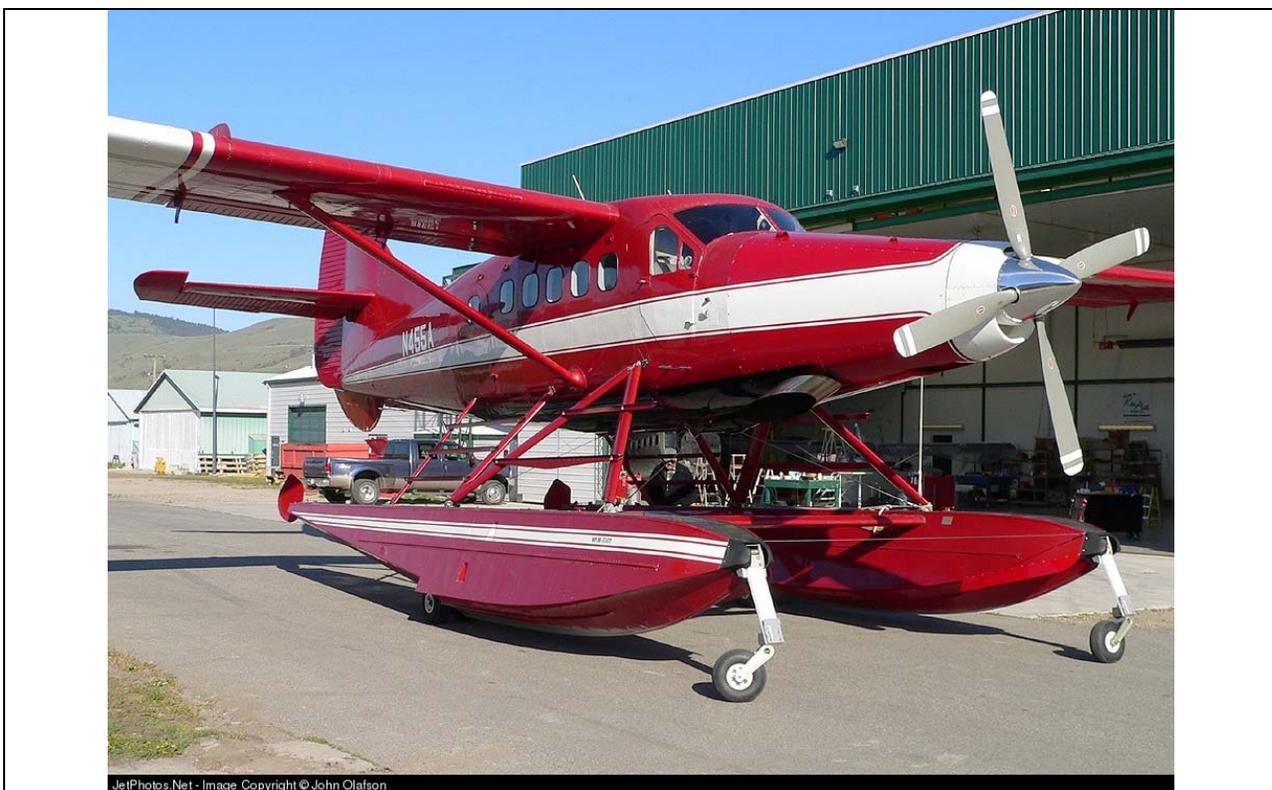
Figure 4: Photo dated April 29, 2005, captioned “s/n 206. The Texas Turbine Conversion has just been completed at Kal Air Repair. Quite a difference in appearance as well as performance.” Source: <http://jetphotos.net/viewphoto.php?id=465705&nseq=2>

Kal-Air Repair, Ltd, of Vernon, BC, Canada, modified the airplane to replace the original piston engine with a turbine engine. (See Figure 4) The work release was signed April 26, 2005, when the airplane had 7889.9 flight hours. The modification installed a Garrett TPE331 series engine and related propeller, in accordance with a Supplemental Type Certificate (STC SA09866SC) from Texas Turbines. As part of the overhaul, an avionics shop (Sebrof Aviation) in the area replaced the instrument panels, as well as nearly all of the avionics and instruments, using new parts. The Sky Connect flight tracking system and the Garmin GNS-530, Garmin GNS-430, a marine band radio, and the radar altimeter were installed at this time. Kal-Air also completed an extensive list of repairs throughout the airplane, replaced many components, and made lesser modifications, such as adding an aft cargo net and anticollision strobe lights. The annual inspection was signed on July 5, 2005, prior to re-entry into service and this entry notes that the Hobbs meter was replaced with a new part, showing no flight hours.³
