IV. Rudder System Scenarios

A. Rudder System Overview

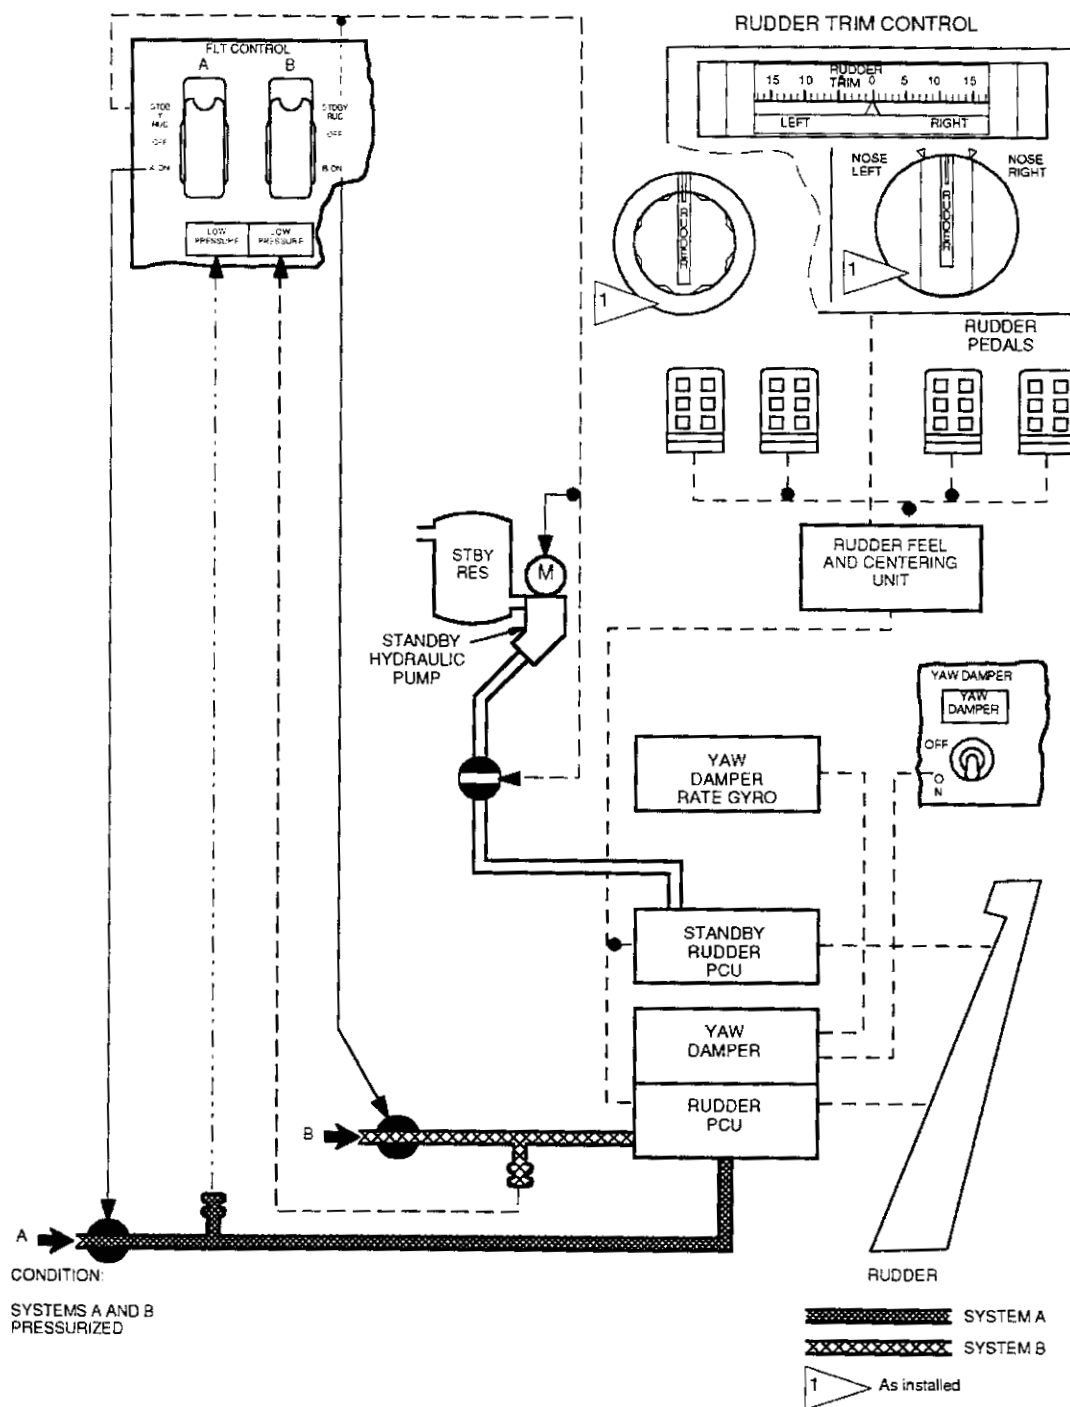
Pilot control of the rudder is provided through the captain's and F/O's rudder pedals. The pedal motion is transmitted by a single cable system to the aft quadrant, and then through linkages to the main and standby PCUs, as shown in Figures 7 and 8. Except for the yaw damper, as discussed below, the rudder surface follows the pedal command. The pedals provide the flight crew with an indication of rudder surface positioning.

Figure 7: Rudder Control System Schematic

Figure 7 also shows the yaw damper system, which is designed to improve airplane ride quality by minimizing small-amplitude yaw oscillations. The yaw damper electronic module, or coupler, provides an electrical signal to the

yaw damper actuator, which is part of the main rudder PCU. The yaw damper and pilot inputs are summed within the PCU such that yaw damper rudder inputs do not move the pedals.

The rudder feel and centering mechanism attaches to the aft quadrant, and applies a force to the quadrant—and thus to the pedals—that is roughly proportional to the rudder deflection. The pedal force required for full rudder deflection is approximately 70 pounds. Rudder trim allows the pilots to maintain a rudder deflection without having to hold in a pedal deflection. This trim is provided by an electric trim actuator that rotates the feel and centering unit, thereby changing the centered or neutral rudder position.

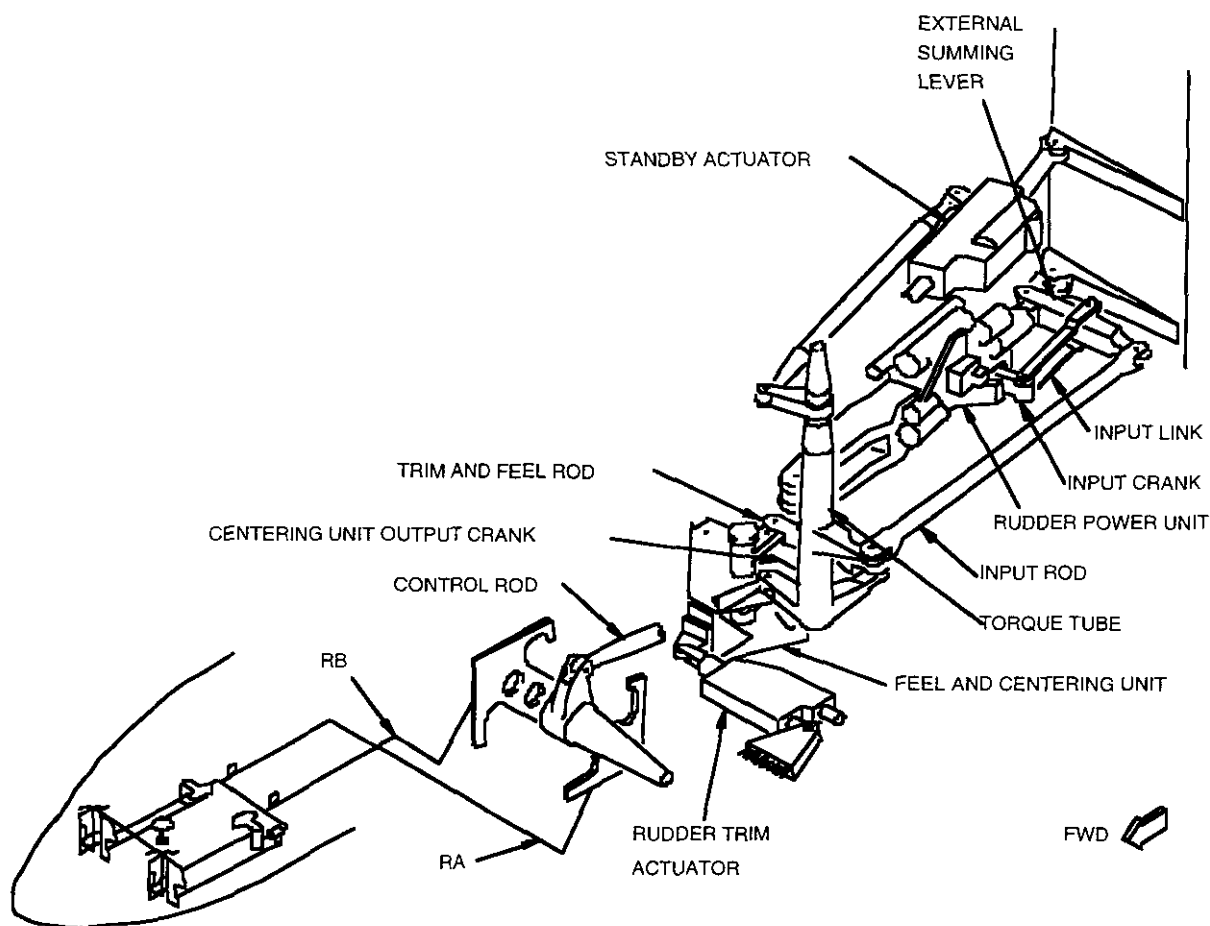
Figure 8: Main and Standby PCU Installation

Aft quadrant rotation is transmitted to the main PCU through a dual-load-path linkage, and to the standby PCU by a single-load-path linkage. During normal operation, the main PCU is powered by the A and B hydraulic systems, and the standby PCU is depressurized. The standby PCU is pressurized by the standby hydraulic system after failure of one or both of the hydraulic systems (A and B). The standby PCU contains a pressure-operated bypass valve that allows it to be backdriven by the main PCU during normal operation.

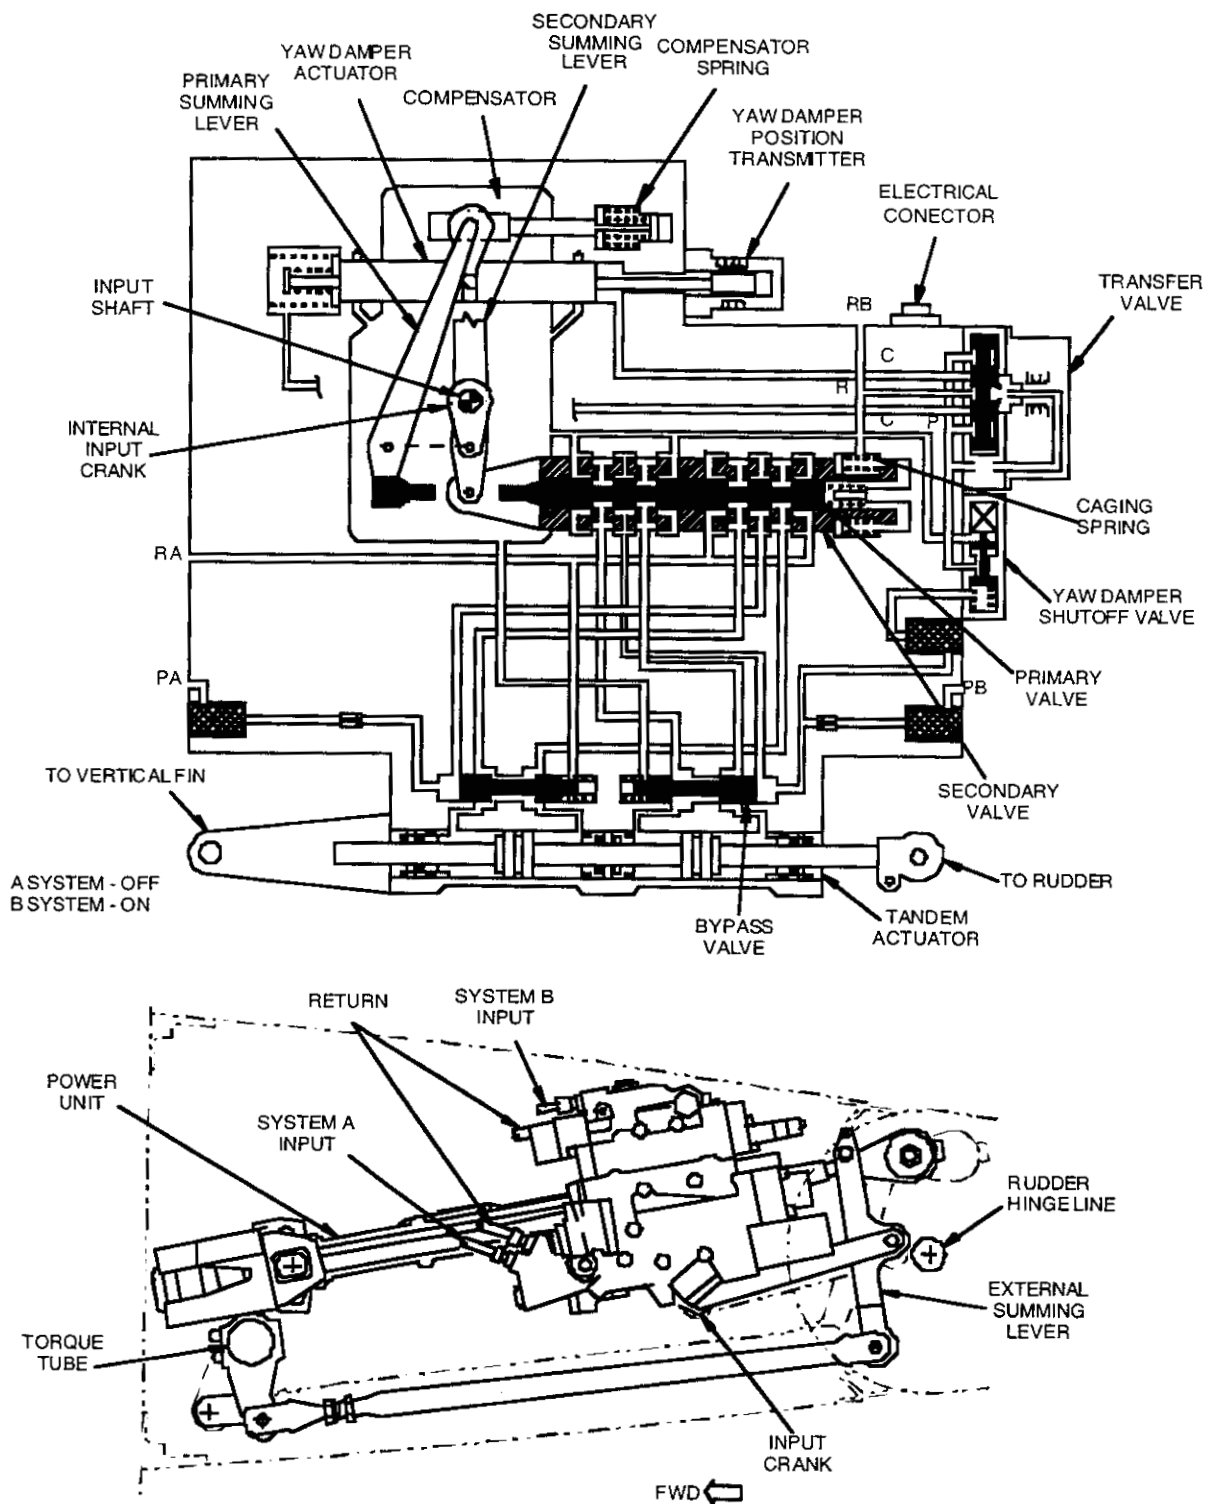
Figure 9: Main PCU Functional Schematic

Figure 9 provides a schematic view of the main PCU. The main control valve is connected through a dual-load-path linkage to both the yaw damper piston and to the pilot input linkage. The linkage sums inputs by the pilots and yaw damper to the control valve. The yaw damper piston is controlled by an electro-hydraulic servo valve that receives an electrical input from the yaw damper coupler. The yaw damper piston in the Flight 427 PCU (as in all 737-300 airplanes) is limited by a mechanical stop that only allows it to command three degrees of rudder.

When the PCU control valve is displaced by either a pilot or yaw damper input, it directs hydraulic flow to one side or the other of the actuator. The actuator then continues to move until the actuator piston rod moves the feedback linkage sufficiently to return the valve to its centered or neutral position.

The main PCU control valve is a dual concentric valve; that is, it contains two concentric slides with each of these slides controlling two hydraulic systems. The inner valve slide is the primary slide and the outer slide is the secondary slide. During normal operation, the primary slide is displaced first, and the secondary slide is displaced only when the primary slide does not provide enough hydraulic flow to keep up with the input command.

The two slides are designed to provide approximately equal flow. Thus, the primary slide can provide a rudder rate of approximately 33 degrees per second (no air load), while the primary and secondary slides acting together can provide a rate of approximately 66 degrees per second. The valve is designed in this way so that if one of the slides jams, the other slide can negate the effect of the jam and, in the worst of cases, allow the air load to force the rudder back to approximately neutral.

The main PCU also has a hydraulic bypass valve for each hydraulic system. Each bypass valve allows hydraulic flow between the two sides of the associated piston. When one side of the PCU is not pressurized, its bypass valve is open and allows essentially unrestricted flow. This allows the PCU to maintain full rate capability after a failure of one hydraulic system. When the PCU is pressurized, the bypass valve is closed and the only flow is
