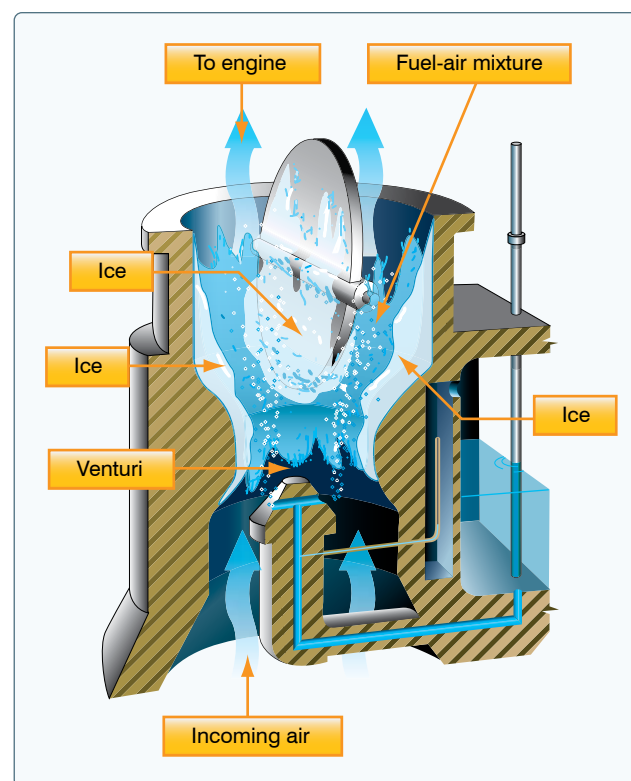
**Figure 7-11.** The formation of carburetor ice may reduce or block fuel-air flow to the engine.

As mentioned earlier, one disadvantage of the float-type carburetor is its icing tendency. Carburetor ice occurs due to the effect of fuel vaporization and the decrease in air pressure in the venturi, which causes a sharp temperature drop in the carburetor. If water vapor in the air condenses when the carburetor temperature is at or below freezing, ice may form on internal surfaces of the carburetor, including the throttle valve. [Figure 7-11]

The reduced air pressure, as well as the vaporization of fuel, contributes to the temperature decrease in the carburetor. Ice generally forms in the vicinity of the throttle valve and in the venturi throat. This restricts the flow of the fuel-air mixture and reduces power. If enough ice builds up, the engine may cease to operate. Carburetor ice is most likely to occur when temperatures are below 70 degrees Fahrenheit (°F) or 21 degrees Celsius (°C) and the relative humidity is above 80 percent. Due to the sudden cooling that takes place in the carburetor, icing can occur even in outside air temperatures as high as 100 °F (38 °C) and humidity as low as 50 percent. This temperature drop can be as much as 60 to 70 absolute (versus relative) Fahrenheit degrees ( $70 \times 100/180 = 38.89$

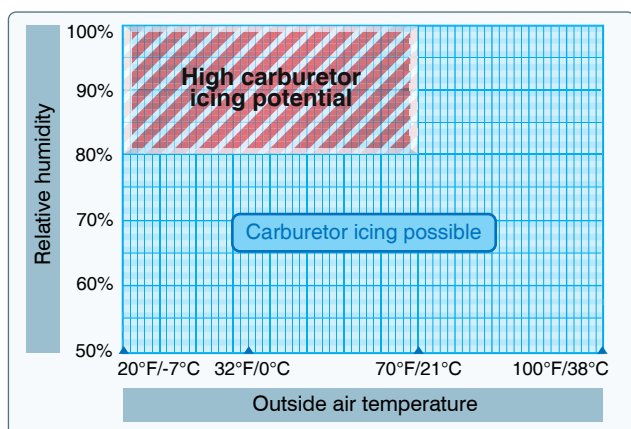
**Figure 7-12.** Although carburetor ice is most likely to form when the temperature and humidity are in ranges indicated by this chart, carburetor icing is possible under conditions not depicted.

Celsius degrees) (Remember there are 180 Fahrenheit degrees from freezing to boiling versus 100 degrees for the Celsius scale.) Therefore, an outside air temperature of 100 F (38 C), a temperature drop of an absolute 70 F degrees (38.89 Celsius degrees) results in an air temperature in the carburetor of 30 F (-1 C). [Figure 7-12]
