## **RASIP FINDING**

### **2.08.03**

During the aircraft ramp inspection on Aircraft N-870TV, arrival into Seattle on 02/05/99, the RASIP Team found that only one half of the smoke curtain was installed: The other half of the smoke curtain had been removed and deferred as a Non-MEL item.

### **2.08.03 RRXA RESPONSE**

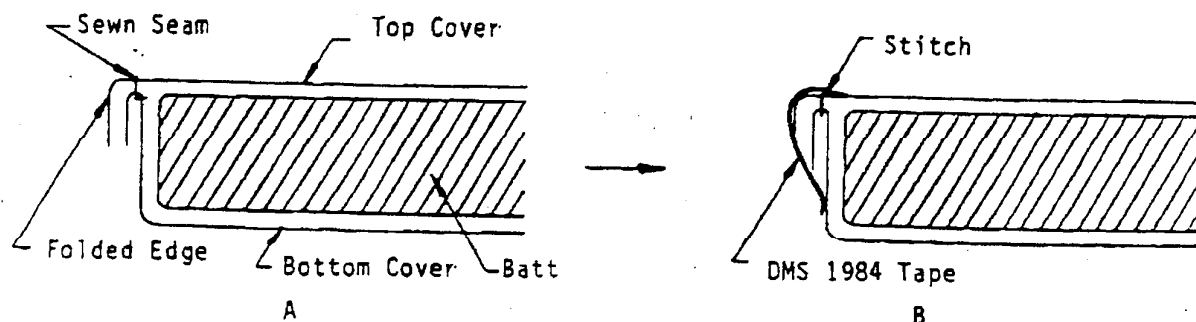
**FIGURE 5.1**  
**SEALING SEAMS WITH TAPE**

5.6.2.1 Fold the seam edge areas of the blanket cover so that they lay flat against the blanket as shown in Figure 5.1A.

5.6.2.2 Remove the release liner from the DMS 1984 splicing tape. Apply the tape to the folded seam edge, completely covering the sewn seam as shown in Figure 5.1B. Apply the tape so that it follows the contour of the blanket and does not bridge wrinkles or shallow spots.

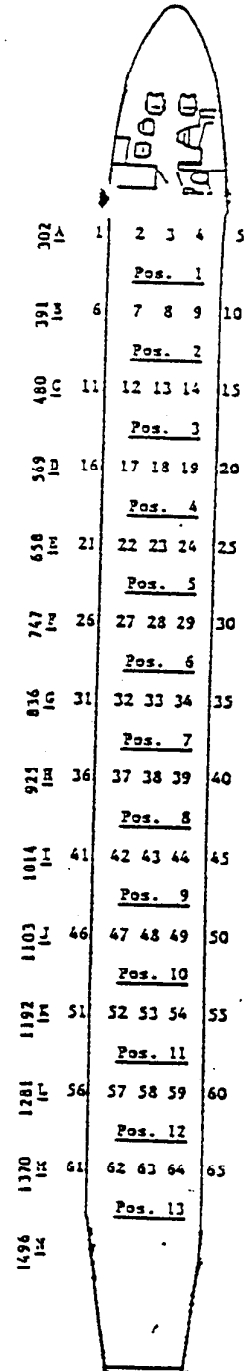
Figure 1

3889344-1  
End Restraint Fitting

D16 thru D20  
E21 thru E25  
F26 thru F30  
G31 thru G35  
H36 thru H40  
I41 thru I45  
J46 thru J50  
K51 thru K55  
L56 thru L60  
M61 thru M65

## DC-8F-54 BROKEN OR MISSING PALLET LOCK LOCATIONS

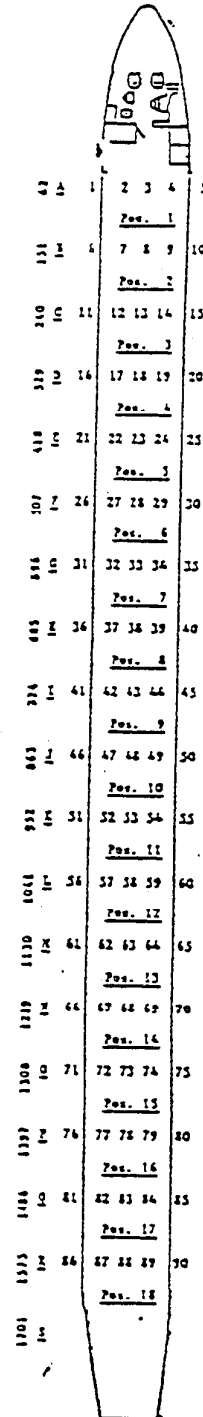
Figure 3

3889344-1  
End Restraint Fitting

D16 thru D20  
E21 thru E25  
F26 thru F30  
G31 thru G35  
H36 thru H40  
I41 thru I45  
J46 thru J50  
K51 thru K55  
L56 thru L60  
M61 thru M65  
N66 thru N70  
O71 thru O75  
P76 thru P80  
Q81 thru Q85  
R86 thru R90

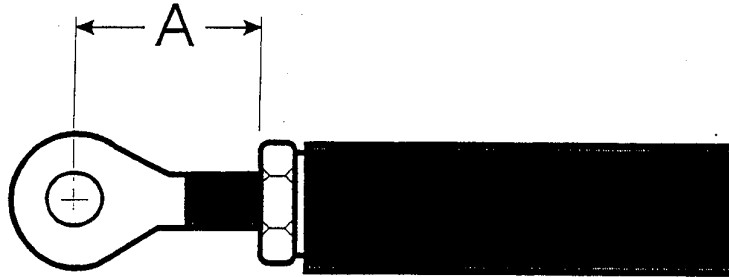
**MEASURE AT BOTH ENDS OF SHAFT**

5. Remove shaft from upper end (Connected to Torque Tube).
6. Remove Latch from the respective broken Shaft.
7. Disconnect Shaft from Latch (Lower End).
8. Measure distance A, or count number of threads, which have to be the same in both sides.

9. Remove complete Shaft.
10. Reverse process to install. Connect upper end of Shaft to Torque Tube. Connect lower end to Latch. Install Latch.
11. Move torque tube clockwise to close latch.
12. With latch completely closed, turn shaft to open position until latch begins opening. Turn shaft toward close position until feel pressure, then make a ¼ turn just to secure the shaft and eliminate slack.
13. Secure shaft by tightening both shaft ends with the lock nuts.
14. Connect Cylinder.
15. Actuate selector valve handle to number 1 position (OPEN).
16. Open door by using hand pump, check mechanism.
17. If mechanism is correct, then operate door by automatic system.

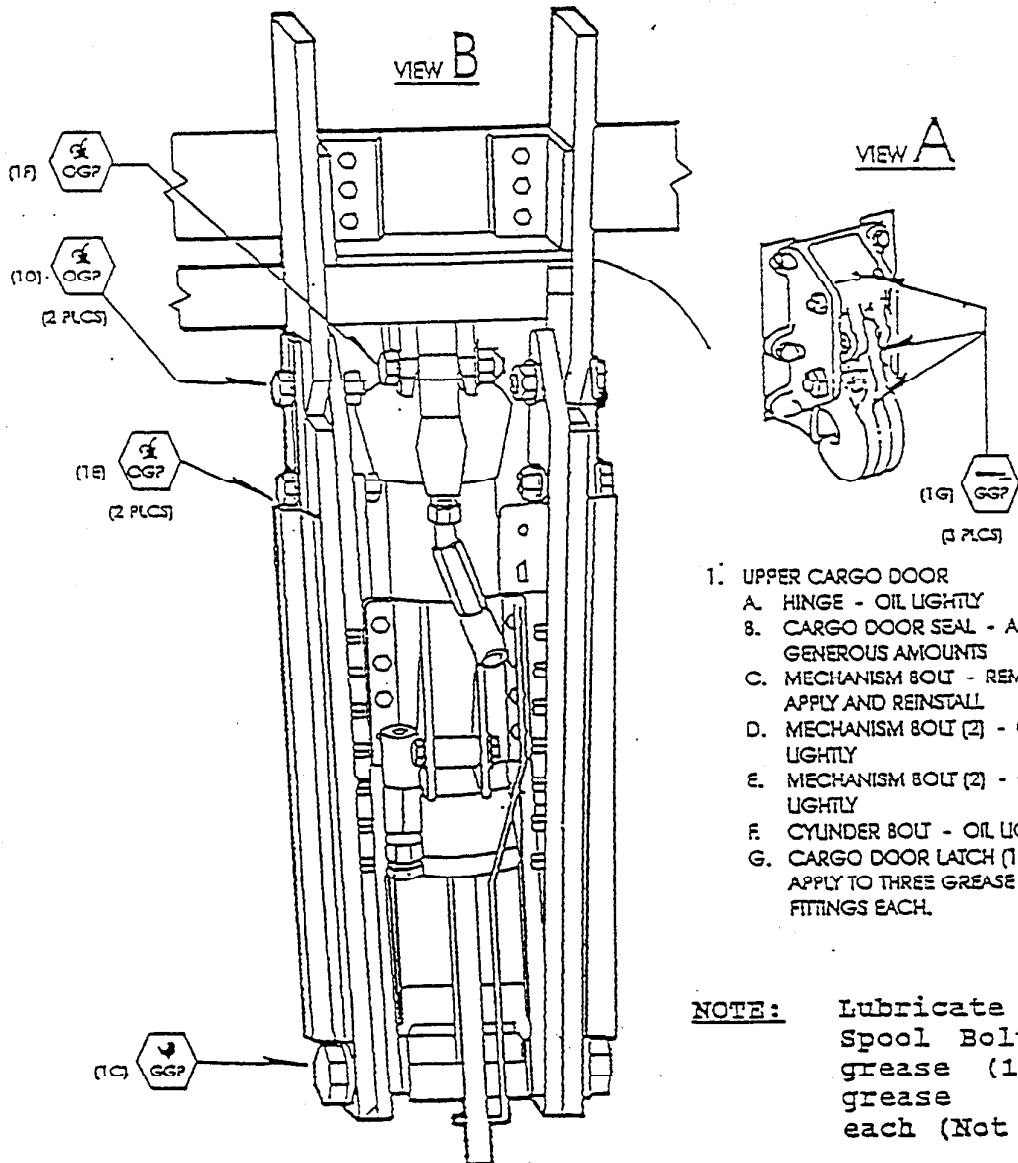
**CARGO DOOR - LUBRICATION**

1. UPPER CARGO DOOR
  - A. HINGE - OIL LIGHTLY
  - B. CARGO DOOR SEAL - APPLY  
    GENEROUS AMOUNTS
  - C. MECHANISM BOLT - REMOVE,  
    APPLY AND REINSTALL
  - D. MECHANISM BOLT (2) - OIL  
    LIGHTLY
  - E. MECHANISM BOLT (2) - OIL  
    LIGHTLY
  - F. CYLINDER BOLT - OIL LIGHTLY
  - G. CARGO DOOR LATCH (12) -  
    APPLY TO THREE GREASE  
    FITTINGS EACH.

**NOTE:** Lubricate Latch  
Spool Bolts with  
grease (12) - 1  
grease fitting  
each (Not Shown)

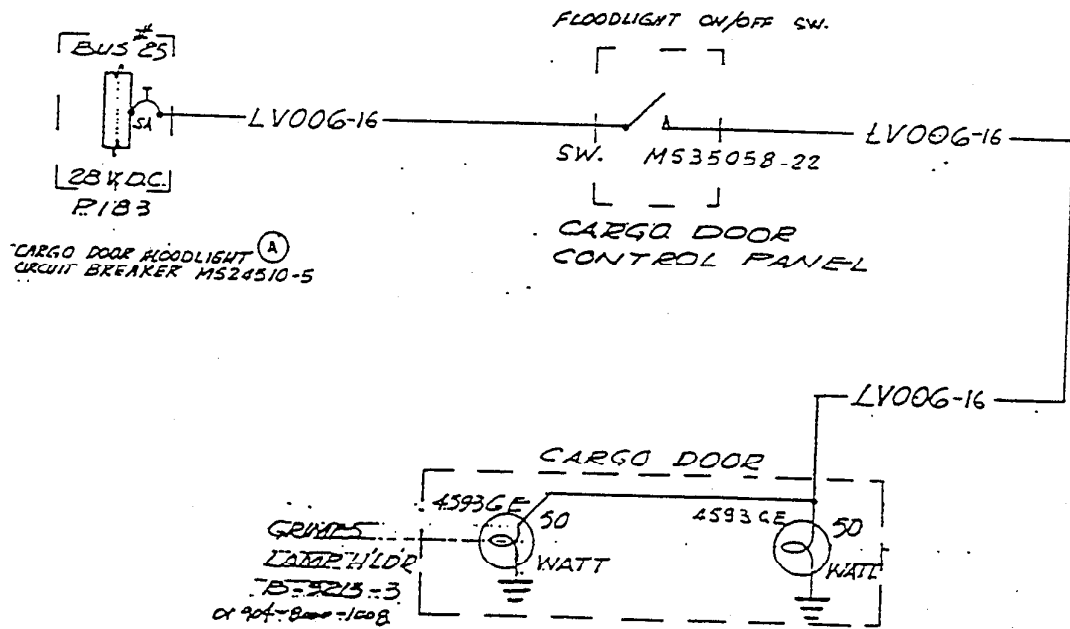
WIRING DIAGRAM FOR CARGO DOOR FLOOD LIGHT

d. Operate the system through several cycles to determine if the switch is operational. No further testing is required.
