**EMERY WORLDWIDE AIRLINES**

**EXHIBIT 17Q**

EWA RESPONSE TO  
17 Q

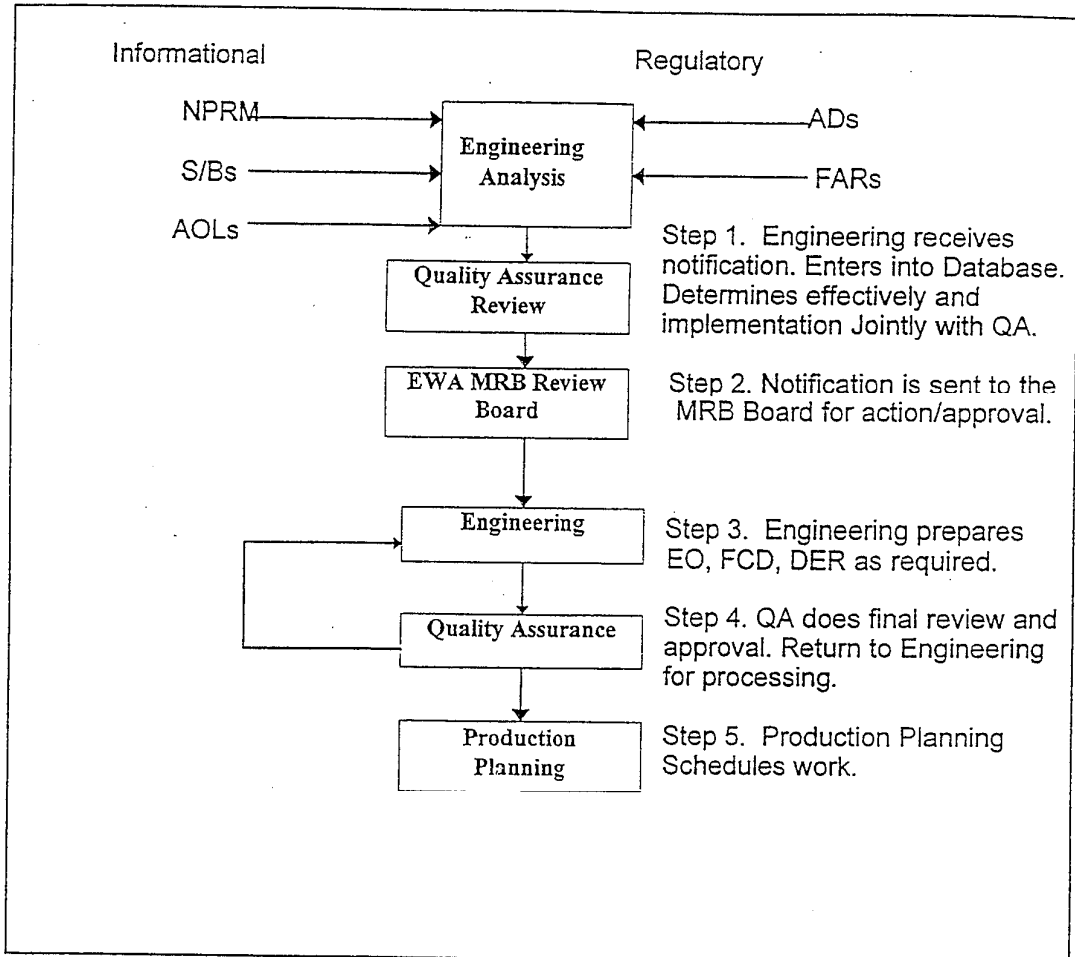
This procedure is shown by a flow chart to reflect the process steps that involve several sections of the Technical Services Department.
