M/V Cosco Busan

HIGHWAY FACTORS FACTUAL REPORT

**NATIONAL TRANSPORTATION SAFETY BOARD
OFFICE OF HIGHWAY SAFETY
WASHINGTON, D.C. 20594**

Vessel:	<i>M/V Cosco Busan</i>
Date:	November 7, 2007
Time:	0830 hrs Pacific
Location:	San Francisco Harbor, Oakland Bay Bridge, Span D-E, 37° 48.1 N, 122° 22.5 W
Owner/Operator:	Regal Stone Ltd./ Fleet Management
Complement:	24 Crew, 1 Pilot

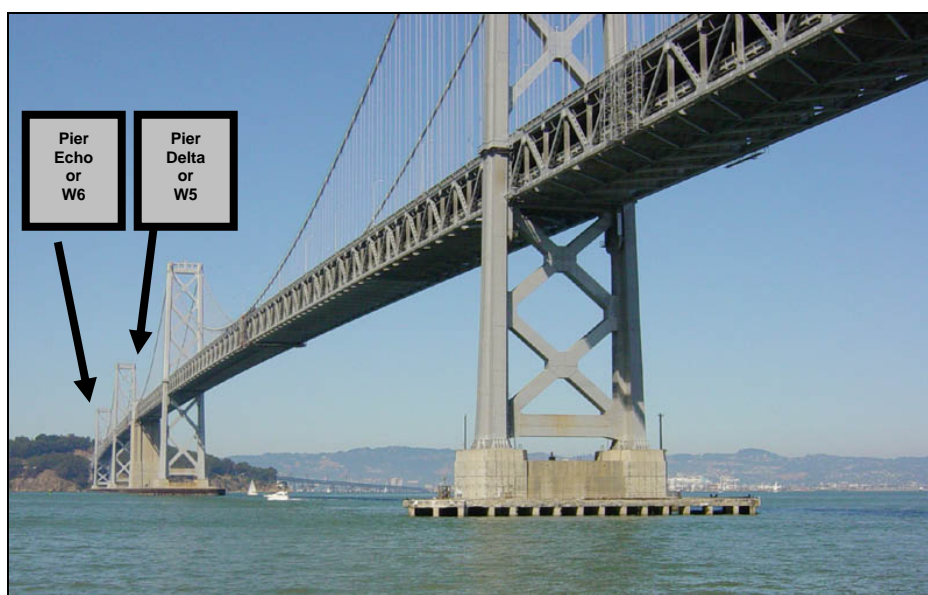
Bay Bridge Looking East

The impact occurred on Pier W-5. This nomenclature is used by Caltrans and means that it is the fifth pier west of the San Francisco end of the bridge. On NOAA and other maritime CHARTS, this pier is referred to as Pier “Delta.”
