1
2
3
4
5
6 **National Transportation Safety Board**
7 **Engineering Factual Report**
8

12 Vessel: *Ferry Andrew J. Barberi*
13 Date: October 15, 2003
14 Location: Pier B1, South side corner, Staten Island, New York
15 NTSB No.: DCA04MM001
16

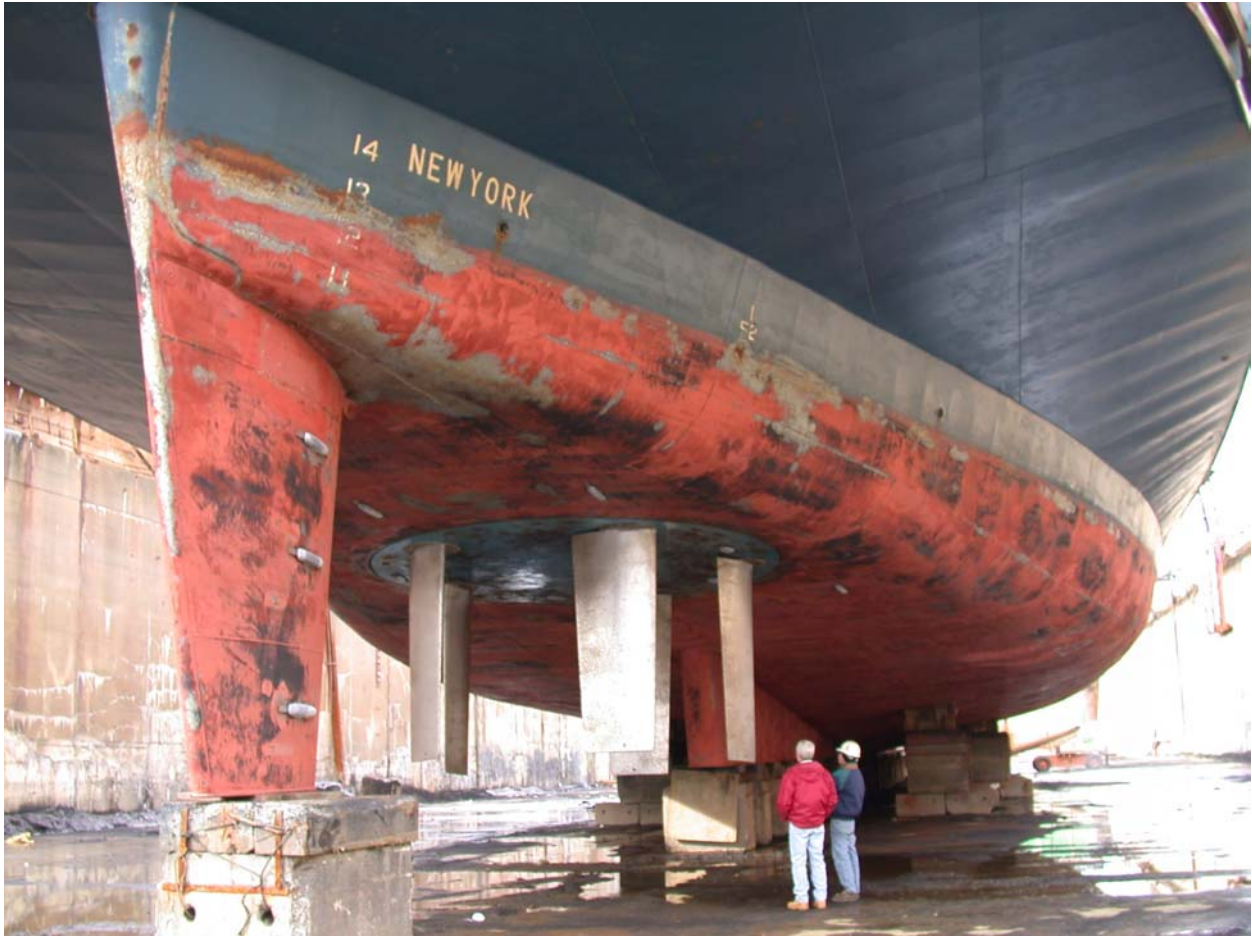
3
4 Fig. 1- Andrew J. Barberi Voith-Schneider propeller
5

1 a single engine when required. The propellers each have an internal combining and reducing
2 gear/right angle gear, as the axis of the propeller rotor is vertical.²³

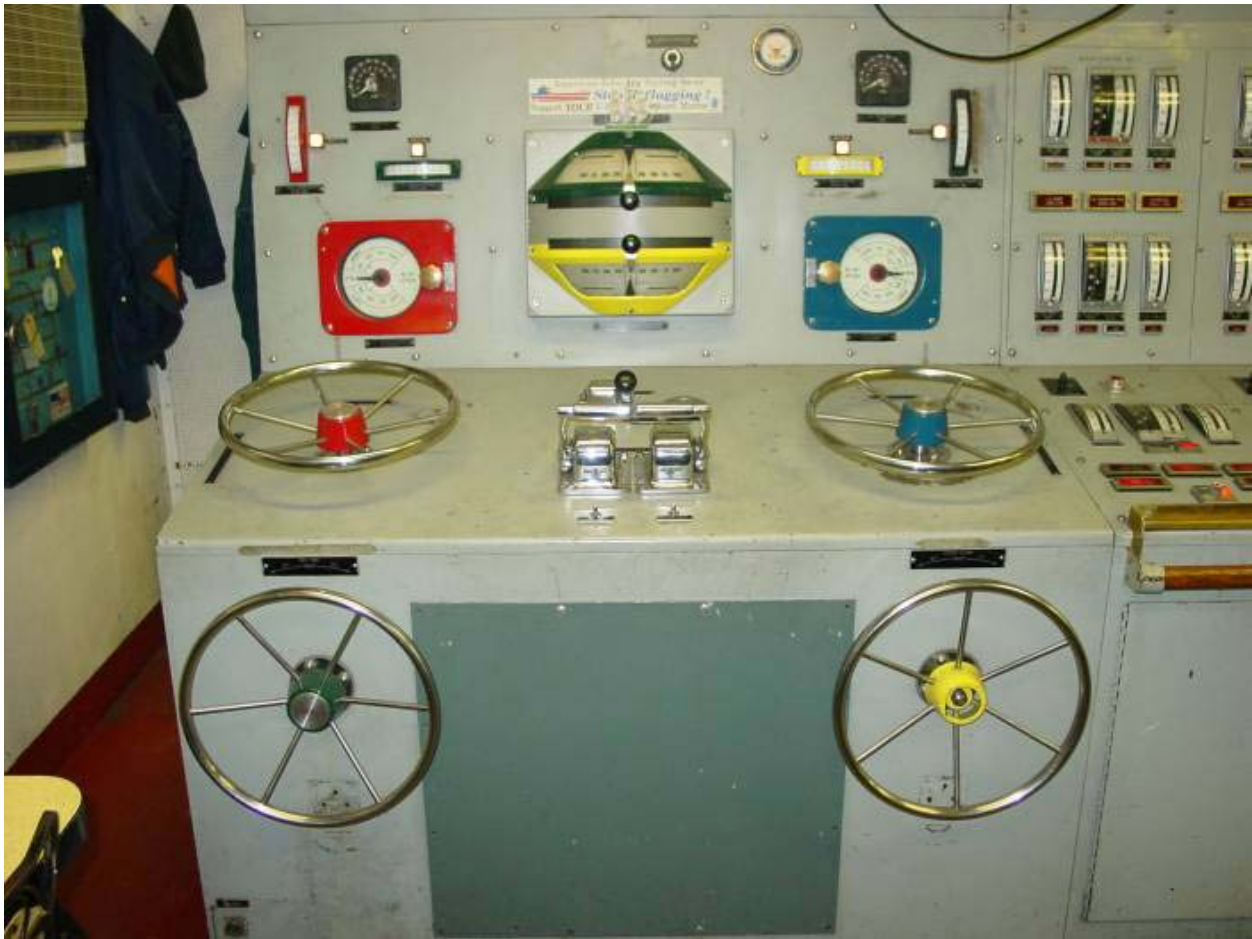
Figure 2- Engine Control Room Propulsion control station

1 presses a transfer button. He notifies the individual in the receiving station that this task has
2 been accomplished, at which time the person receiving control presses an “accept” button in his
3 station to complete the transfer operation. Both direction control wheels for both propulsion units
4 must be at zero pitch to perform this transfer of control. Figures 2 is a photo of the engine
5 control room propulsion control station, and figure 3 is a photo of a wheelhouse control station
6 located on each bridge.

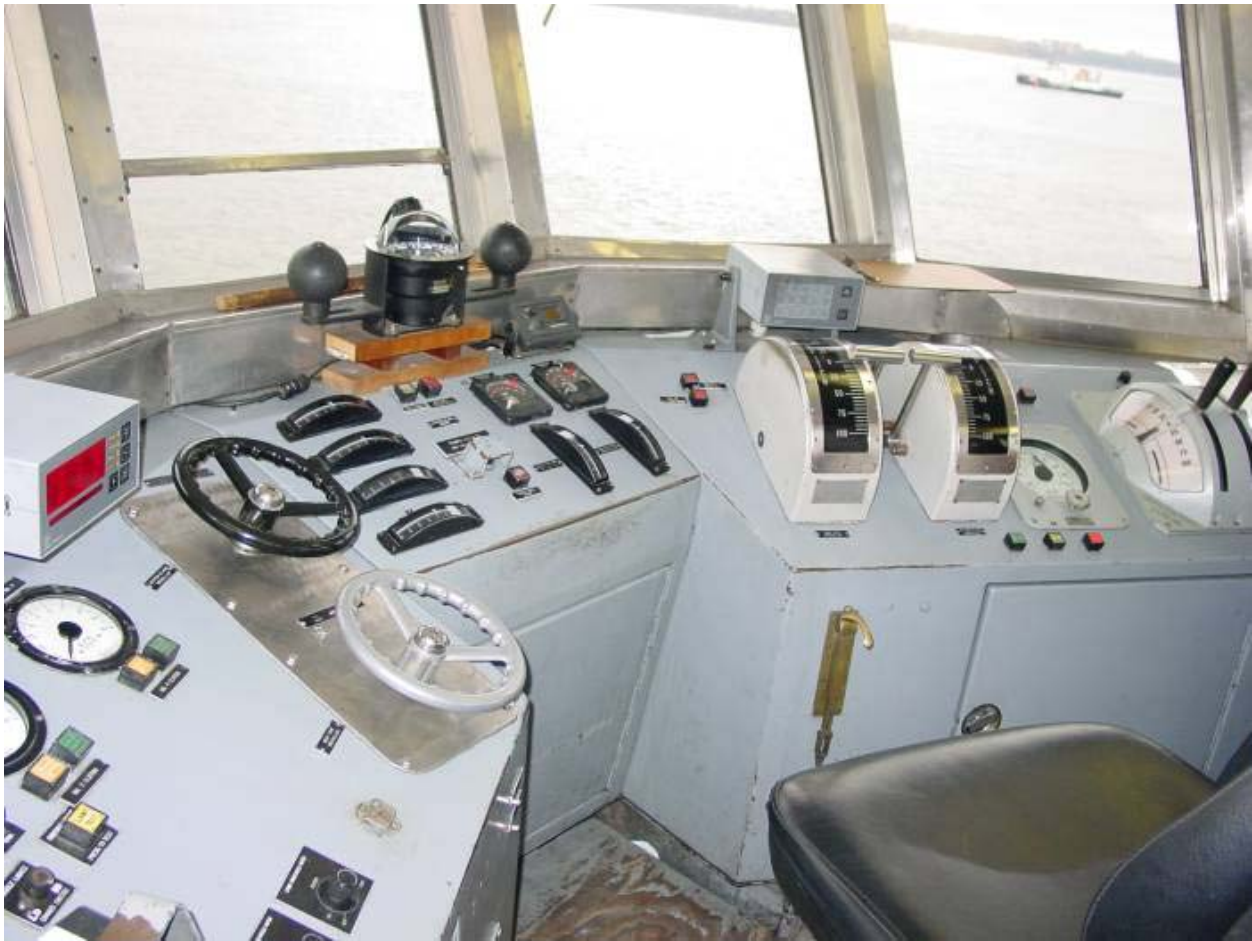
1
2 Figure 3- Wheelhouse Propulsion control station
