Subject: N92WL Crash Data
Attachments: N92WL_Crash.zip

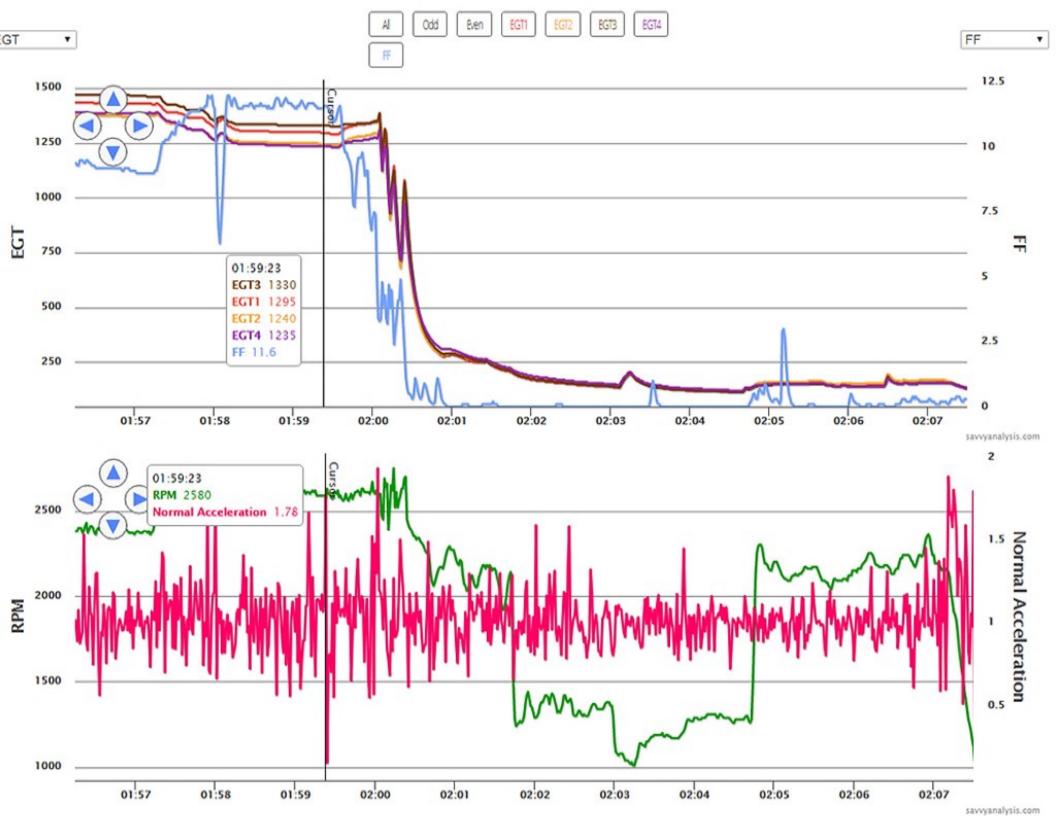
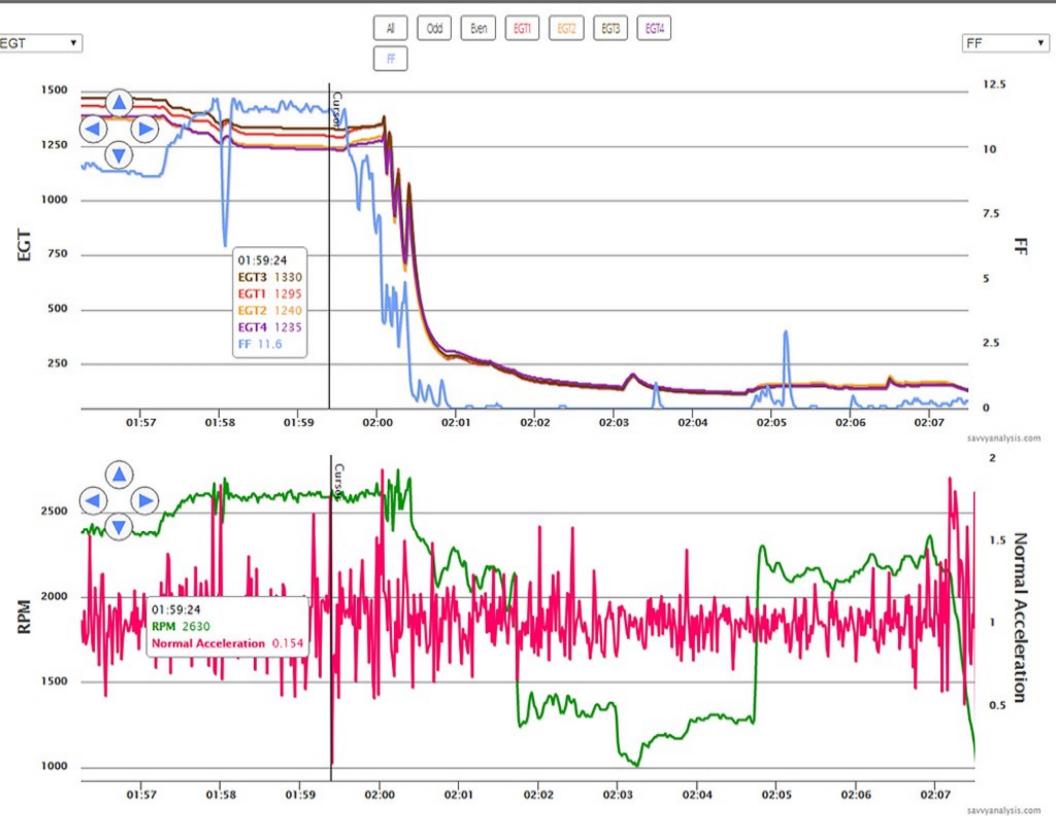
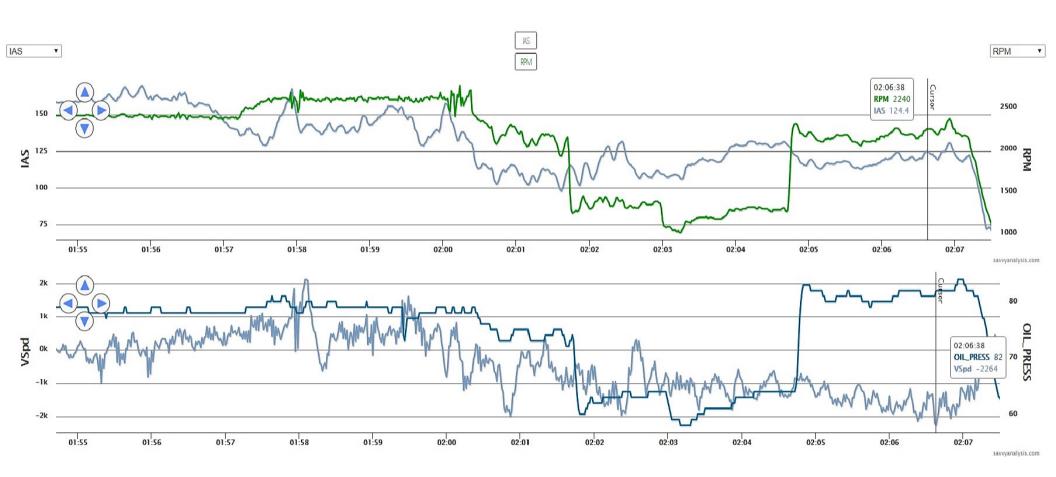
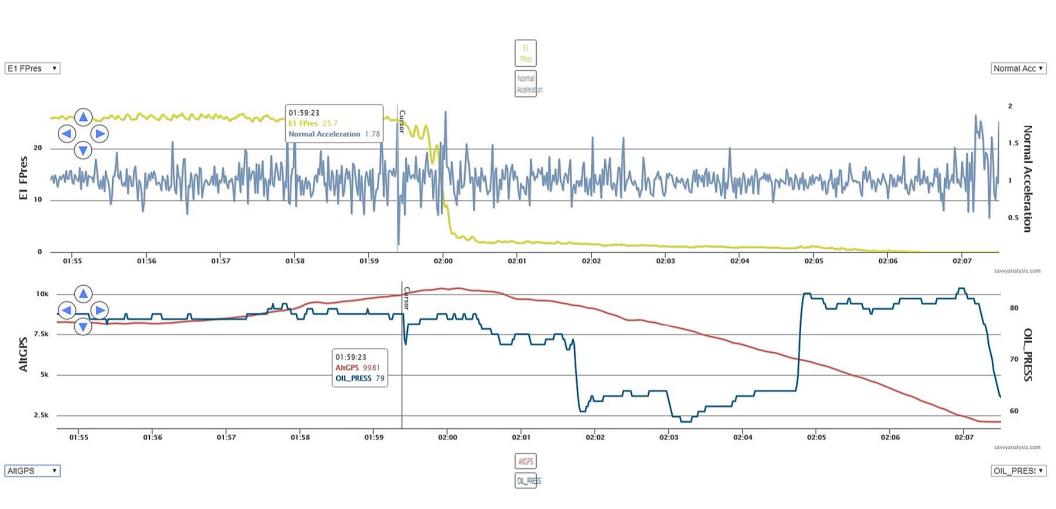
Nice talking to you the other day. I've pulled the data into some screen shots to try and paint a better picture of what happened and included them in the zip file attached. Each graph has a label on the left or right side indicating what data set we are reading. Then the time stamp at the bottom corresponds to each graph horizontally.

It appears they were in a climb, hit a +1.78 G bump that went all the way down to +0.154 G. So, generally speaking, it went from nearly 2 G to 0 in 1 second. That's a bump. About 20 seconds after the fuel flow starts to taper off, fuel pressure tapers off, the climb slows, and the engine starts to turn off. The bump I marked with the curser on the graph and labeled the file 01-59-23 and the 1 second later of 01-59-24. That is flight time, not local time.

The rest is pretty obvious I guess. All engine parameters are normal, other than fuel pressure and fuel flow. Good oil pressure, which increases again when they push the prop back in halfway through the decent.

Notice the Vertical speed and Indicated Airspeed during the decent. Best glide as best as I could calculate on that airplane was 105 KIAS with the prop pulled back which I established in Phase 1. The airspeed tape was marked with "G" for best glide.

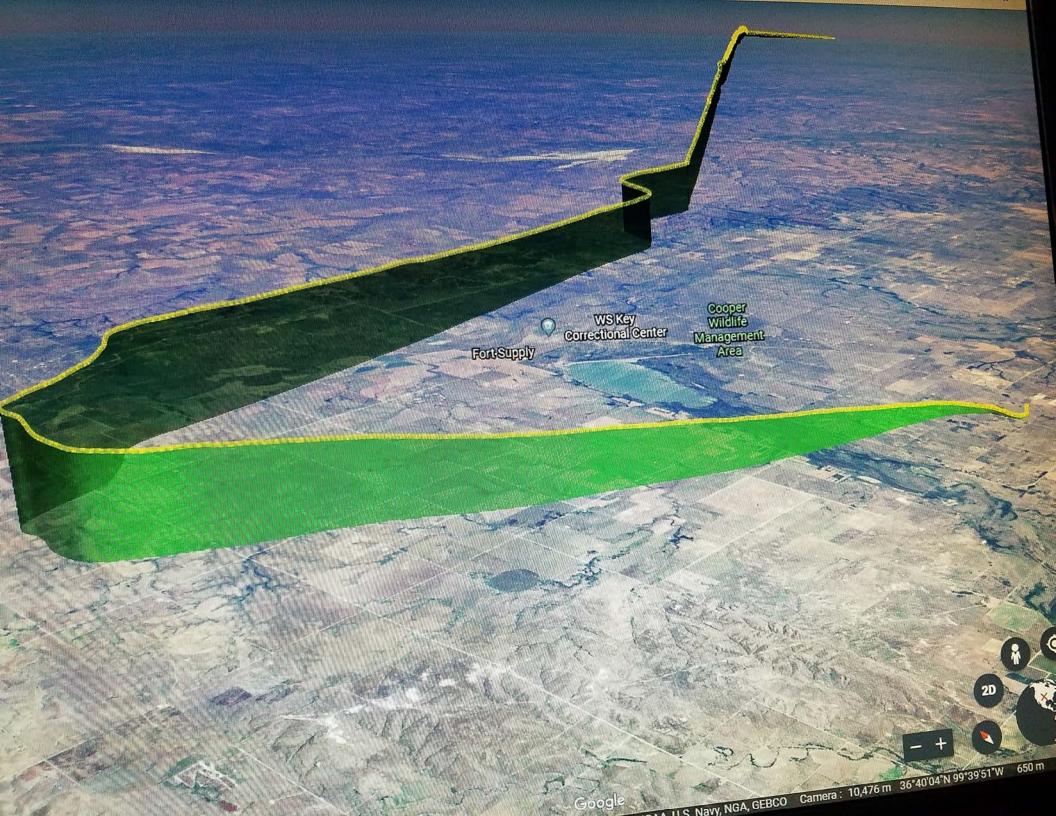
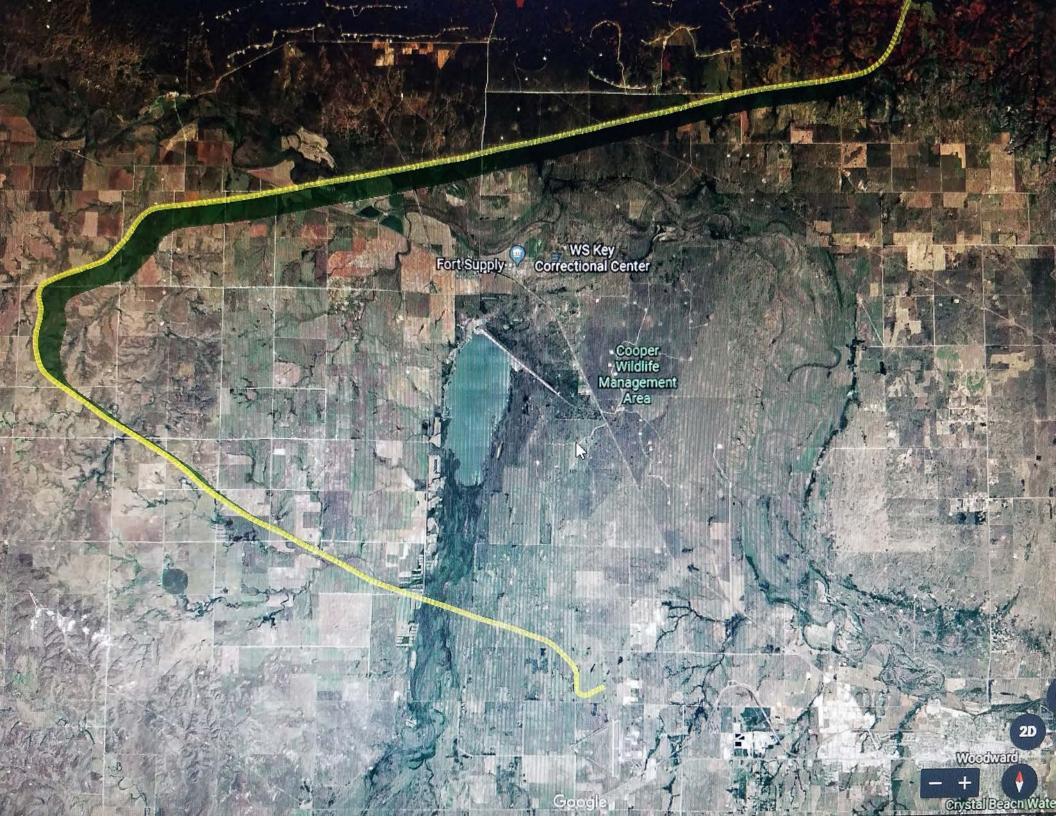
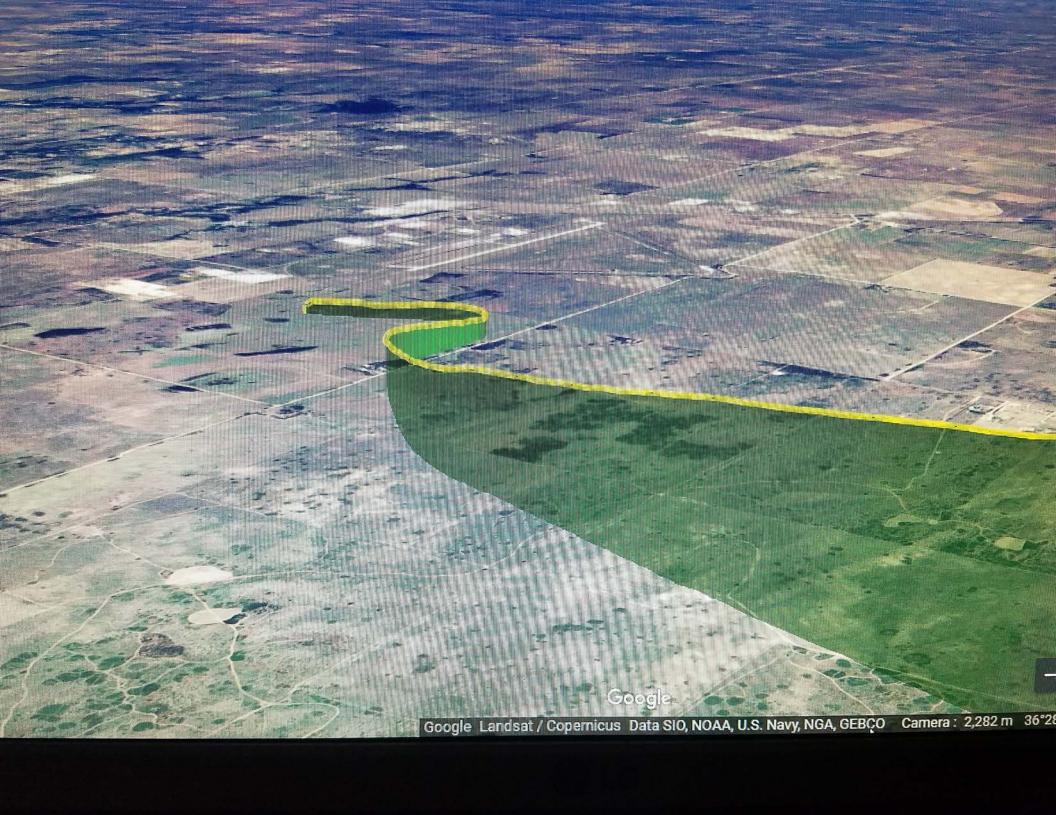
I've also plotted the flight on Google Earth using the GPS data. I pulled a few screen grabs of that, although it doesn't tell us more than we already know.
