**HUMAN PERFORMANCE FACTORS GROUP CHAIRMAN'S
FACTUAL REPORT**

**Bridge Collapse
Mount Vernon, Washington: 05/23/2013**

**HWY-13-MH-012
(26 pages)**

**NATIONAL TRANSPORTATION SAFETY BOARD
OFFICE OF HIGHWAY SAFETY
WASHINGTON, D.C.**

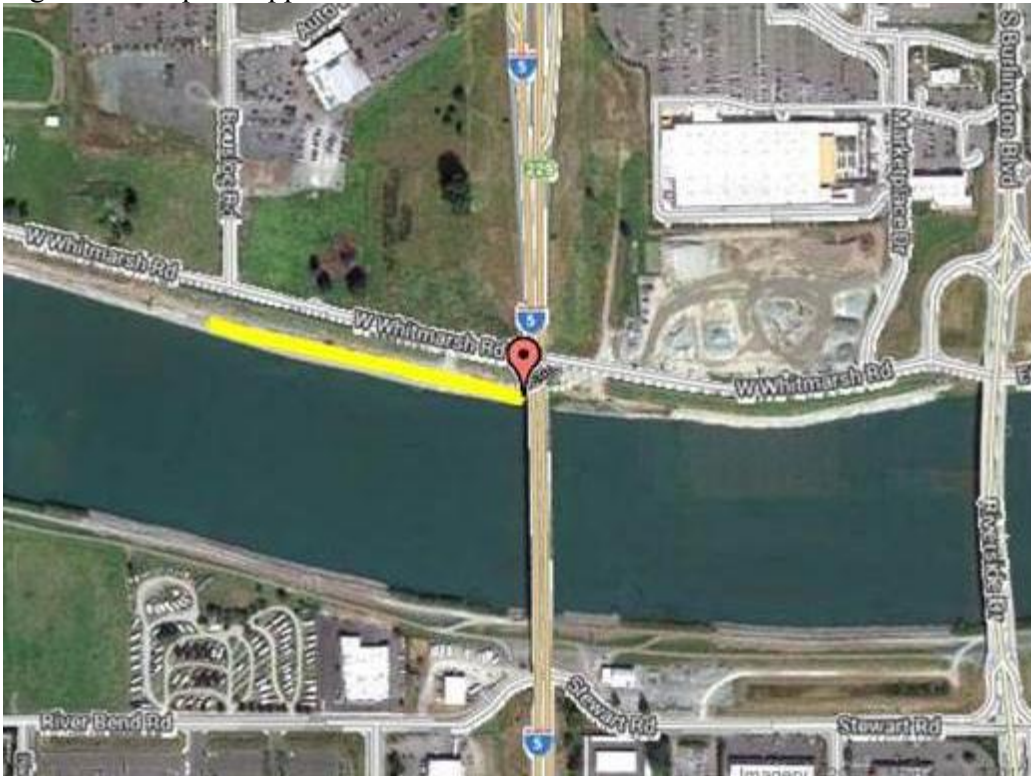
Figure 1. Graphic Approximation of Sun Position

Using the above GPS data, investigators used a NOAA website³⁸ to generate the following graphic approximation of the sun's position at the time of the accident (Figure 1). The accident location is shown with a red marker in the center of the image and the sun position is represented by the yellow line.
