*Board of Pilot Commissioners for the
Bays of San Francisco, San Pablo
and Suisun*

INCIDENT REVIEW COMMITTEE REPORT:

**NOVEMBER 7, 2007 ALLISION WITH THE
SAN FRANCISCO-OAKLAND BAY BRIDGE**

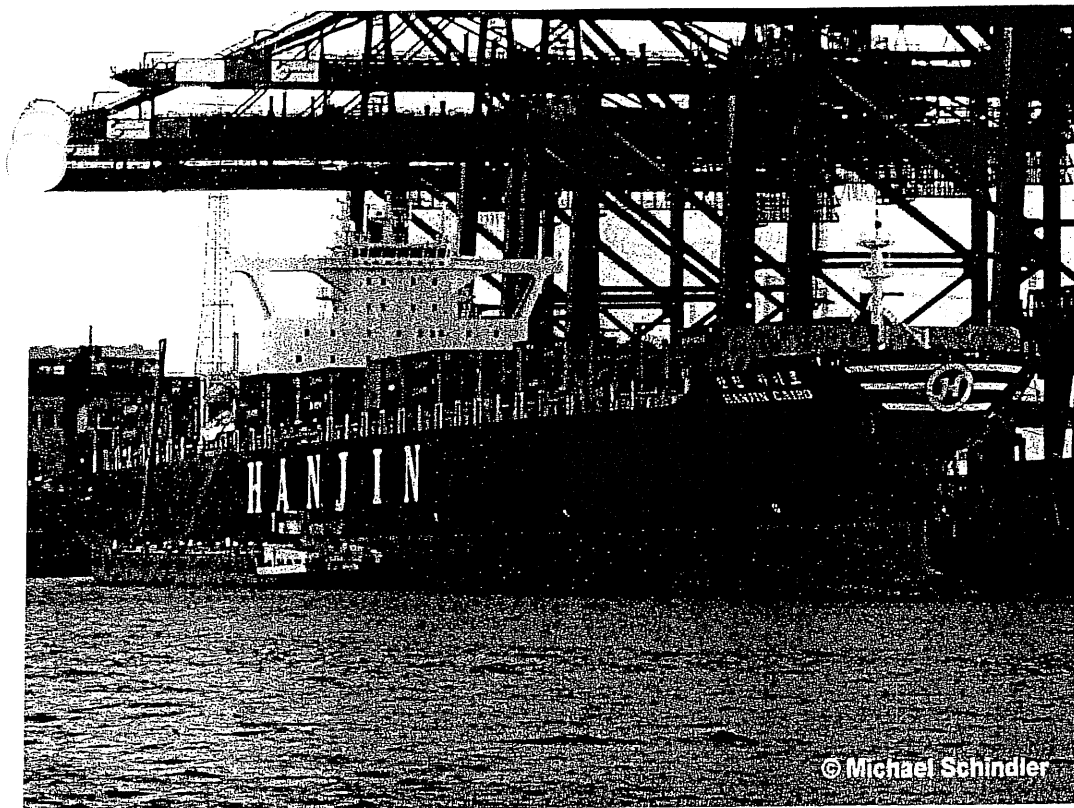
Encl: (10)

Name: COSCO Busan
Type: Container ship
SKN-nr: 000058
Length: 274,67 m
Beam: 40,00 m
Draught: 14,00 m
GT: 65.131 t
Capacity: 5.750 TEU
Owner/Manager: NSB Niederelbe
Built: 2001
Shipyard: Hyundai Heavy Ir
Flag: Germany
Port of registry: Hamburg
IMO-number: 9231743
Callsign: DPSQ
Date: 09.11.2006
Location: Predöhlkai 1 - Eu
