**MP 608 – Marshall, Michigan Incident
NTSB/PHMSA Information Request No.33**

Enbridge Energy Company Permanent Repair Report

EEC Report Number: BC2010-056
Report Date: 06/19/2010

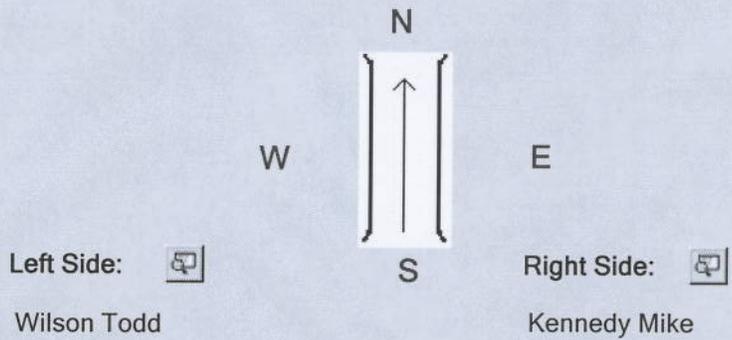
Nature of Repair & Fitting added to Mainline (Attach sketch - Identify upstream & Pipe Orientation) Two tight fit sleeves and one oversleeve were installed. Total of nine ft of Sleeve was installed.
Welding Procedure or Procedures with Welder Name(s) WPS LB-32 Longitudinal Butt Weld - Kennedy Mike(R) Wilson Todd(L) WPS LB-32 Longitudinal Butt Weld - Julian Dave(R) Matula Bob(L) WPS UF-49 Uphand Fillet Weld - Julian Dave(R) Matula Bob(L) WPS UF-49 Uphand Fillet Weld - Julian Dave(R)

*Note: Right and Left are determined by looking down stream.

Flow Direction:

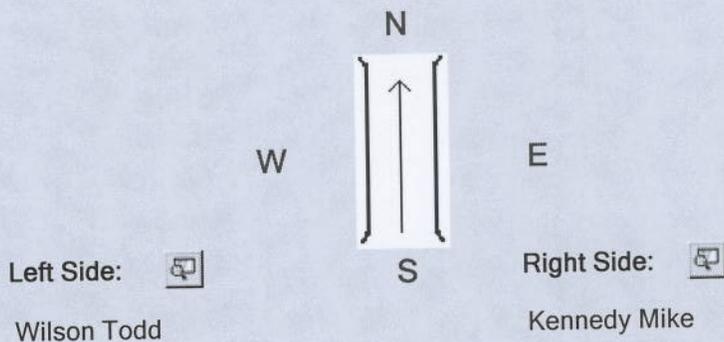
*Note: Right and Left are determined by looking down stream.

Flow Direction:
