NATIONAL TRANSPORTATION SAFETY BOARD
Vehicle Recorder Division
Washington, DC 20594

On-Board Image Factual Report

Specialist's Factual Report
By Christopher Babcock

Location: Midland, Texas
Date: November 15, 2012, 1635 Central Standard Time (CST)
Vehicle 1: 2006 Peterbilt Truck-Tractor Combination
Operator 1: Smith Industries
Vehicle 2: Freight Train ZLCAI-14
Operator 2: Union Pacific
NTSB Number: HWY13MH003

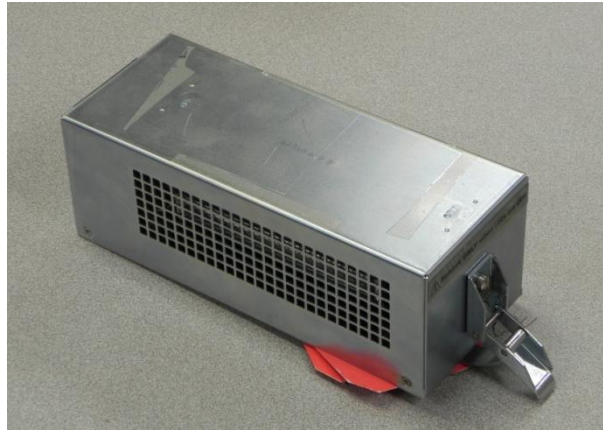
Figure 1. Exemplar Wabtec Traintrax TIR hard drive.

Several weeks of data were present on the hard drives, however only video from the day of the accident was downloaded. Figure 1 shows an exemplar external hard drive where the video files are stored.
