MILLION AIR SERVICES

Shop Order:

SO-02614

Aircraft Number:
 N422PB
 Type:SR22
 S/N: 2379

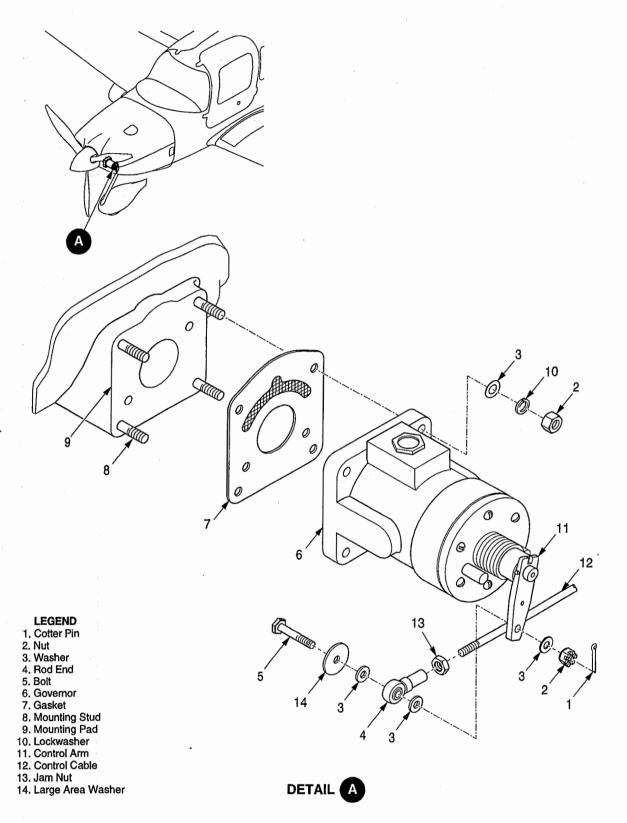
SR20_MM61_1812

Figure 61-201 Governor Installation

A. Propeller Governor (See Figure 61-201)

- (d) Adjust governor control cable jam nuts so power control lever in the full forward position causes governor control arm to make contact with governor low pitch control arm stop.

- 2 Loosen adjustment screw locknut and turn screw in clockwise direction to decrease engine speed or in counterclockwise direction to increase engine speed.
- 3 Tighten adjustment screw locknut.

Note: One thread on governor control cable push rod measures 0.0313 inch (0.7950 mm) and equals approximately 20 RPM.

- At control quadrant, adjust governor control cable rod end so governor control arm moves off of low pitch stop the distance required to obtain increase in cruise RPM. For example, to gain 20 RPM, shorten rod end one revolution until a 0.0313 inch (0.7950 mm) gap exists between governor control arm and low pitch stop.
- At governor, adjust governor control cable rod end until governor control arm contacts low pitch stop. Verify minimum rod end thread engagement of 0.312 in (0.79 cm).
- At throttle body, adjust throttle control cable rod end until throttle body control arm contacts full forward stop. Verify minimum rod end thread engagement of 0.312 in (0.79 cm).
- 5 In full forward and full aft positions, ensure power lever has positive clearance with slot in engine control panel.
- 6 Install engine cowling. (Refer to 71-10)
- 7 Conduct test flight.
