NATIONAL TRANSPORTATION SAFETY BOARD

Maintenance Records Group Chairman's Factual Report

A. ACCIDENT DCA13RA081

Location: Bagram Air Field, Afghanistan
Date: April 29, 2013
Time: 1527 Local Time
Aircraft: National Airlines flight 102, a Boeing 747-428BCF, registration
N949CA

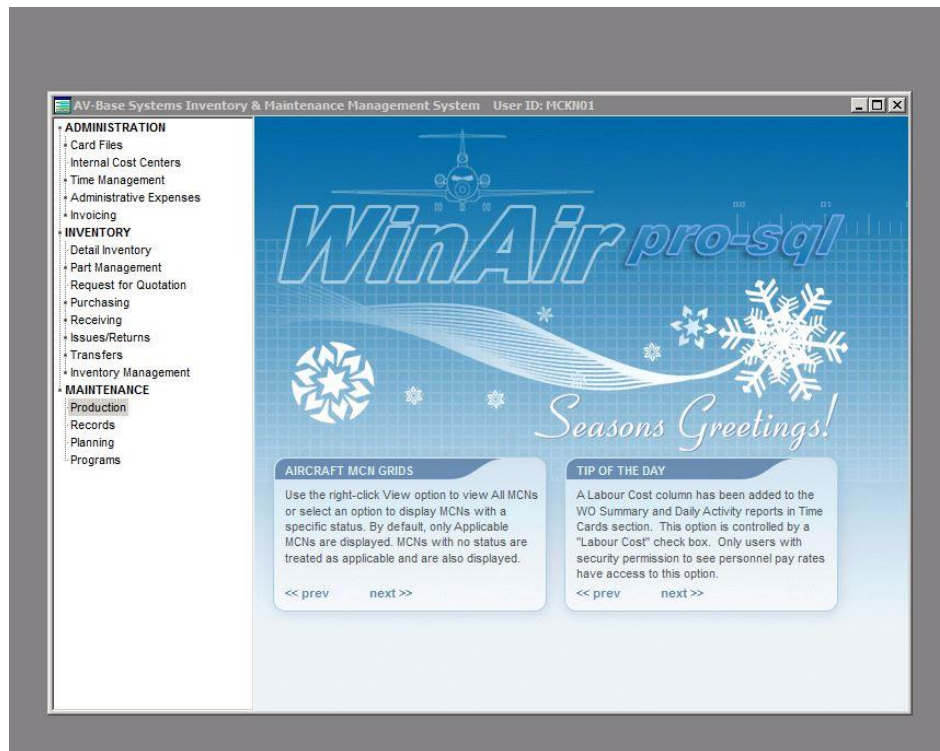
National Airlines uses computer software called WinAir (an AVBASE Inventory and Maintenance Management System) to track and document airplane maintenance (See Figure 1). The software provides record storage, indexing, and retrieval of aircraft maintenance documents and records. Items written in the National Airlines Maintenance/Flight Log (known as the airplane logbook), including airplane discrepancies, are entered into WinAir.

Figure 1 - Computer screen shot of WinAir.

Typically, at the end of a flight crew's trip/day, a copy of the current maintenance logbook page (white copy) is removed from the logbook and sent to the National Airlines facility in Orlando, Florida. Following scheduled maintenance, unscheduled maintenance, crew change, or flight number change, an electronic copy of the white page is sent to the Orlando facility. The pink page/copy remains in the logbook and the logbook sent to Orlando. National Airlines personnel in Orlando enter information from the electronic copy of the white page into WinAir. When the original white page is received at Orlando, the white page information is checked against the original information entered from the electronic copy.

Within WinAir, all tracked airplane parts and upcoming maintenance checks are tracked and can be listed. WinAir provides the maintenance personnel with dates and times for upcoming maintenance activities, time until replacement of components, and part and serial numbers for currently-installed components.
