# NATIONAL TRANSPORTATION SAFETY BOARD

MATERIALS LABORATORY FACTUAL REPORT

Report No. 14-020

Place : Casselton, North Dakota  
Date : December 30, 2013  
Vehicle : BNSF Grain Train, G-RYLRGT9-26A  
NTSB No. : DCA14MR004  
Investigator : Richard Hipskind, RPH-10

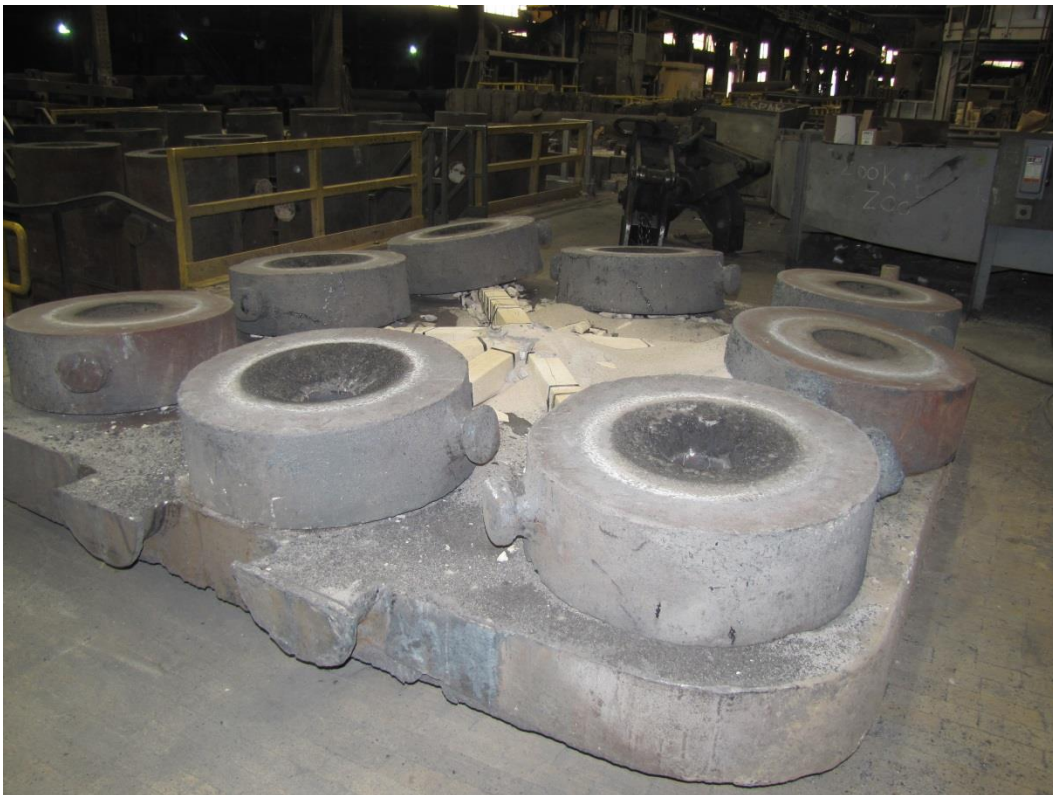
Figure 2 – The bottom of an ingot mold, after teeming and removal of the cylindrical molds.

The ingot mold configuration consisted of a series of 8 to 12 vertical cylindrical molds, interconnected via a central spider-gate distribution system (Figure 2). The ingot molds were “big end up,” which is the preferred casting shape for fully killed steel.<sup>4</sup> The bottom pour setup was composed of a slotted cast iron base-plate, cast iron stools that the molds rest on, the ingot molds, and refractory gates for each stool. Horizontal refractory runners connect to the refractory king brick that distributes the molten steel to each of the runners. Above the king brick, there was a cast iron trumpet with a refractory lining and a cast iron base plate cover. Casting sand was placed between the cast iron and refractory components, excluding only the up gates. Steel rigging was used to keep the molds vertical and properly spaced. The top of the trumpet (or funnel) was covered with an aluminum-foil covered cardboard conical cap that prevented sand from entering the trumpet and gates during the start of teeming.

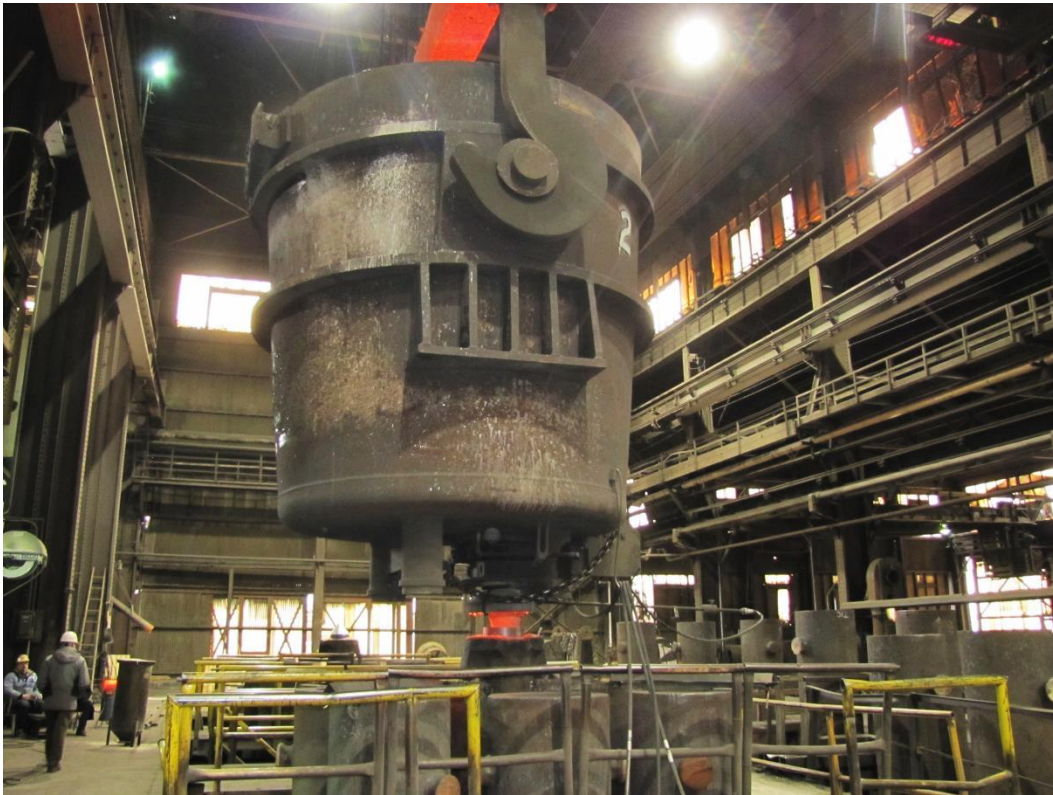
Figure 3 – A ladle positioned over the center trumpet after ingot teeming.

Once the proper temperature and chemistry were achieved, the ladle was positioned by the overhead crane above the center trumpet (Figure 3). A fiber shroud was affixed under the off-center slide gate nozzle of the ladle, and a tube was connected above the shroud to allow the flow of neutral gas into the ladle. The neutral gas stirred the liquid in the ladle, helping to homogenize the temperature and composition. The argon bubbling also prevented entrainment of atmospheric oxygen into the tap stream. Once the nozzle was opened, the molten steel burned away the cap on the top of the center trumpet, and flowed into the spider gate system, filling the ingot molds. The process took approximately 45 minutes to fill the largest ingot molds.

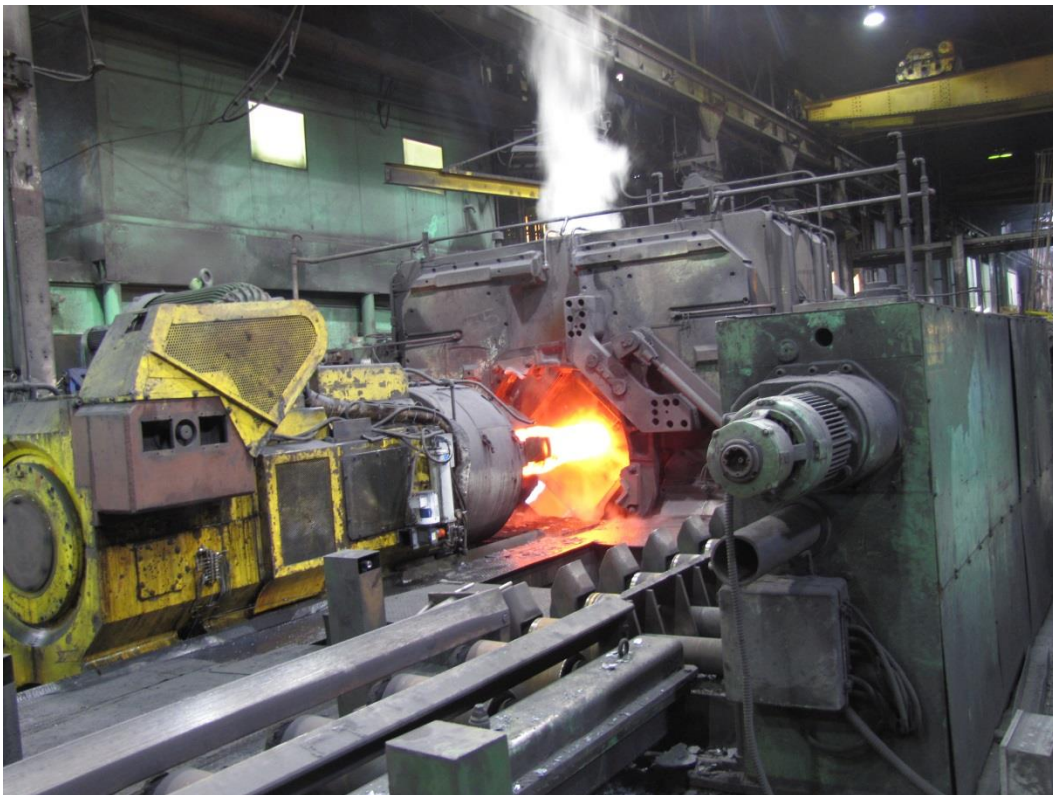
Figure 4 – Radial forging of a heated cut ingot, held by the “A” manipulator.

handling manipulator. The ingot section was fed into a four-hammer radial forge, where the part cross-section was reduced and fed towards a second work piece manipulator on the opposite side (Figure 4). The cut ingot was passed back and forth through the radial forge several times, leaving a spiral appearance on the forging surface from the computer synchronized hammer blows.

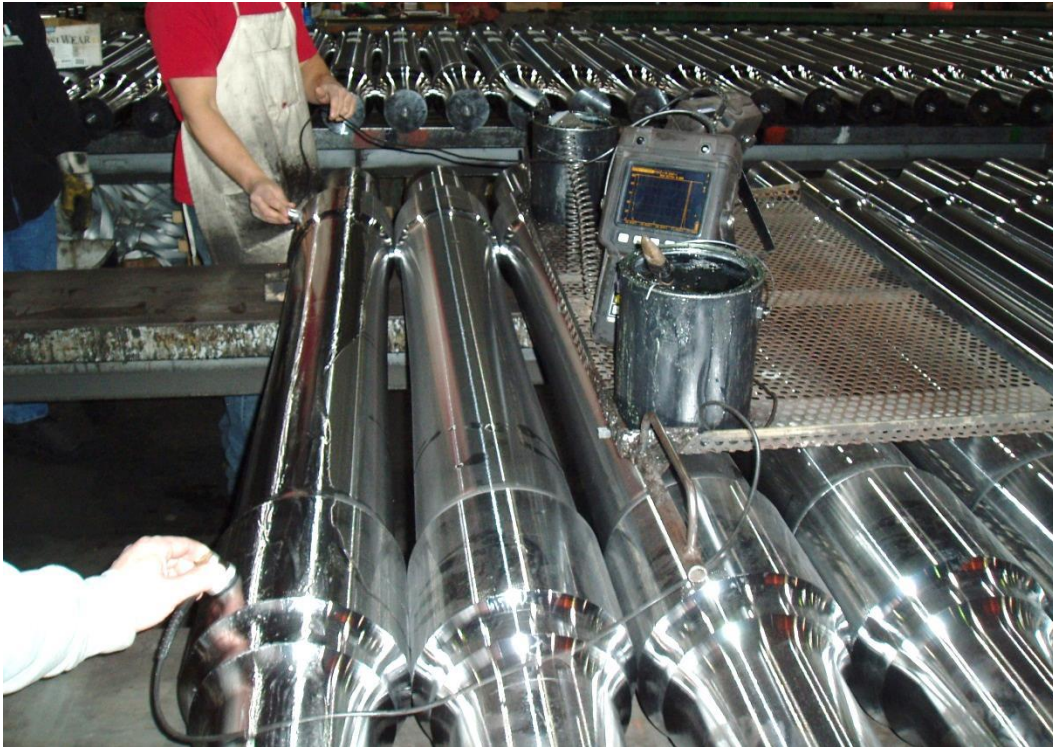
Figure 5 – Radial UT inspection of a finished axle.

The axles rolled along an inspection and shipping-preparation table for simultaneous access by two UT operators. The operators used portable UT devices and inspected the axle from both ends. During the radial UT inspection, the operators brushed couplant from paint cans along the length of the axle barrel (Figure 5). The operators then probed the length of the axle with a circular transducer, looking for an 80% backwall reflection drop, which would result in rejection of the part.<sup>8</sup> The axle was then inspected again along the barrel length rotated 90° from the original inspection line to probe for oblong and irregular shaped internal defects. The axles were axially UT inspected from each end using UT devices calibrated to axial inspection configurations (Figure 6). Once tested and cleared, each axle was tagged with a bar code traceable to a serial number, heat number, facility, date, and processing label (Figure 7).

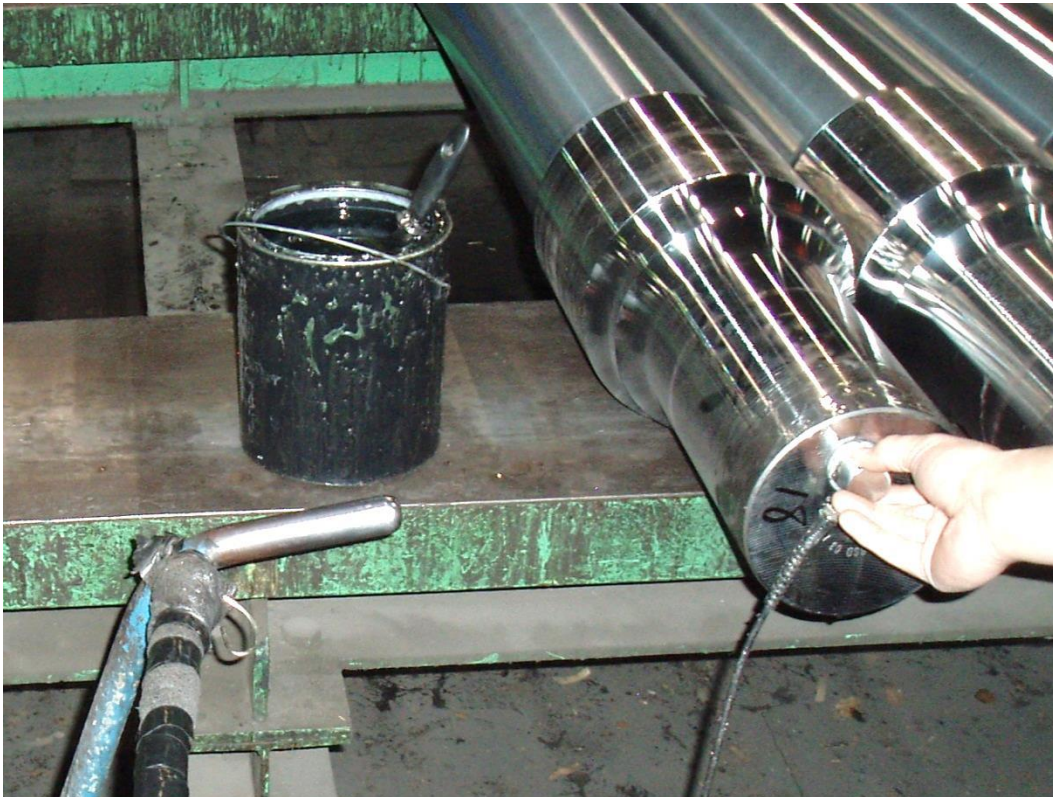
Figure 6 – Axial UT inspection of a finished axle.

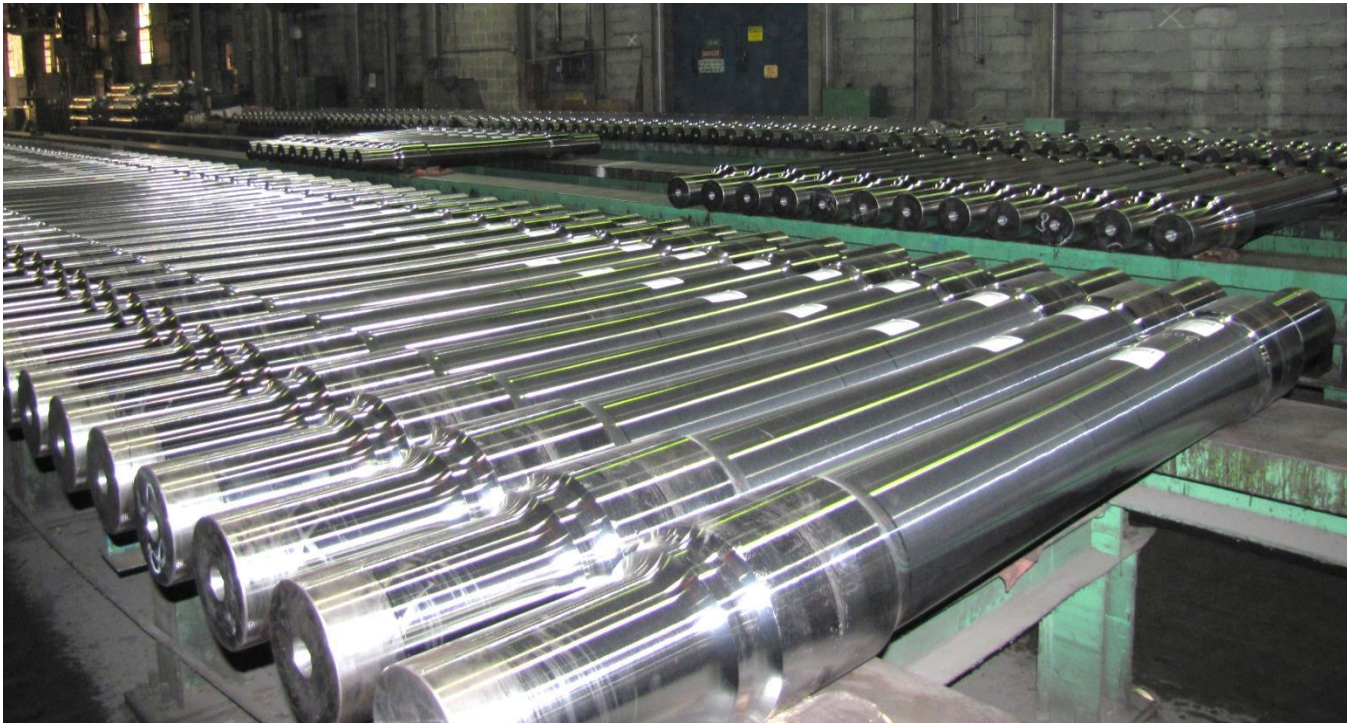
Figure 7 – Finished axles, after inspection identified with bar code labels.
