5 Amtrak Passenger Train 89 Collision with Maintenance of Way Equipment

6 Chester, Pennsylvania - April 3, 2016

7 Mechanical Group Factual Report

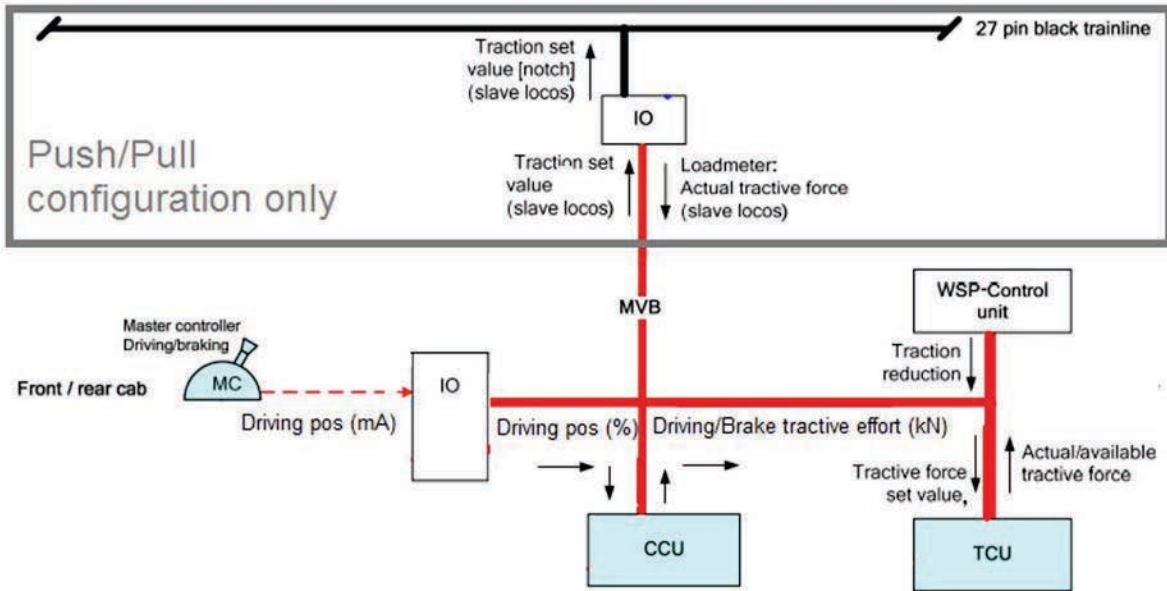
Figure 1-ACS64 Traction control principle

2 Generates the torque force set value from the CCU's traction set values. Monitors  
3 the motors and inverters and regulates the tractive capacity. Reports each axle's actual  
4 and available tractive force to the CCU. See figure 3.
