NATIONAL TRANSPORTATION SAFETY BOARD

Group Chairman's Factual Report

OPERATIONAL FACTORS

DCA16FA199

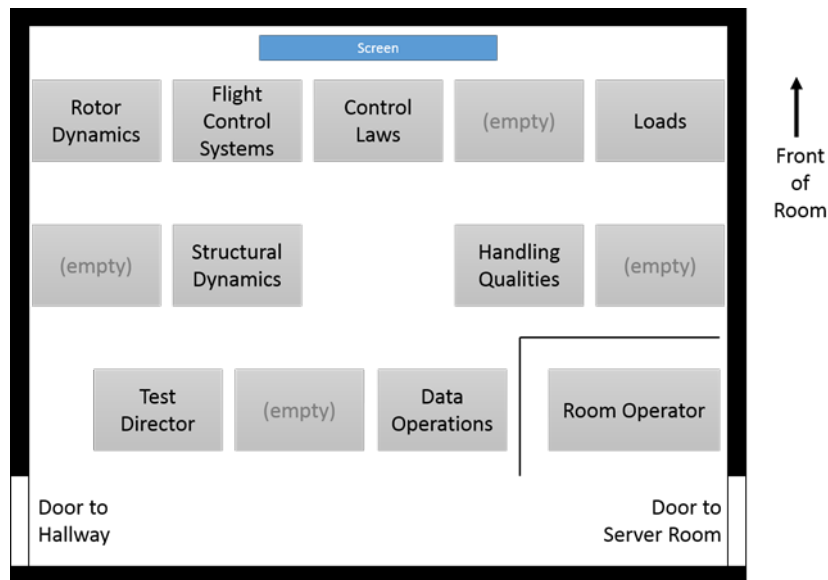
Figure 1- Telemetry Room Configuration

The flight test monitoring was conducted through a dedicated telemetry room (TM) located at Bell Plant 6, Arlington, Texas. This room received the telemetry data from the helicopter and distributed that data in real time to nine flight test engineer stations using IADS (Interactive Analysis & Display System). The telemetry data is processed and saved using Bell Helicopter's CAFTA (Computer Aided Flight Test Analysis) system. The nine flight test engineer stations were as follows: Test Director, Rotor Dynamics, Control Laws (CLAWs), IADS manager, Structural Dynamics, Handling Qualities, Data Operations, and the Telemetry Room Operator. A large screen was positioned in the front of the room to display selected data. The Test Director is the only flight test engineer that communicates with the helicopter via voice radio communications. All flight test engineers can communicate with each other through a voice loop system internal to the telemetry room. The Test Director's duties are to supervise and direct the conduct of the test being performed.

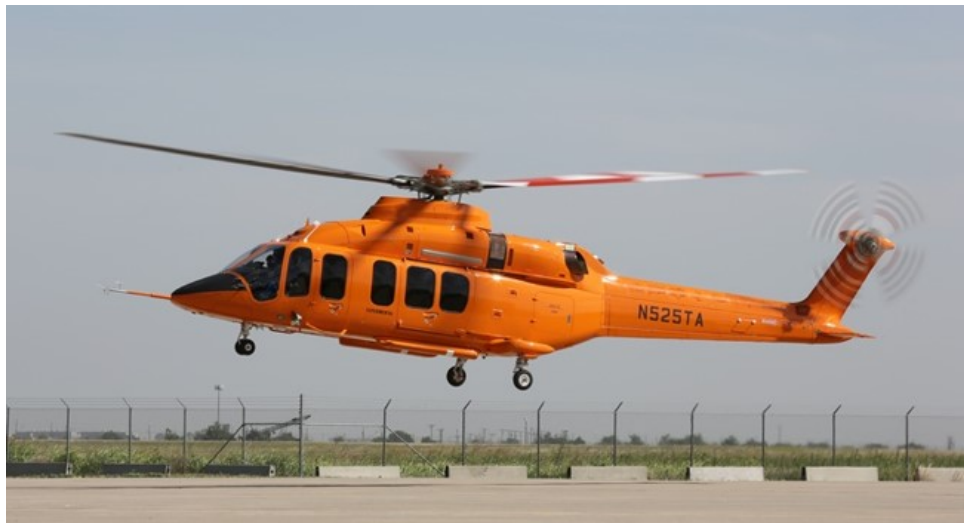
Figure 3- Bell 525, N525TA (Photo courtesy of Bell Helicopter)

The accident helicopter was a Bell Helicopter Model 525, registration N525TA, serial number 62001, manufactured in 2015, and was a conventional main rotor and tail rotor design. It was powered by two General Electric (GE) CT7-2F1 turboshaft engines, each capable of producing 2,000 shp. The registered owner was Bell Helicopter Textron Inc, and issued an Experimental – Research & Development airworthiness certificate on April 25, 2016. The helicopter was a manufacturing prototype being developed for certification as a transport category helicopter, in compliance with Title 14, Code of Federal Regulations, Part 29.

The helicopter was an experimental transport category helicopter manufactured by Bell Helicopter, designated as a Bell model 525, registration N525TA, powered by two General Electric CT7-2F1 2,000 shp³ engines, and was operated by Bell Helicopter. The helicopter was piloted by two Bell employees who each held airline transport pilot certificates. The purpose of the flight was to evaluate engine loads at maximum continuous power (MCP), 2 to 1 simulated engine failures, longitudinal roll oscillations, light on gear dynamic checks, and run on landings in the heavy forward center of gravity (CG) configuration.

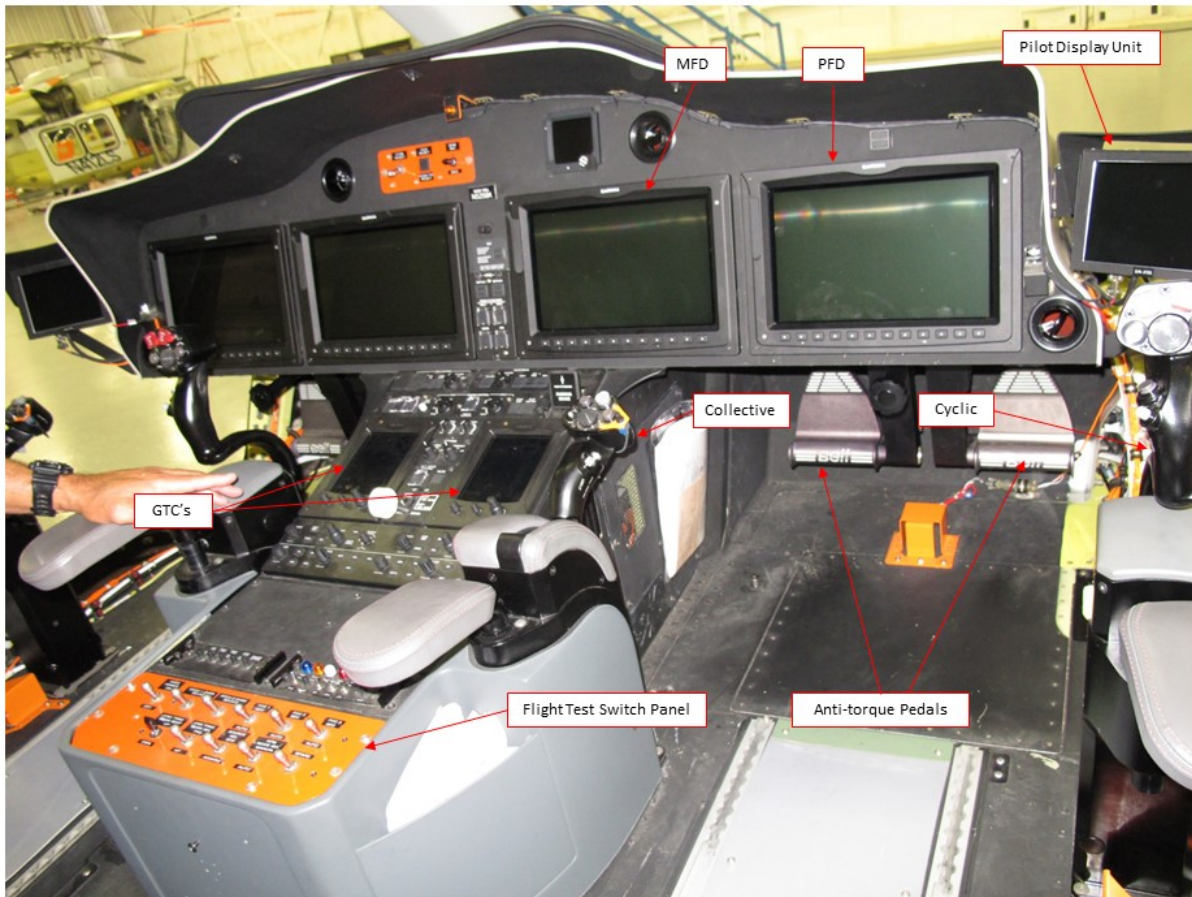
Figure 5 - Cockpit Overview. Photo of the cockpit of ship #2, N525BK (NTSB photo)

The cockpit is configured for two pilots in a side-by-side seated position and a center console between them. Each pilot had a cyclic side stick controller forward of the seat's right armrest and a collective side stick controller immediately forward of the seat's left arm rest. Each pilot has a set of anti-torque pedals forward of their feet. The instrument panel consists of four identical primary flight display/multifunction display panels. The center console consists of two Garmin Touch Control (GTC) panels, landing gear handle, Nav/Com panel, and the Flight Test Switch Panel which includes some controls for the One-Engine-Inoperative (OEI) Special Training software. Directly above the GTC's were the engine control COSIF¹⁹ knobs. Outboard of the instrument panel, each pilot had an additional pilot display unit (PDU) that provided real time flight test instrumentation parameters such as density altitude, boom airspeed, mast airspeed, engine torque, load factor, pitch/yaw/roll rates, slip angle, main rotor and tail rotor flapping angles.

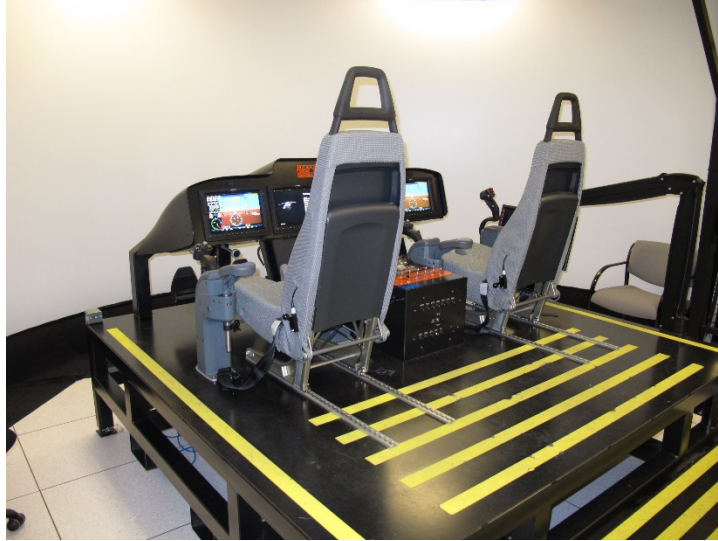
Figure 8- RASIL Cockpit (NTSB photo)

The majority of pilot training consisted of time spent in the RASIL engineering simulator. The RASIL consists of an accurate engineering representation of the cockpit, including control feel, and visual inflight representation projected on a screen that wrapped around the cockpit. Next to the RASIL cockpit was a separate “Rig Room” containing actual flight hardware (hydraulic servos) rigged to apply flight loads into engineering representations of related hardware. When a control was moved in the RASIL cockpit, hardware would actually respond to the command in the Rig Room.

Pilots assigned to the 525 program would routinely operate the RASIL while developing flight procedures, validating software changes, and reviewing flight test plans. While there were no written logs showing when a pilot or flight crew worked in the RASIL the lead test pilot stated that he knew the crew had reviewed the test card for the mishap flight in the RASIL, and the RASIL engineers stated that the crew routinely worked in the RASIL. Typical training flow would involve two RASIL sessions for each test flight. If the pilots had been in the RASIL within two weeks of a test flight, they were considered current.
