NATIONAL TRANSPORTATION SAFETY BOARD

Attachment 10 - B707 Simulator Work

OPERATIONAL FACTORS

DCA11MA075

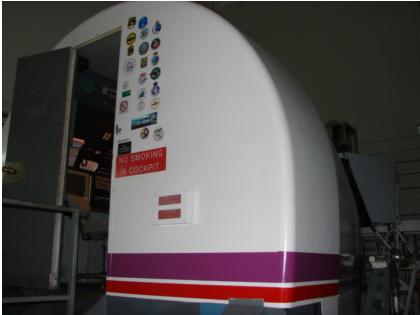
Photo 1: Pan Am B707 Full Flight Simulator (FFS)

On June 16, 2010, from 0835 to 1045 EDT, in support of the Omega Air 70 accident investigation, the NTSB Ops Team conducted documentation of the B707 Level A simulator used for recurrent training by the accident crew located at Pan Am International Flight Academy in Miami, Florida. Following documentation of the cockpit and instructor panels in the simulator, Ops Team members conducted a series of flight profiles to demonstrate the B707 simulator capabilities.

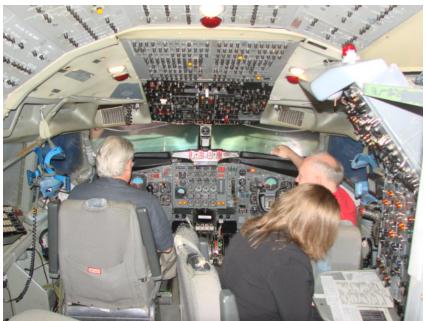
Photo 2: Pan Am B707 FSS Cockpit

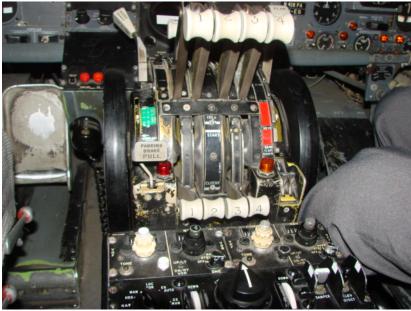
Photo 3: Pan Am B707 FFS Throttle Quadrant

Engine Failures: A dual engine failure was simulated by reducing thrust to idle on the #1 and #2 engines simultaneously at V1 (there is no way for the instructor to induce a dual engine failure in the Pan Am B707 simulator).
