**OPERATIONS  
GROUP FACTUAL**

**National Transportation Safety Board**

**Derailment of BNSF Grain Train G-RYLRGT9-26A**

**And Subsequent of Collision BNSF Oil Train U-FYNHAY4-05T**

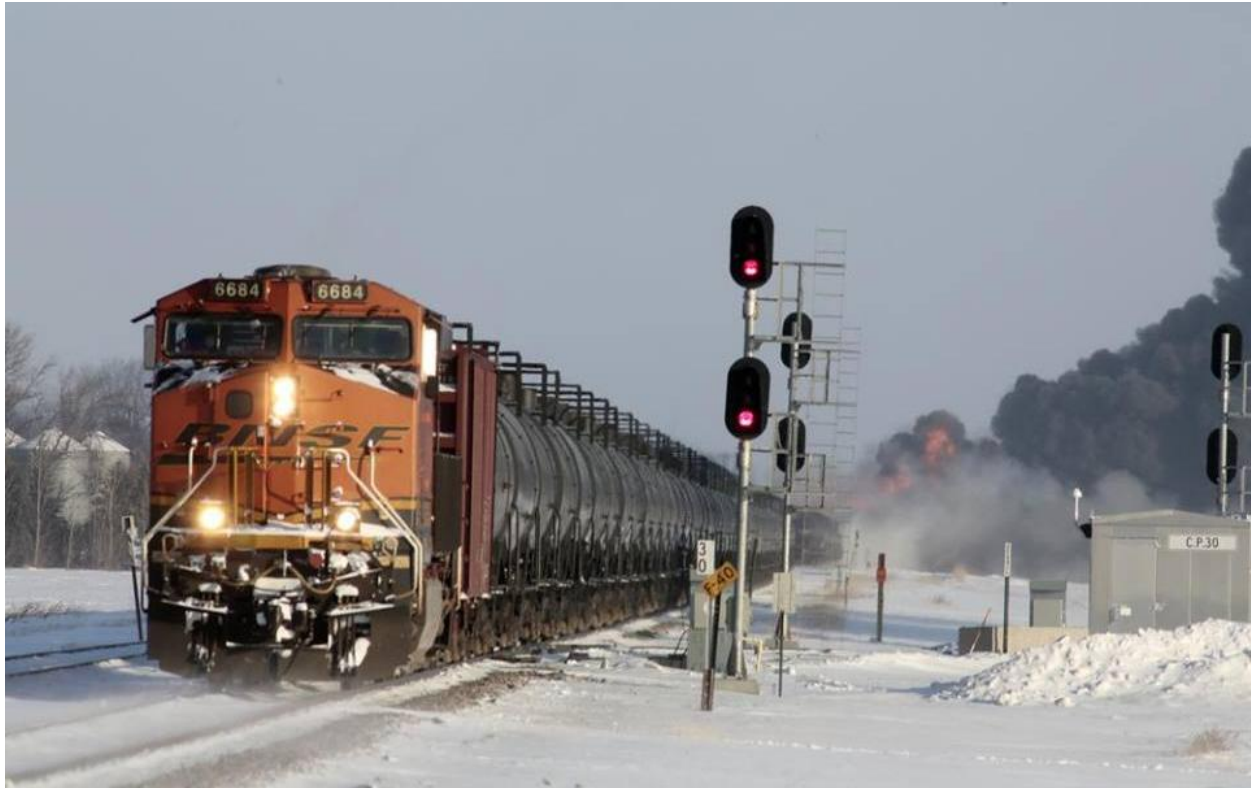
**Figure 2-Photograph of the Eastbound Train's DPU, BNSF 6684**

Upon receiving the request, the road foreman of engines consulted with the crew to see if they felt it was safe to move the cars, which they did. The engineer and student engineer went to the DPU on the eastbound train and the conductor and road foreman of engines went to the east to the nearest grade crossing and made a cut of an estimated 50 tank cars, and the engineer and student engineer pulled the cars about a quarter mile west, away from the burning cars.
