NATIONAL TRANSPORTATION SAFETY BOARD

Group Chairman's Factual Report

OPERATIONAL FACTORS

DCA17FA076

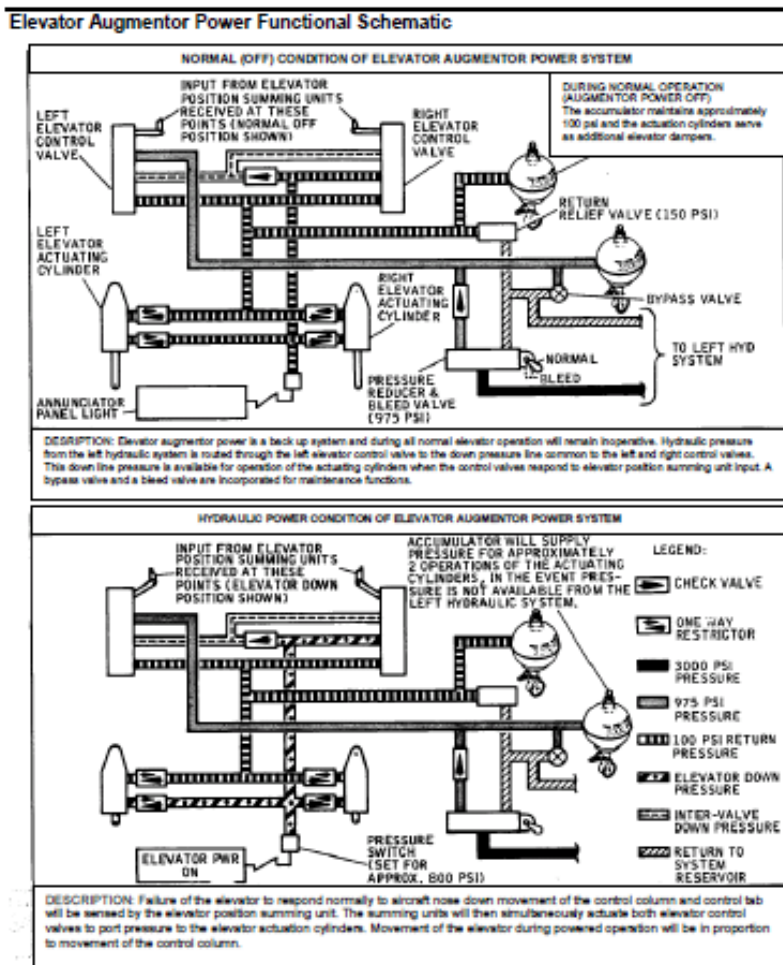
The actuator cylinders with restrictor check valves and a low-pressure accumulator in the return line were also used as gust dampers.

To provide the flight crew with operating information, an elevator power-on light was provided on the annunciator panel. The light was operated by a pressure switch and would come on when hydraulic pressure was used to drive the elevator. The augmentation system was tested as part of the Taxi Checklist. For additional information, see Section 14.2 Taxi Checklist of this Factual Report.

Figure 9: Elevator Augmentor Power Functional Schematic.⁷¹

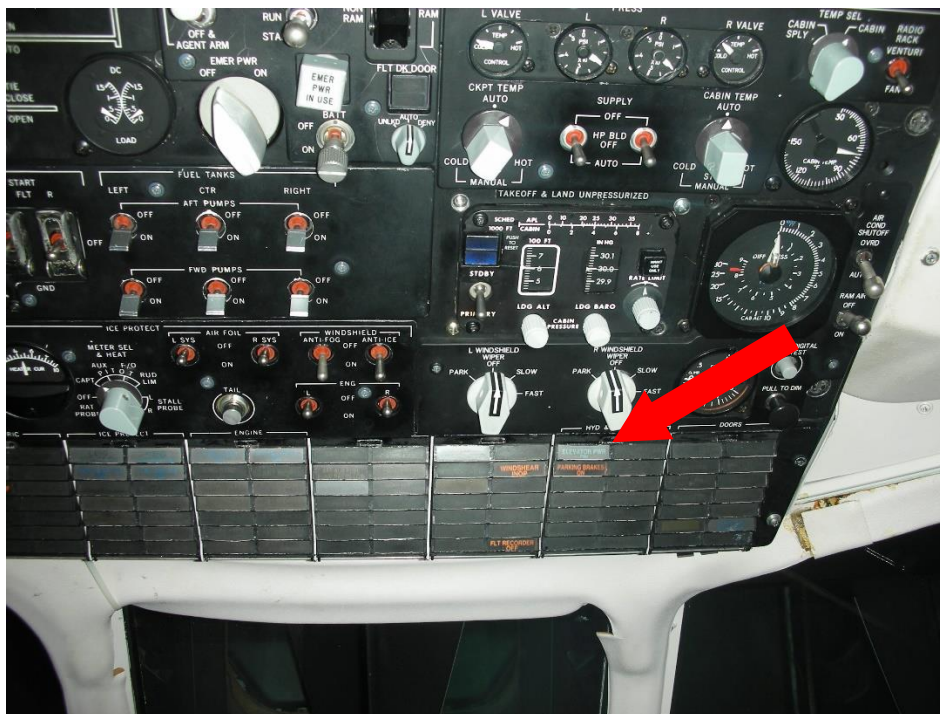
Control column to the full aft position while noting that the ELEVATOR POWER ON Light is off and then pushing the control column full forward while noting that the Blue ELEVATOR POWER ON Annunciator Light illuminates indicating the elevator augmentation system is working. While still holding the control column full left and noting hydraulic.

Photo 2: Overhead annunciator indications with control column full forward. “Elevator Pwr On” light indicated by arrow.⁹⁹

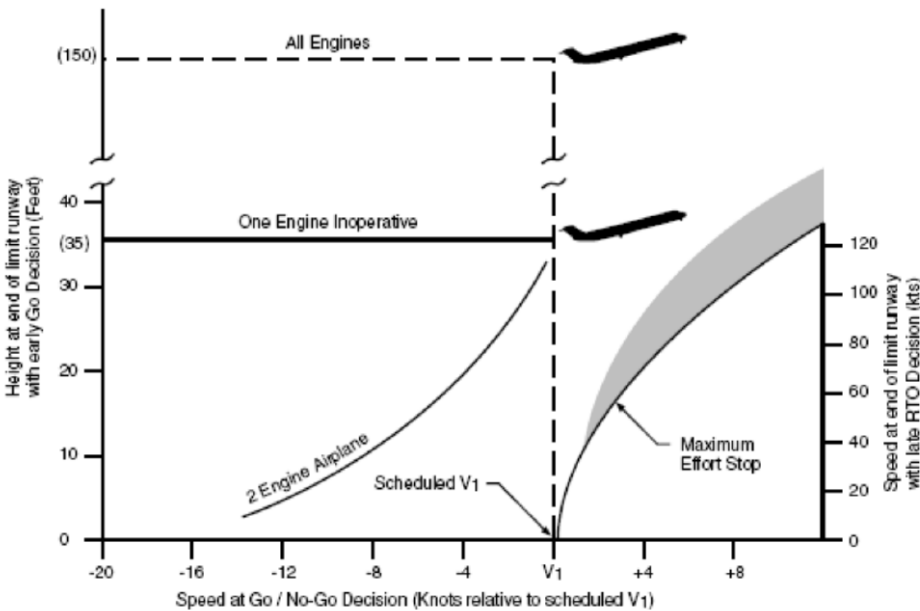
When takeoff weight is at or near the runway limited takeoff weight (due to field length, not obstacle clearance), the balanced field length approaches the available runway. In this scenario:

- *An RTO past V₁ (late decision) results in the aircraft unable to stop on the remaining runway. Delaying an RTO 4 to 6 knots beyond V₁ (approximately 1 second) may cause the aircraft to leave the end of the runway at approximately 70 knots or more. The shaded area shows that anything less than maximum deceleration significantly increase that speed.*
- *Conversely, an engine failure prior to V₁, coupled with a decision to continue the takeoff (early decision), results in less than 35 feet clearance at the end of the runway.*

Figure 12: Speed at Go/No-Go Decision (Knots relative to scheduled V1).¹⁰⁹
