## **NATIONAL TRANSPORTATION SAFETY BOARD**

### **Operations Group Chairman's Factual Report**

# **OPERATIONAL FACTORS**

**DCA15FA185**

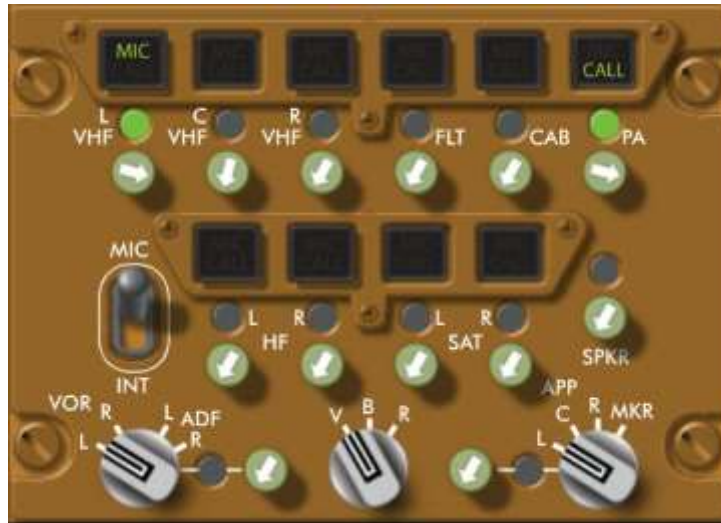
Figure 2: B-777 Audio Control Panel.<sup>33</sup> [Courtesy of Boeing]

The audio control panels were used to manage the radio and interphone communication systems. Navigation receiver audio could also be monitored. The Captain, First Officer, and First Observer audio control panels were installed on the aft aisle stand (Figure 3). Microphones were keyed by pushing the desired audio control panel transmitter select switch and using the MIC position on the control wheel or audio control panel microphone/interphone switch, a glareshield MIC switch, or a hand microphone push-to-talk switch.

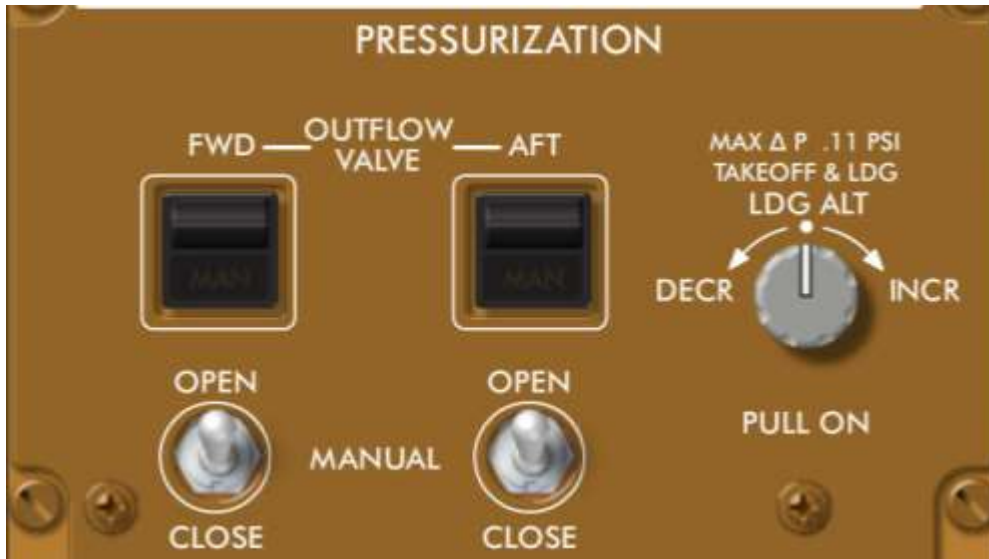
Figure 5: B-777 Pressurization Panel<sup>35</sup>

If both OUTFLOW VALVE switches were in MAN, all automatic cabin altitude control functions were bypassed. To operate either outflow valve manually, the respective outflow valve switch must be pressed to place it in MAN, and the open/close switch must be moved. (See Figure 5) The position of the respective outflow valve could be observed on the EICAS display (See Figure 3).

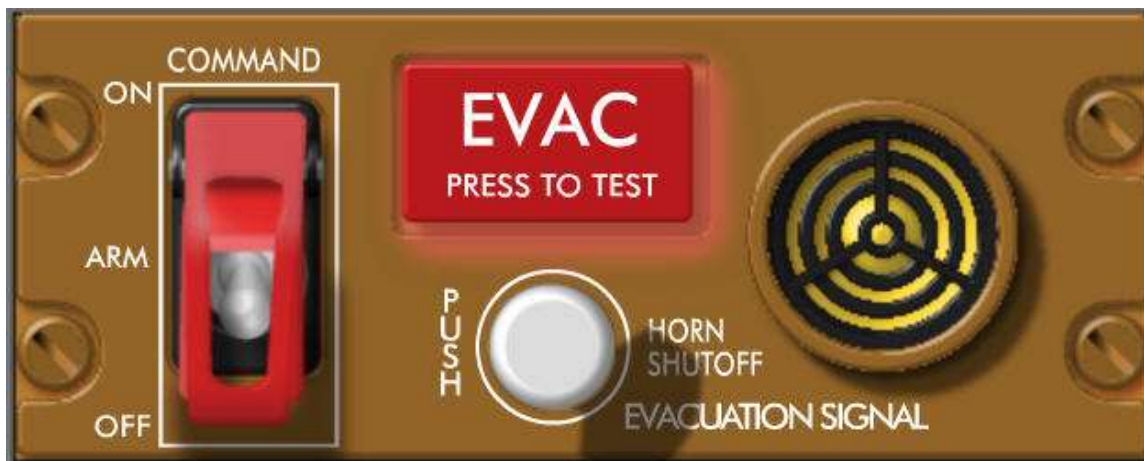
The emergency evacuation signal system alerted the flight attendants to evacuate the passenger cabin. Placing the flight deck evacuation signal COMMAND switch to ON activated the evacuation signal on the flight deck and on the flight attendant panels. With the flight deck evacuation signal COMMAND switch in the OFF (guard down) position, pressing an EVAC COMMAND switch on a flight attendant panel would activate the evacuation signals on the flight deck and on the flight attendant panels.

Figure 6: Emergency Evacuation Command Panel<sup>36</sup>

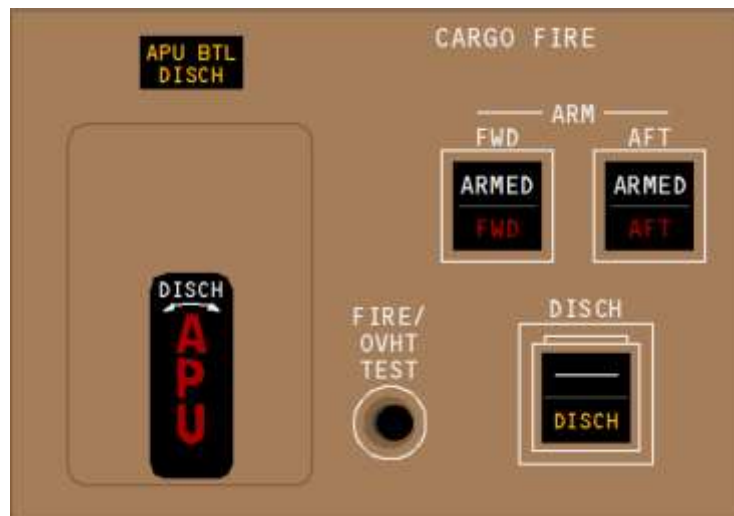
**Figure 9: B-777 Cargo Fire Control Panel.<sup>45</sup>**
