# PA-23-250 AZTEC C

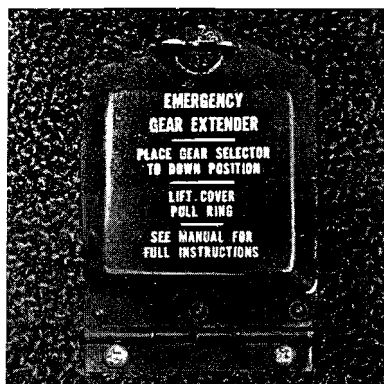
In the event of hydraulic system failure caused by a line breaking or the powerpak malfunctioning, the landing gear can be lowered by using the Emergency Gear Extender. The control for the extender is located beneath a small cover plate under the pilot's seat. When this control is pulled, CO<sub>2</sub> flows from a cylinder under the floorboards through separate lines to shuttle valves adjacent to the gear extension cylinders. The gas pressure opens the shuttle valves, allowing CO<sub>2</sub> to enter the gear cylinders, extending the gears.
