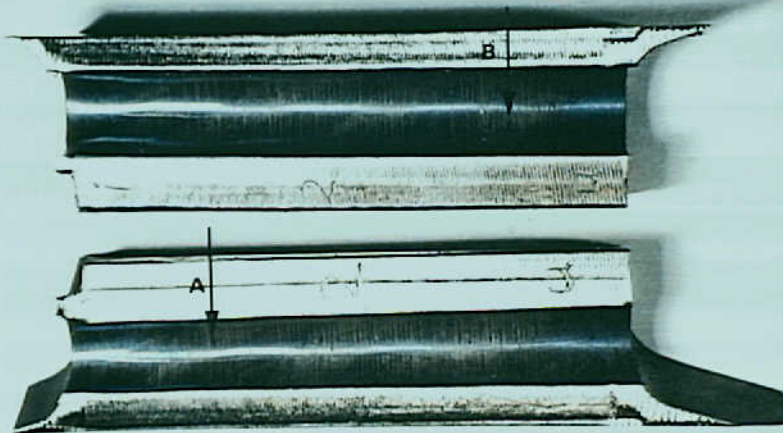
Photo 7. Hole #2 drilled with standard cutting data with HSS. The arrows show BEA indications consisting of impressions of chips smeared on the hole surface.
