SAIB: CE-10-08

SUBJ: Wings: Zodiac CH601XL and CH650 Wing Structural Modifications **Date:** November 7, 2009

| <p>ZODIAC CH 601 XL / 650</p> | <p>ZENAIR UPGRADE CENTER SPAR SECTION</p> | <p>6-ZU-2</p> |

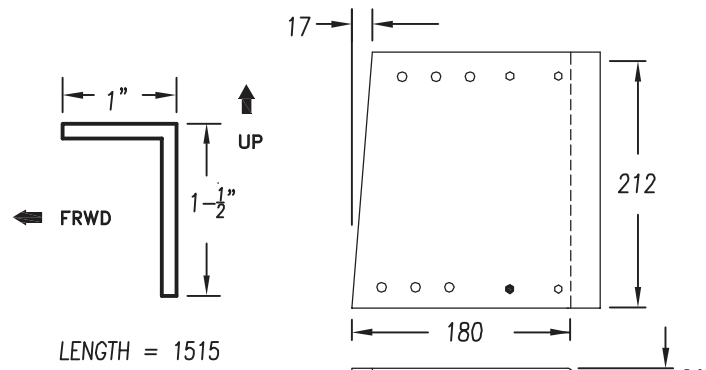
1 **WING UPPER EXTRUSION**
EXT. 6061-T6 1"x1-1/2"x1/8"
(2 REQ'D)
REPLACES PART OF 6W3-6 ANGLE

4 **UPPER ANGLE**
t=.040" 6061-T6 (4 REQ'D)

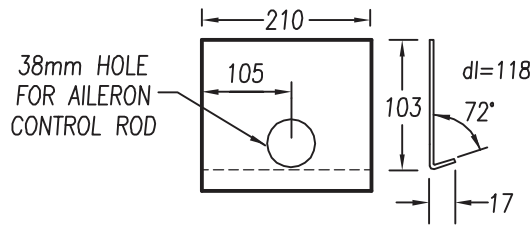
5 **REAR CHANNEL DOUBLER**
t=.040" 6061-T6 (2 REQ'D)
REPLACES HINGE DOUBLER 6W7-3

L **STANDARD L ANGLE**
t=.025" 6061-T6 (8 REQ'D)
TRIM TO FIT

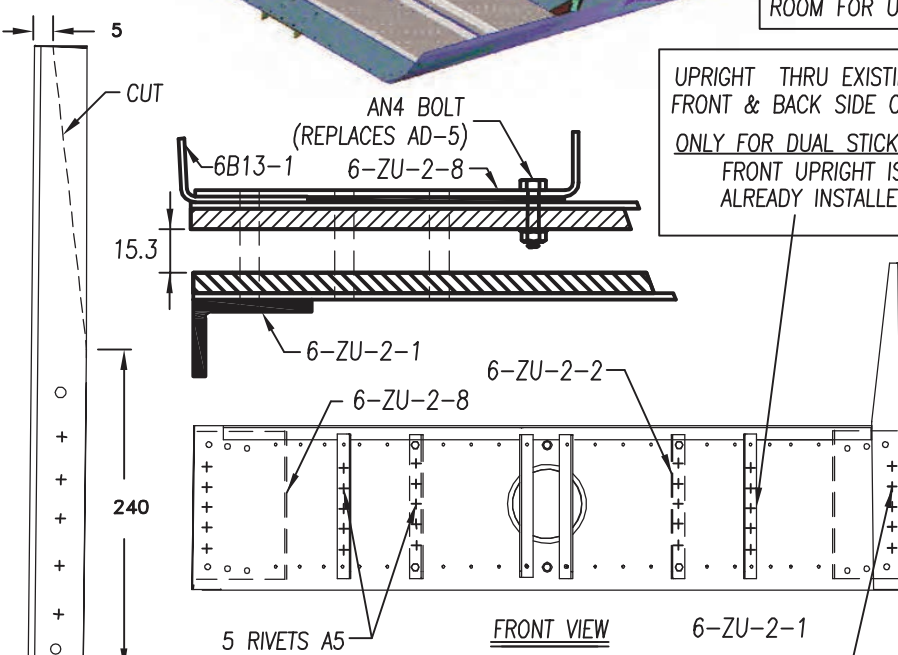
CUT NOTCHES TO MAKE ROOM FOR UPRIGHTS

UPRIGHT THRU EXISTING BOLTS FRONT & BACK SIDE OF SPAR.
ONLY FOR DUAL STICK OPTION: FRONT UPRIGHT IS ALREADY INSTALLED.

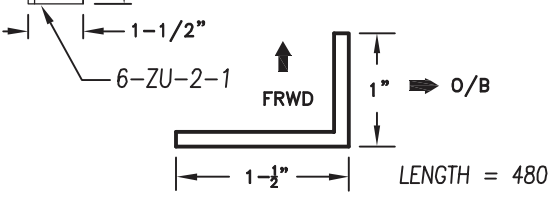
1 FRONT WING UPRIGHTS
EXT. 6061-T6 1"x1-1/2"x1/8"
(1L + 1R REQ'D)
REPLACES 6B13-1 FRONT UPRIGHT and 65-B-13-1

5 RIVETS A5 THRU:
UPRIGHT 6-ZU-2-1
FRONT SPAR WEB 6W4-1

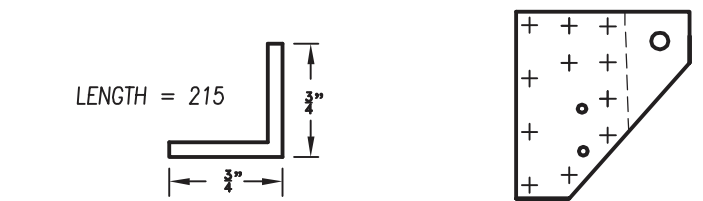
2 SPAR UPRIGHTD
EXT. 6061-T6 (4 REQ'D)
3/4"x3/4"x.093" LENGTH = 215

3 ATTACH PLATE
t=.125" 6061-T6 (1 REQ'D)
REPLACES 6B5-4 (NO CHANCES TO 65-B-5-4)

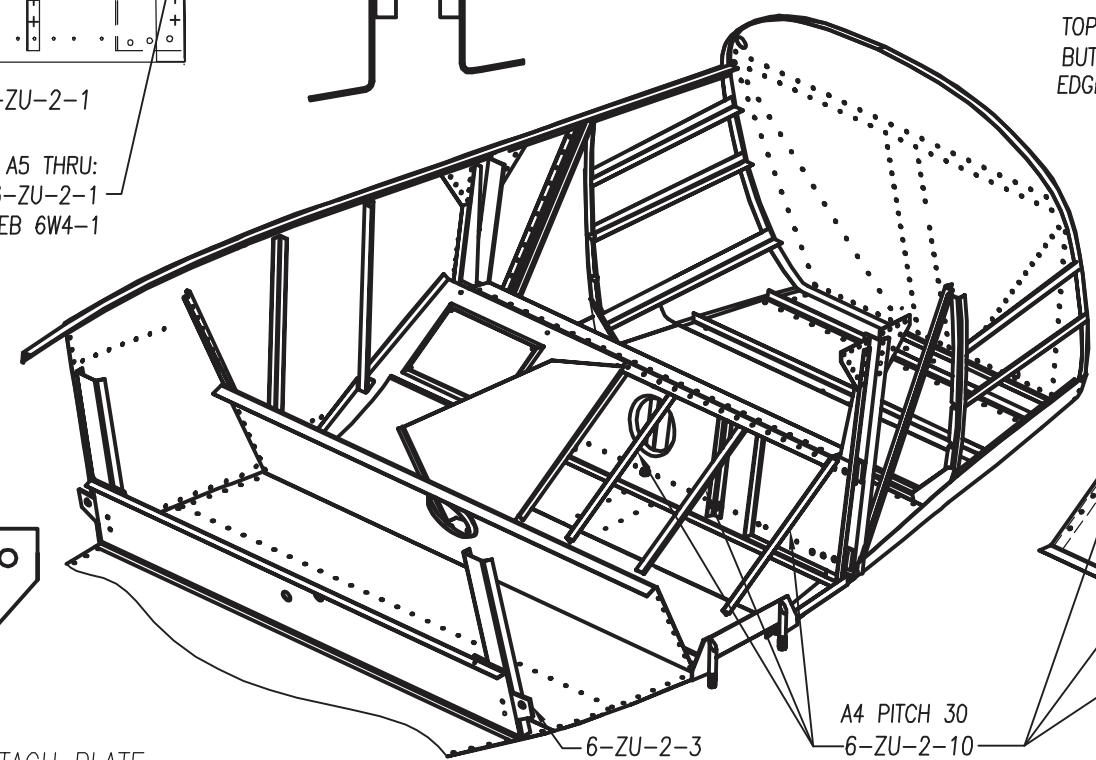
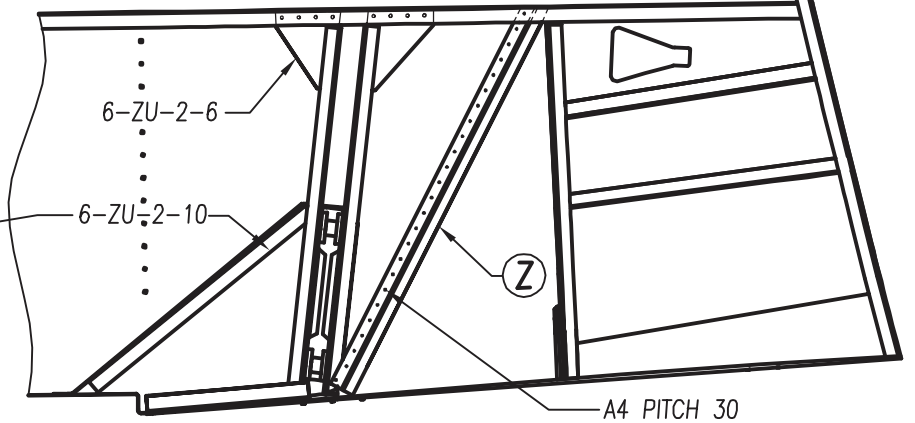
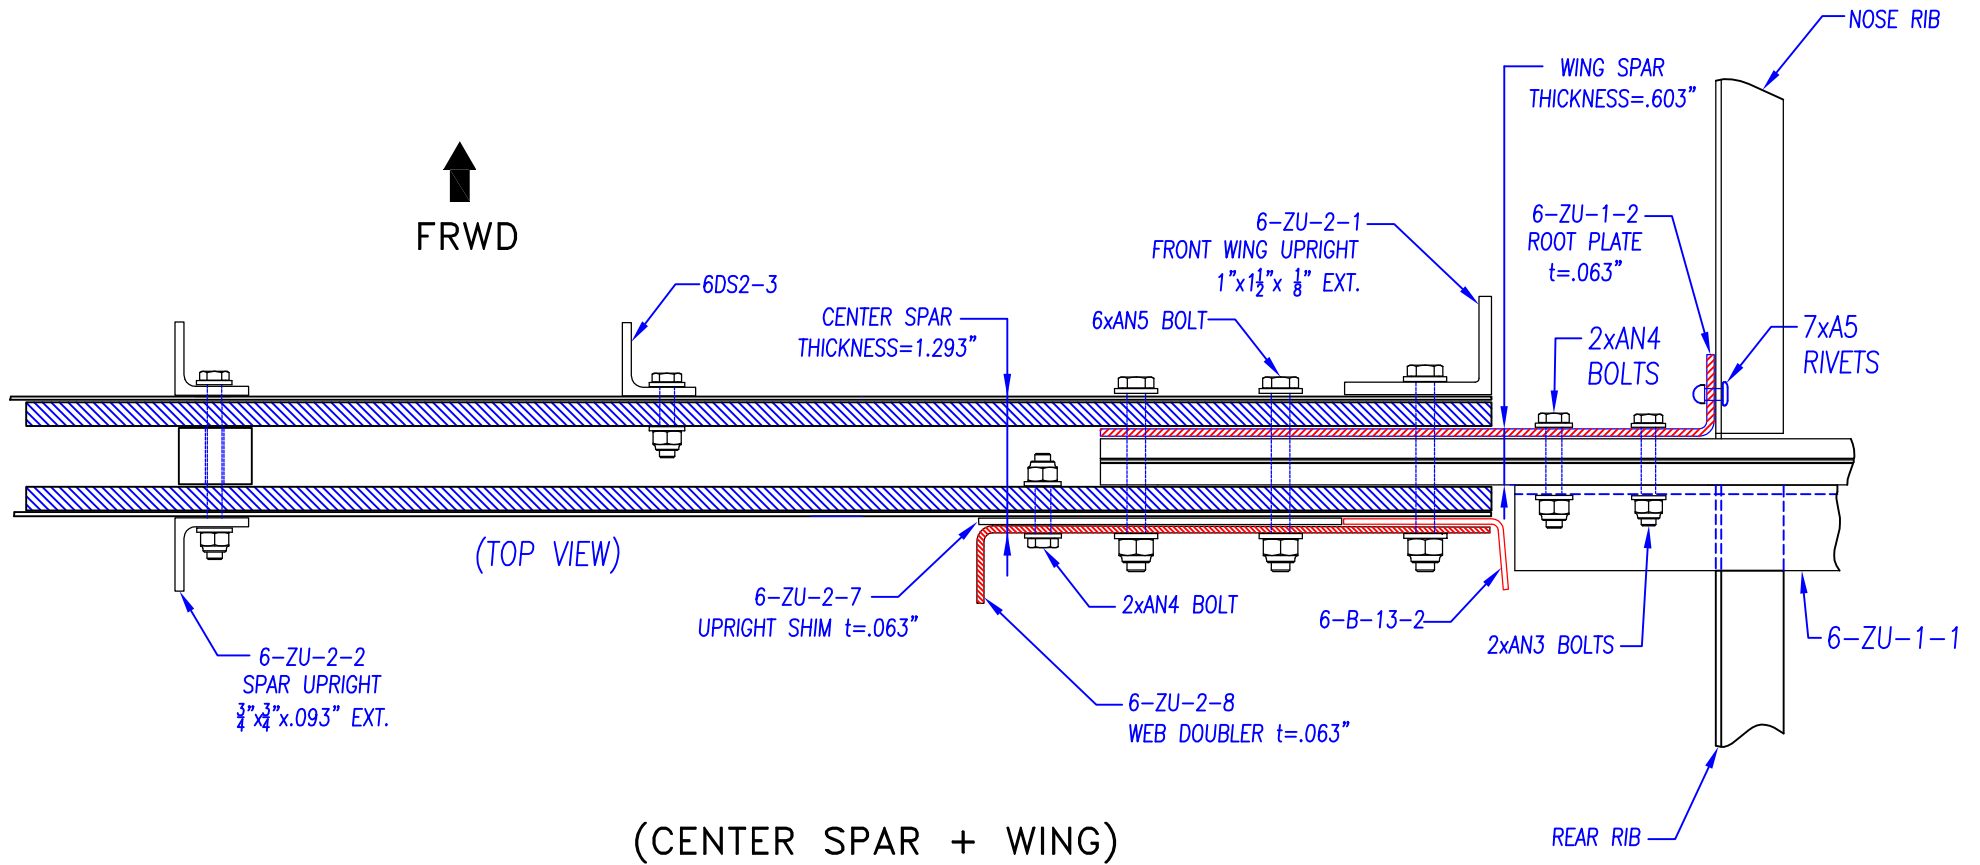
ZENAIR UPGRADE
CENTER SPAR SECTION
