Docket No. SA-522

Exhibit No. 7-GG

A300-600R Vertical Stabilizer Structure
Design & Certification

**A300-600R Vertical Stabilizer Structure
Design & Certification Approach**

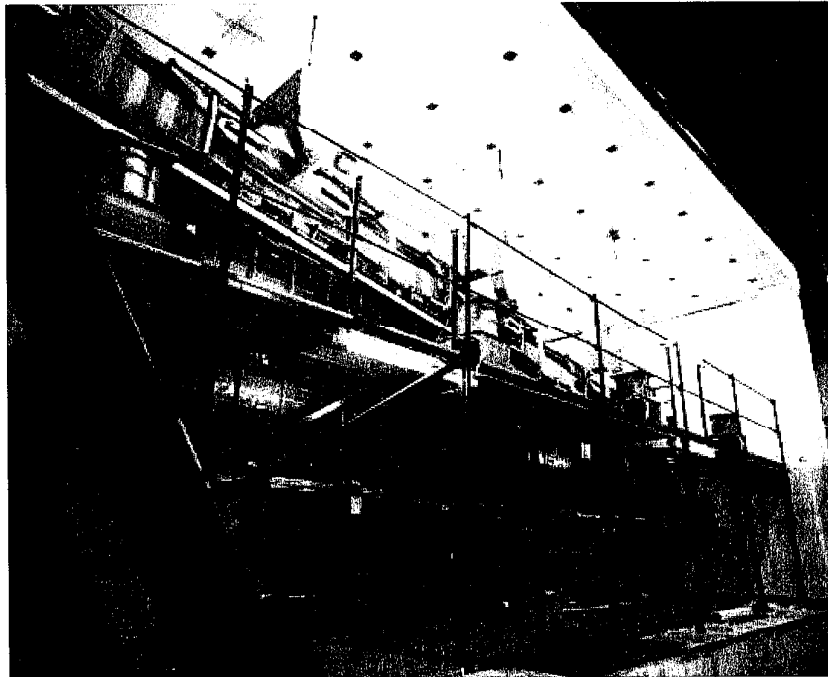
Because of an accidental fracture at the first specimen due to valve malfunction in the hydraulic test system, a new production fin box was prepared for testing in the already existing test rig. Only minor modifications were necessary to run the test. As for the first specimen the aim of this test was to demonstrate static strength, fatigue and damage tolerance for the new and aged structure. Severe climatic conditions had to be taken into account.

The aging had to include effects of fatigue, moisture pick up and the degradations that might occur during the life time. The test was carried out in a climate chamber.
