**SURVIVAL FACTORS GROUP  
CHAIRMAN'S FACTUAL REPORT**

**A. ACCIDENT : DCA99MA060**  
**LOCATION : Little Rock, Arkansas**  
**DATE : June 1, 1999**  
**OPERATOR : American Airlines**  
**TIME : 2351 Central Daylight Time (CDT)**  
**AIRCRAFT : McDonnell Douglas MD-82, N215AA**

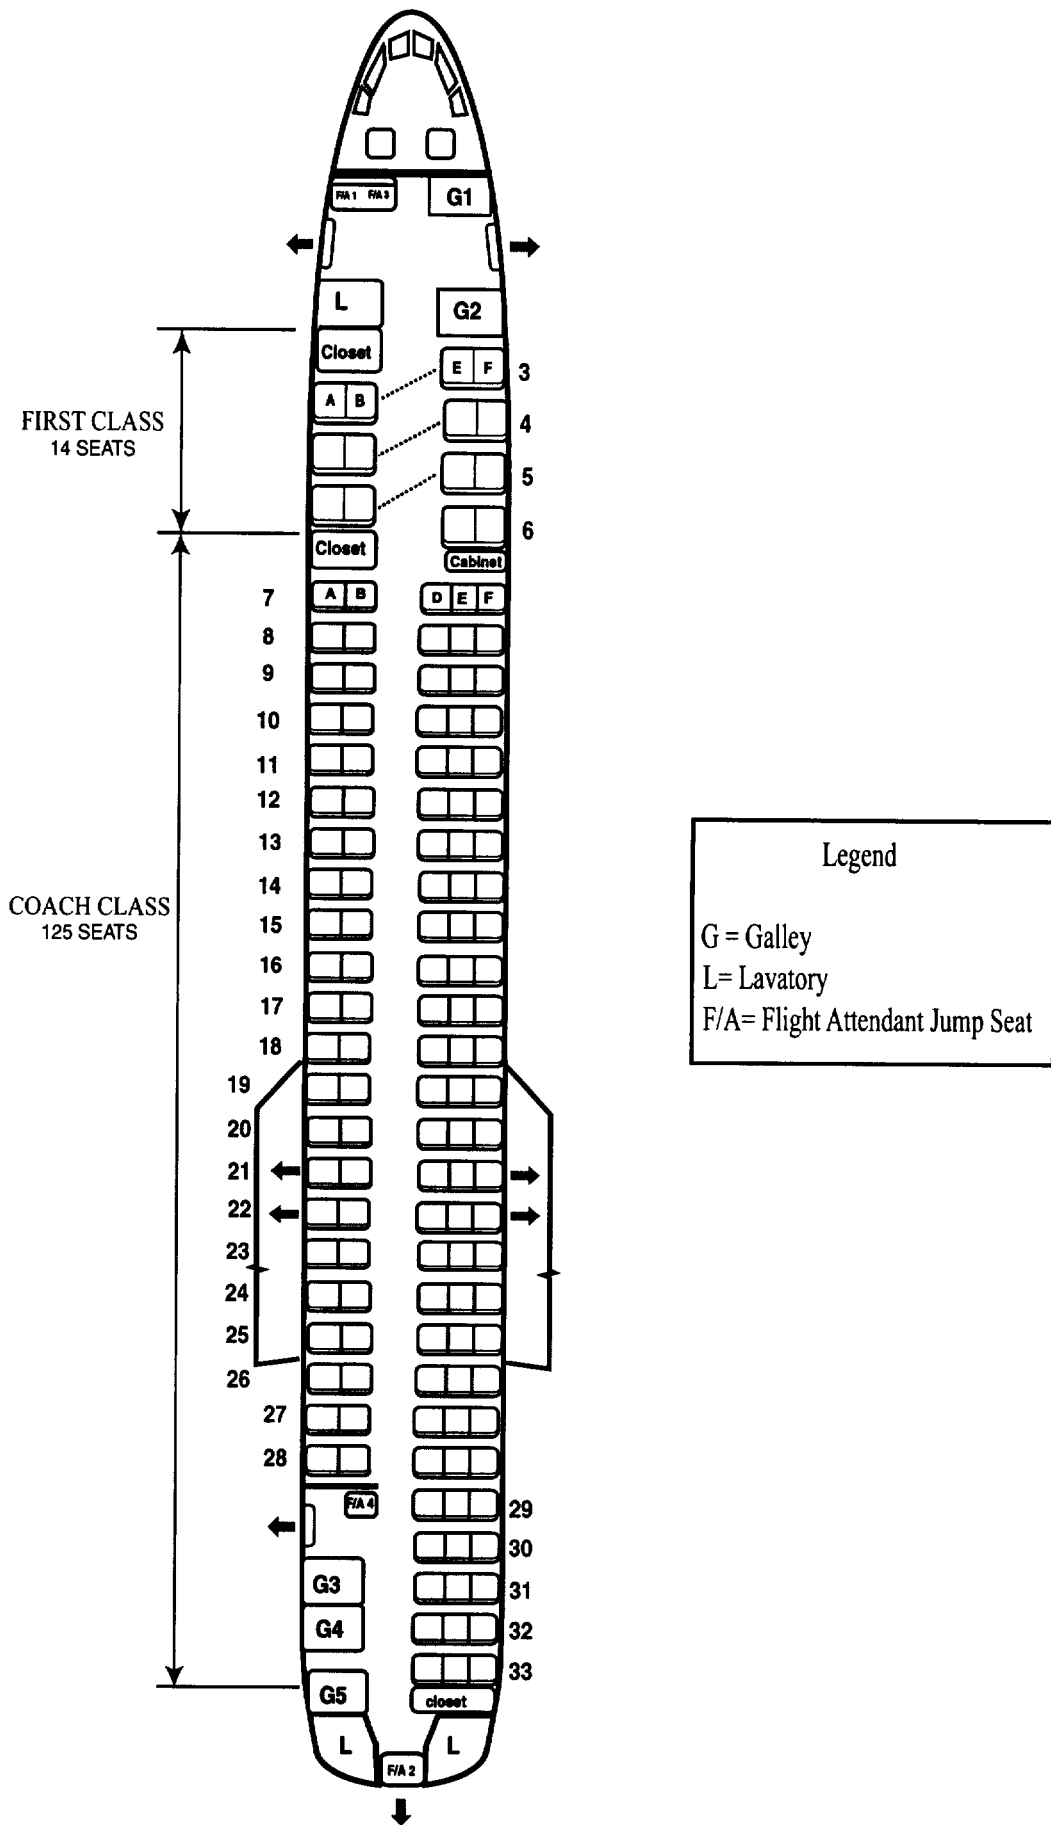
**Figure 1**  
**Airplane Cabin Configuration**

The airplane cabin was configured with 14 first-class passenger seats and 125 coach-class passenger seats. There was an aft-facing double occupancy flight attendant jumpseat at the 1L exit, and forward-facing double-occupancy flight attendant jumpseat mounted on the aft pressure bulkhead. A single forward-facing flight-attendant jumpseat was located in the aft galley at the 2L exit. The cockpit contained 2 flight crew seats and an observer's seat (Figure 1: Aircraft Cabin Configuration).
