NATIONAL TRANSPORTATION SAFETY BOARD
WASHINGTON, D.C.

SURVIVAL FACTORS GROUP FACTUAL REPORT OF
INVESTIGATION

SURVIVAL FACTORS GROUP FACTUAL REPORT OF INVESTIGATION

A.	<u>ACCIDENT</u>	:	DCA97MA058
	LOCATION	:	Nimitz Hill, Guam, Mariana Islands
	DATE	:	August 6, 1997
	TIME	:	0142 Local Time
	AIRPLANE/OPERATOR	:	Boeing 747-3B5B (300), S/N 22487, Flight 801, Operated by Korean Air

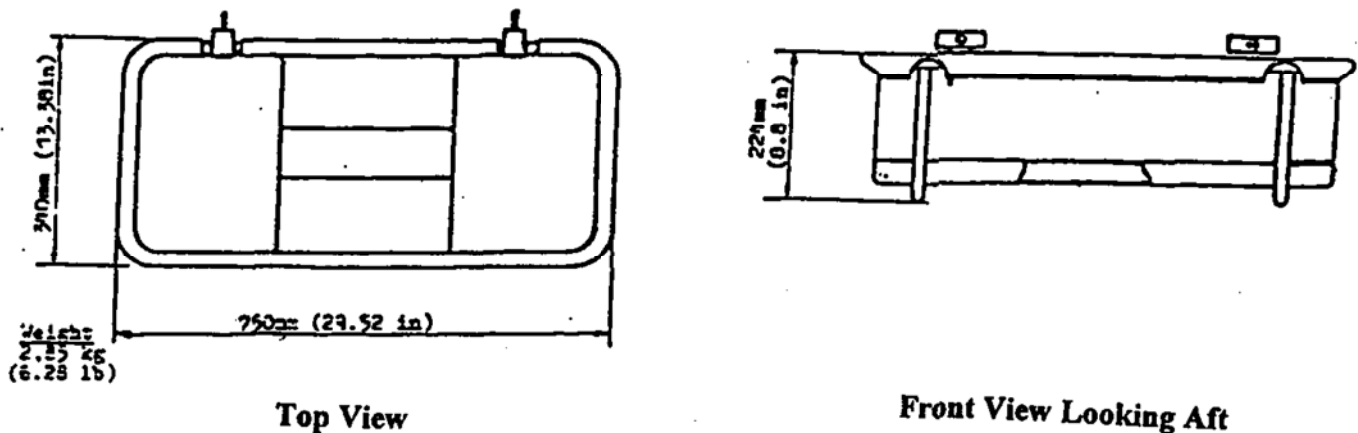
Figure 2
Baby Bassinet

The cabin also had bassinets for infants for in-flight use only, and not for takeoff and landing. The bassinets could be installed on the aft wall of the closet in first class; on the aft wall of the galley's near rows 7, 32 and 54, seats E and D, and seats D, E, F, and G respectively; and on the aft wall of the lavatory in front of row 43, seats D, E, F, and G as required. A diagram of the basset is shown in Figure 2 below:
