C. Summary

On December 8, 2005, 1914 Central Standard Time (CST), Southwest Airlines flight 1248, a Boeing 737-7H4 registered as N471 WN, overran Runway 31C at Midway International Airport in Chicago Illinois, during the landing rollout. The airplane departed the end of the runway, rolled through a blast fence, a localizer antenna array, a perimeter fence, and onto a roadway. The airplane came to a stop after impacting two automobiles. There were several minor injuries among the 98 passengers and 5 crewmembers on board. There was one ground fatality and several other ground injuries. Instrument meteorological conditions prevailed at the time. The airplane was substantially damaged. The flight was conducted under 14 CFR Part 121 and had departed from the Washington/Baltimore International Thurgood Marshall Airport, Maryland.

D. Details of the Investigation

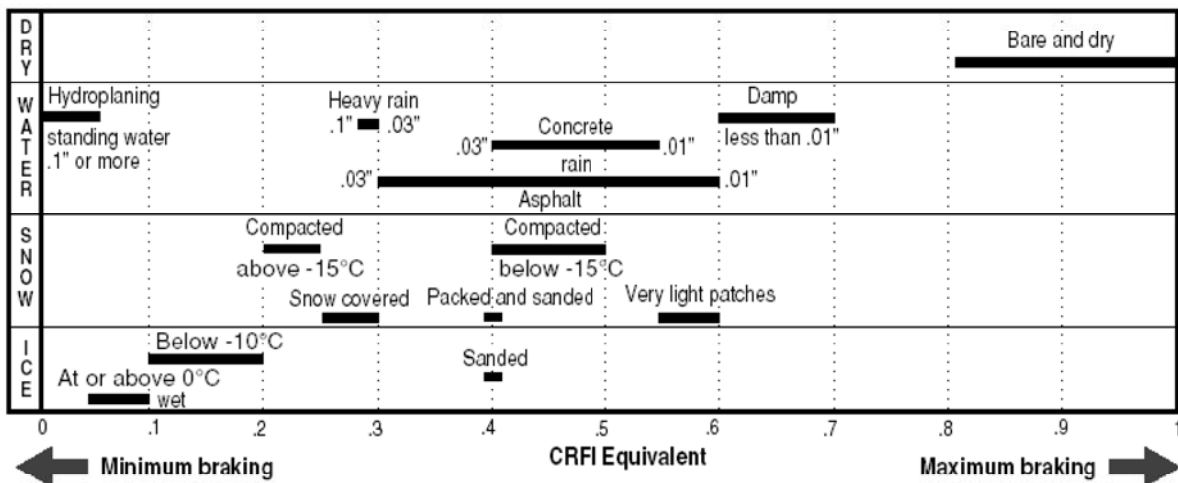
Figure 4. CRFI Equivalents

In addition, Figure 4. contains average equivalent values of CRFI produced by typical runway surface conditions, and, according to Transport Canada, may be used as a guide when CRFI numbers are not available.
