DOCKET NO. SA-510

SURVIVAL FACTORS GROUP FACTUAL REPORT OF INVESTIGATION

Aircraft: Boeing 737-300, N513AU

NTSB Accident Number: DCA-94-MA-076

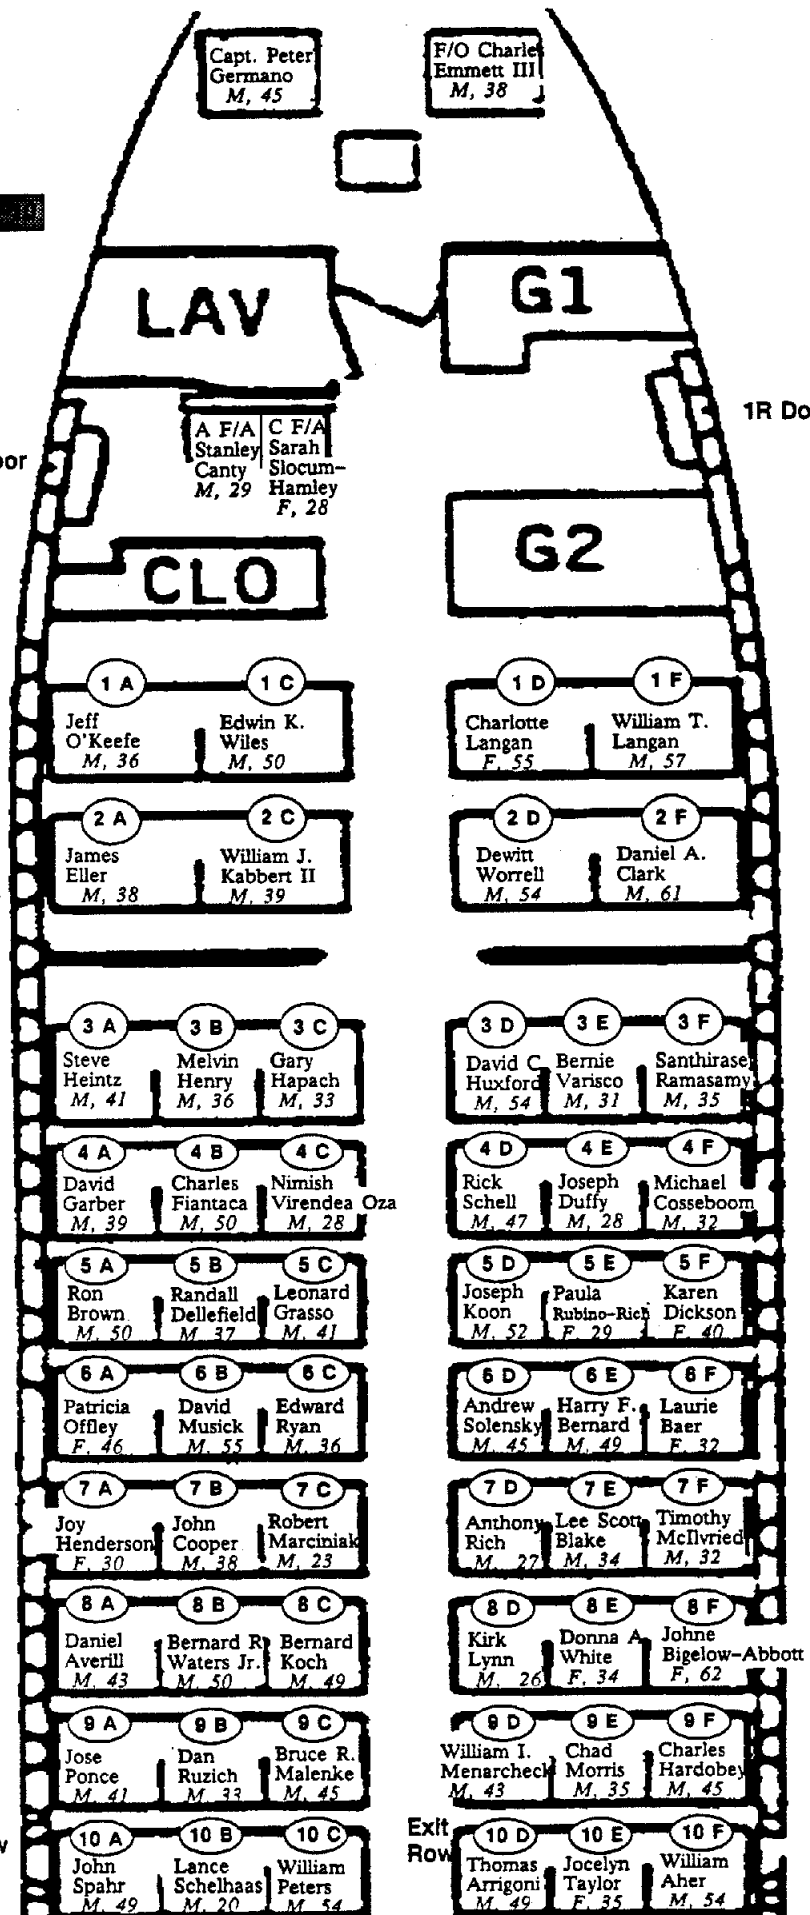
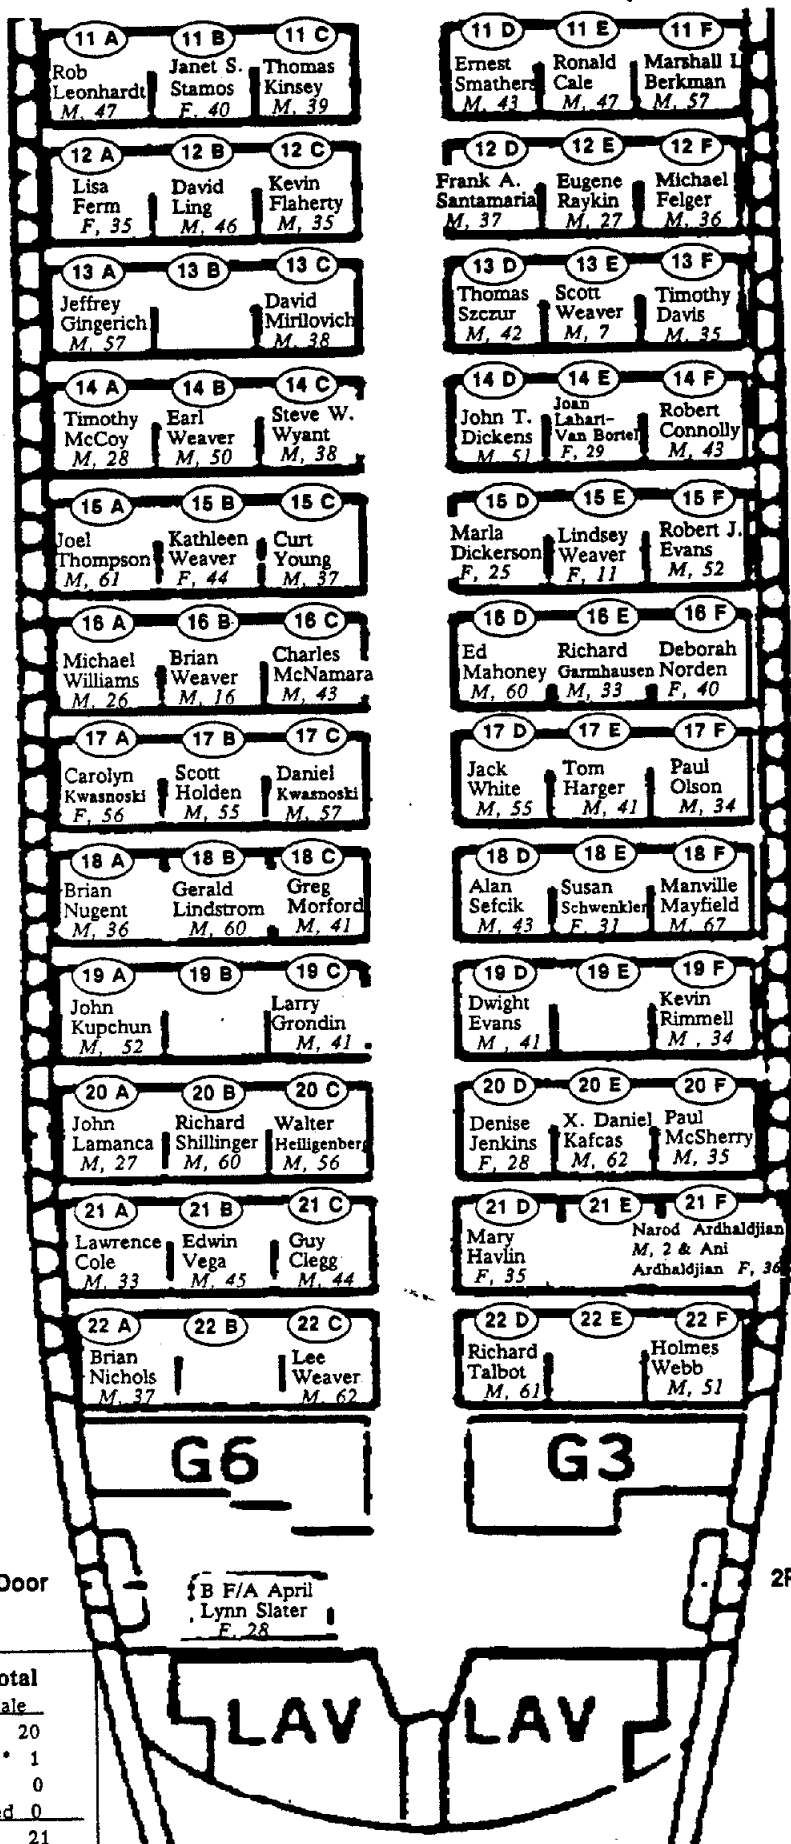
1L Door

1R Door

Emergency Exit Row

ROWS 11-22

2L Door

2R Door

Passengers		126 Total	
<u>Male</u>		<u>Female</u>	
Adult	102	Adult	20
Child *	3	Child *	1
Infant	0	Infant	0
Disabled	0	Disabled	0

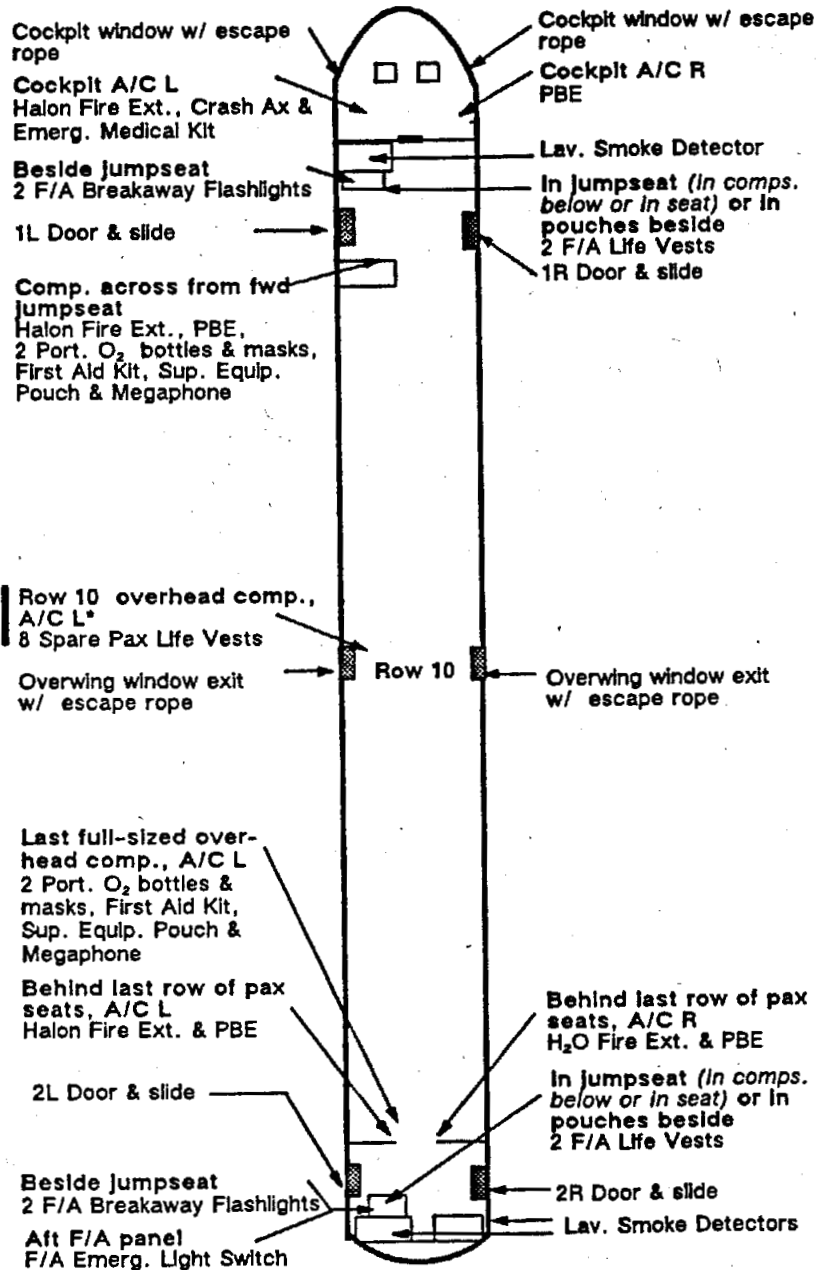
ATTACHMENT B

B-737-300 Emergency Equipment and Exit Locations*

* This chart was copied from the USAir Flight Attendant Emergency Manual Rev. 22/Nov. 1993.

B-737-300 EMERGENCY EQUIPMENT & EXIT LOCATIONS

*Only on LV-equipped A/C, which also have installed one life vest under each pax seat. All 737-300s are having pax life vests installed.
