## **NATIONAL TRANSPORTATION SAFETY BOARD**

### **Group Chairman's Factual Report**

# **METEOROLOGY**

**ERA16FA140**

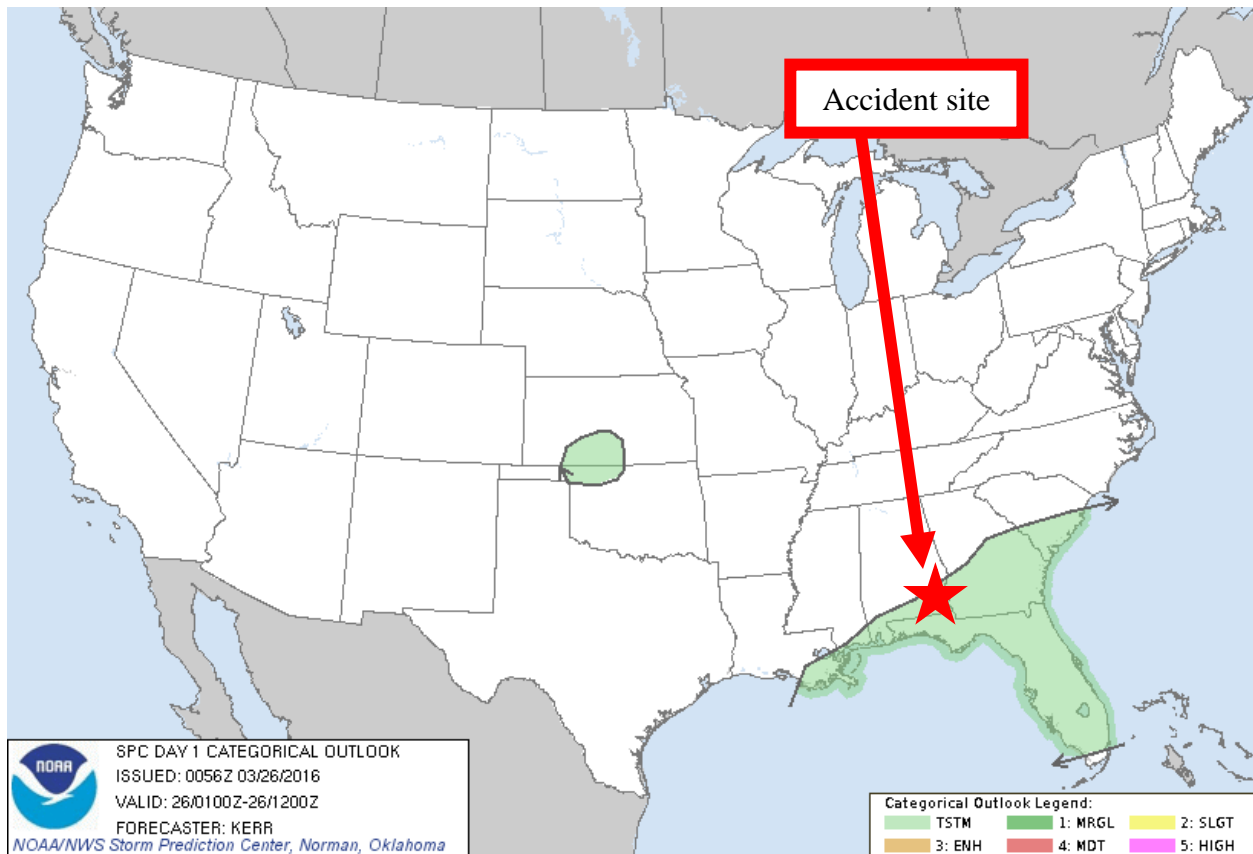
SPC issued the following Day 1 Convective Outlook at 1956 CDT on March 25 (figure 7) with areas of general (non-severe) thunderstorms forecast for the accident site around the accident time:

**Figure 7 – Storm Prediction Center day 1 Convective Outlook valid at the time of the accident**
