NATIONAL TRANSPORTATION SAFETY BOARD

STRUCTURES GROUP CHAIRMAN'S FACTUAL REPORT

A. ACCIDENT: CEN19FA030

Operator: Bismarck Air Medical
Location: Harmon, North Dakota
Date: November 18, 2018
Time: 2240 Central Standard Time
Aircraft: Cessna 441
Registration: N441CX

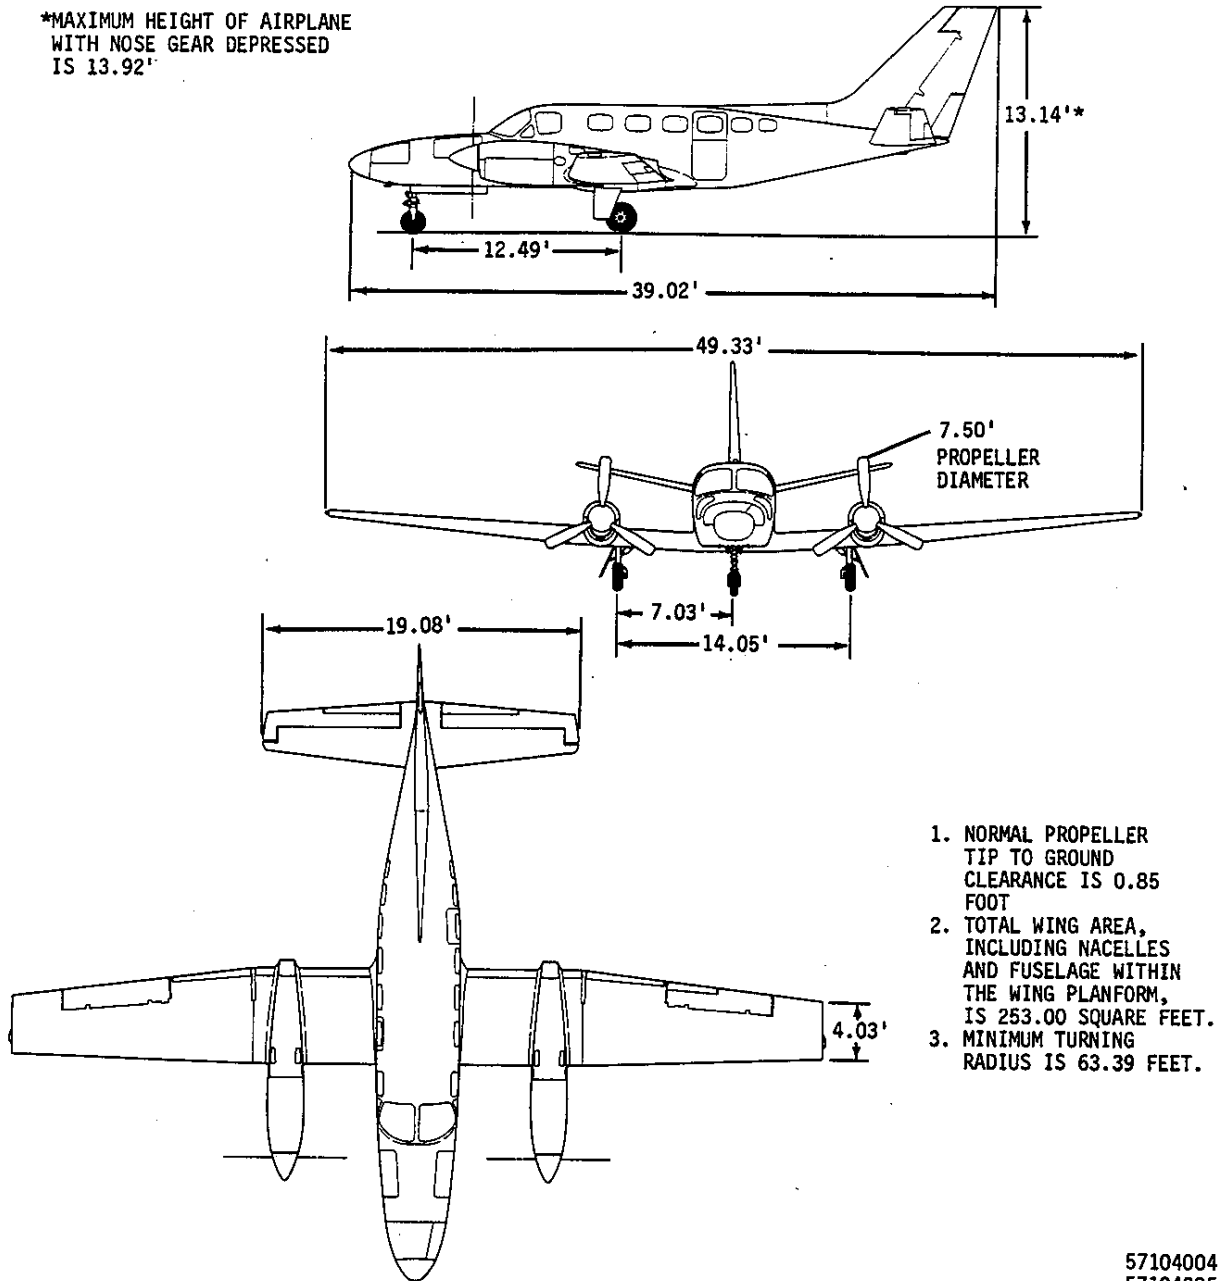
*MAXIMUM HEIGHT OF AIRPLANE
WITH NOSE GEAR DEPRESSED
IS 13.92'

Figure 1 - Cessna 441 Conquest II 3-view drawing

The Cessna 441 Conquest II is a twin-engine, pressurized, low wing, all metal airplane with a conventional tail and retractable tricycle landing gear (Figure 1¹). The airplane is 39.02 feet long, 13.14 feet tall at the tail, and has a wingspan of 49.33 feet. The airplane is powered by two Garrett TPE331 turboprop engines with McCauley 4-blade full-feathering tractor propellers. The accident airplane was configured for air medical transport and had small winglets installed at the outboard end of each wing increasing the wingspan by about 6 inches.

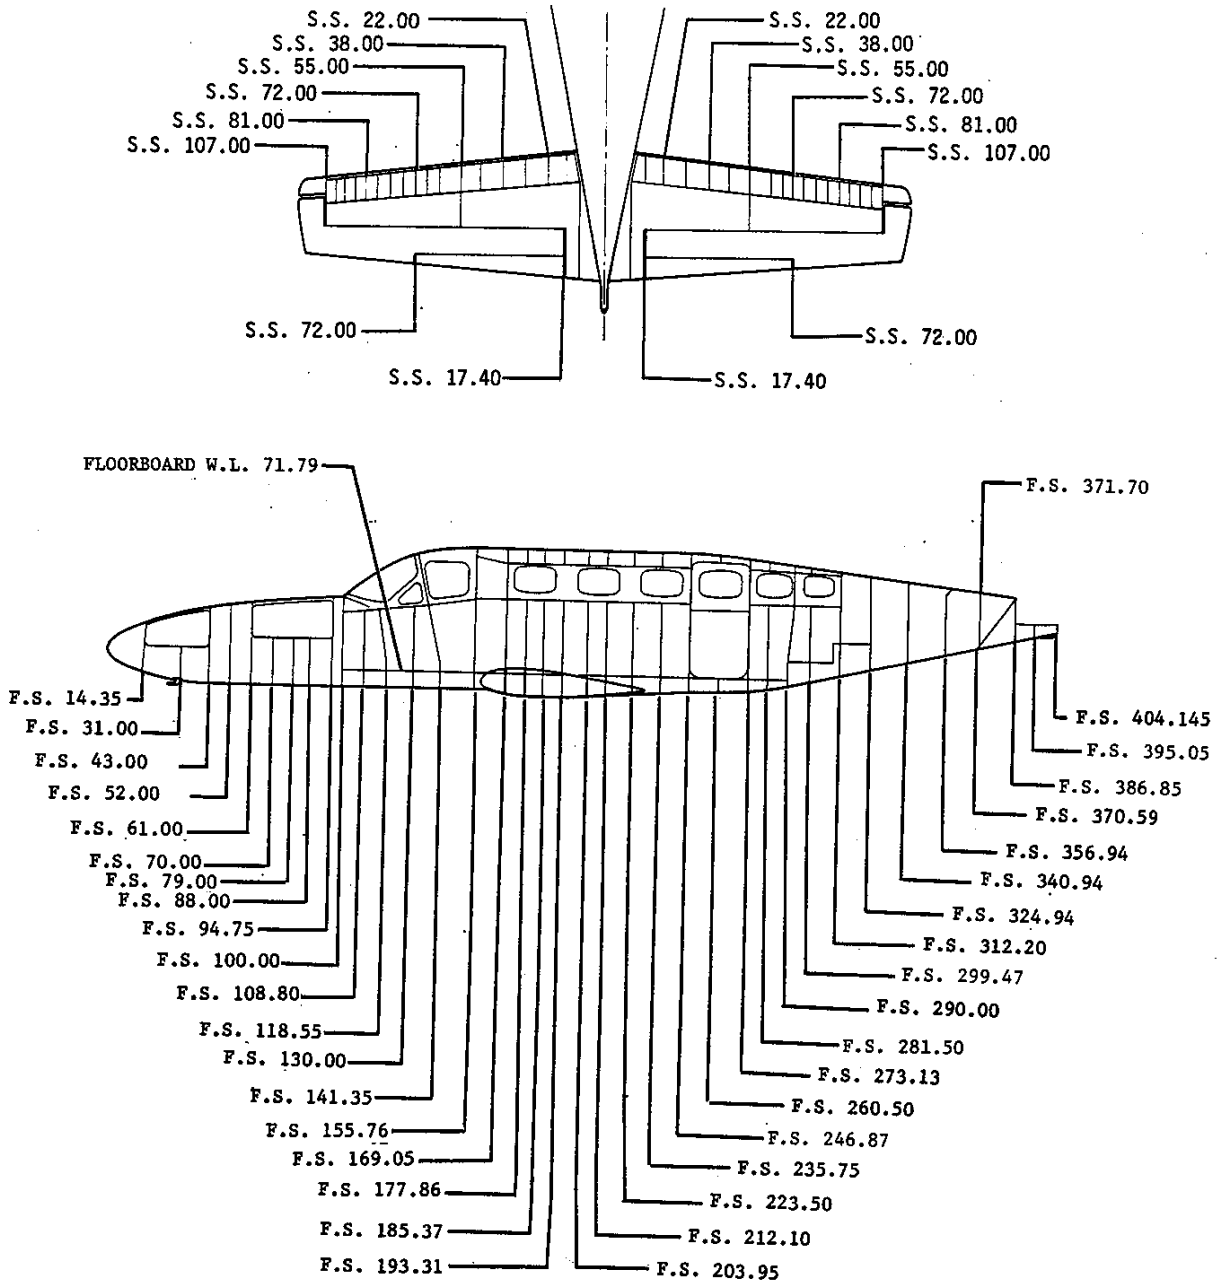
Figure 2 – Cessna 441 fuselage station and stabilizer station diagram

Cessna defines the location of parts of the airplane longitudinally and laterally using station locations and vertically using waterline locations measured in inches from a datum as shown in Figures 2 and 3. The fuselage station (FS) datum is located forward of the nose of the airplane. The center wing station (CWS) datum is located at the centerline of the airplane and distances on the left and right sides are measured outboard to the end of the center wing. The panel (outboard) wing station (PWS) datum is located at the attach point to the center wing and is defined as PWS 10.00 on the left and right outboard wings. The horizontal stabilizer station (SS) datum is located at the centerline of the airplane and distances on the left and right sides are measured outboard. The waterline (WL) datum is parallel to the ground and located 84 inches below the propeller centerline. The Cessna 441 wing is manufactured in 3 pieces. The center wing spans from outboard of the left engine to outboard of the right engine (LCWS 120.411 to RCWS 120.411) and is about 20 feet long. The outboard wing sections, each about 14.5 feet long (PWS 10.00 to PWS 184.32) attach to the center wing at left or right CWS 120.411 (PWS 10.00). The center wing is constructed with 3 spars, a front spar centered at FS 169.05, a main spar centered at FS 177.45, and a rear spar centered at FS 204.05. The outboard wings are constructed with 2 spars, a main spar and an aft spar that connect with the center wing main and aft spars.

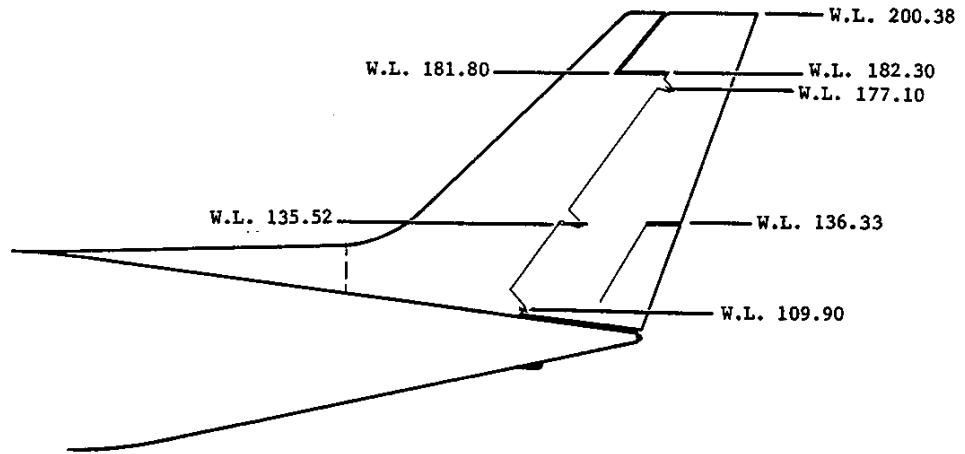
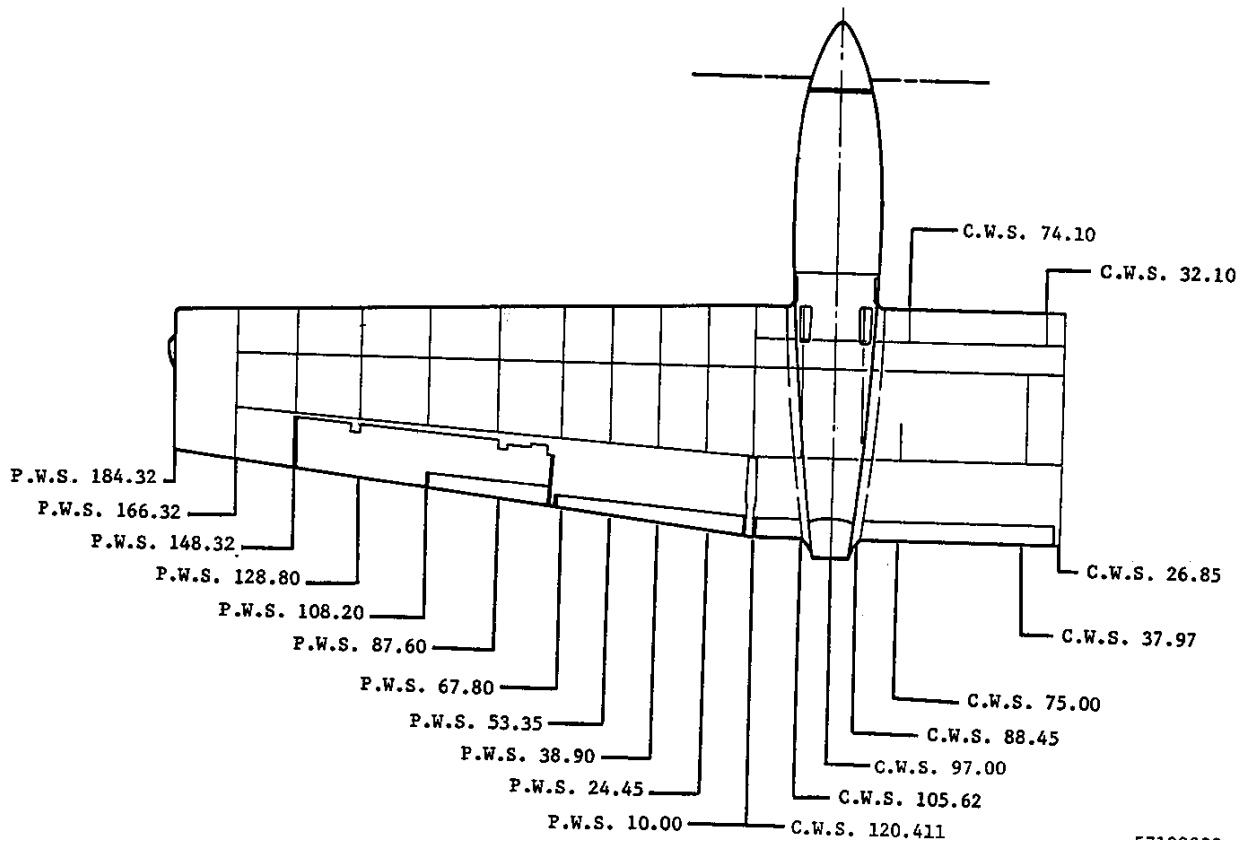
Figure 3 – Cessna 441 wing station and waterline station diagram
