Re: Accident ID DCA17FP006  
Millersville, PA  
2 July 2017 Pipeline Accident

Re: Incident # DCA17FP006  
Recommendation # P-18-1 through 4  
Honeywell Response

1 ¼ IPS to 4 IPS (PE) Main

**For Use On Polyethylene Gas Systems Only**

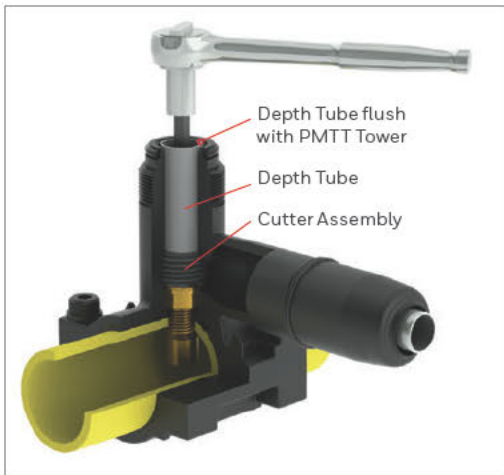
Fig. 4 - Full installation of Cutter Assembly, Cutter Sleeve engaged in (PE) Main, Depth Tube is flush with top of PMTT Tower

4. **Connect Outlet.** Connect PE service line to the PMTT assembly outlet using the appropriate installation instructions for that joint.
5. **Leak Test.** Test tapping tee/service line assembly in accordance with your company's standard leak test procedures.
6. **Tap the PE Main.** Place Depth Tube on top of the Cutter Assembly. Thread Cutter Assembly downward using a 5/16" hex wrench. Continue threading the Cutter Assembly downward until the Depth Tube is flush with the PMTT Tower, engaging the cutter.

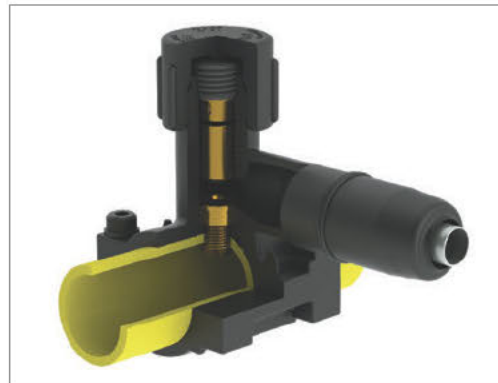
Fig. 6 - Completed Installation of Permalock Tapping Tee (PMTT)

8. **Replace PMTT Cap.** Install the PMTT Cap on the PMTT Tower. Hand tighten until the cap contacts the Cap Stop.
